## CITY OF OREGON CITY CITY COMMISSION WORK SESSION AGENDA

Review of Jon Storm Dock Structural Assessment

**JON STORM DOCK**  
**STRUCTURAL ASSESSMENT**  
SEPTEMBER 30, 2025  
KPFF PROJECT NO. 10022400409

# FIELD REPORT

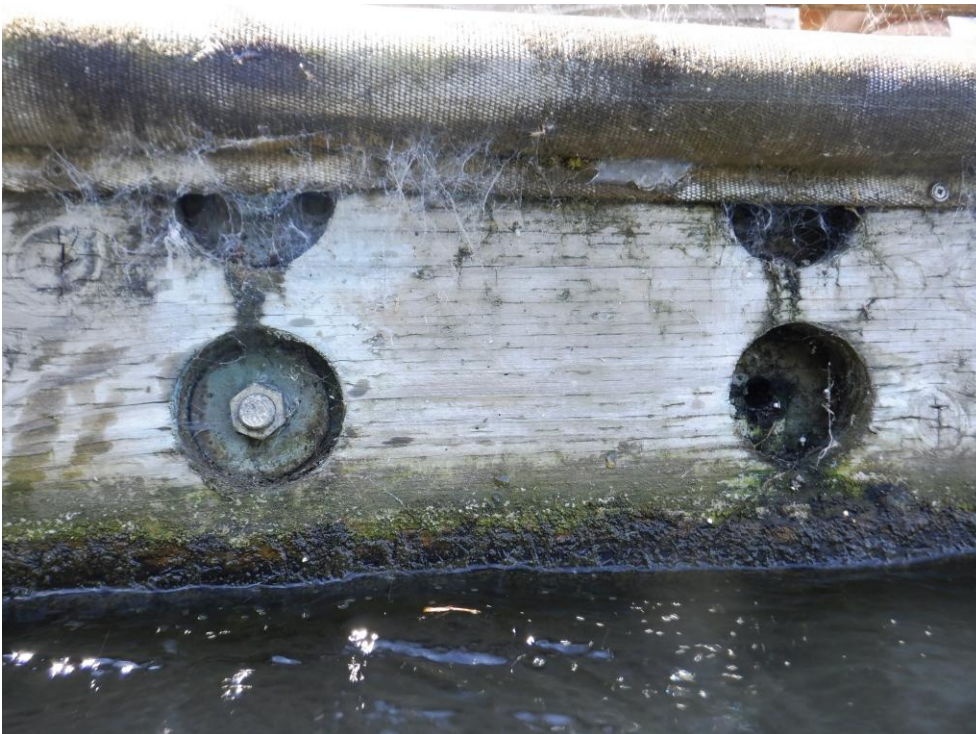
**Specific Defects:** A number of missing tie rods were observed in the timber fender system with one concrete float section, between piles 8 and 9, observed to move up to ¼ in. height when weighted down. The timber fender system, which consists of two 3 x 12 members and a 2 x 12 with a rub rail attached to the top, was observed to be damaged or hanging off the dock sections at piles 3, 5, 6 and 7. The bull rail was damaged at piles 2 and 4. The utilities for the dock were observed to be leaking at the connection beneath the ramp at the time of this inspection. See photos for visual representations. See attached drawing for specific locations of defects observed.

Figure 2: Missing bolts observed in fender system.

**Recommendations:** Replace missing tie rods in the timber fender system and replace the damaged/hanging members. Repair the damaged bull rail at damaged sections.

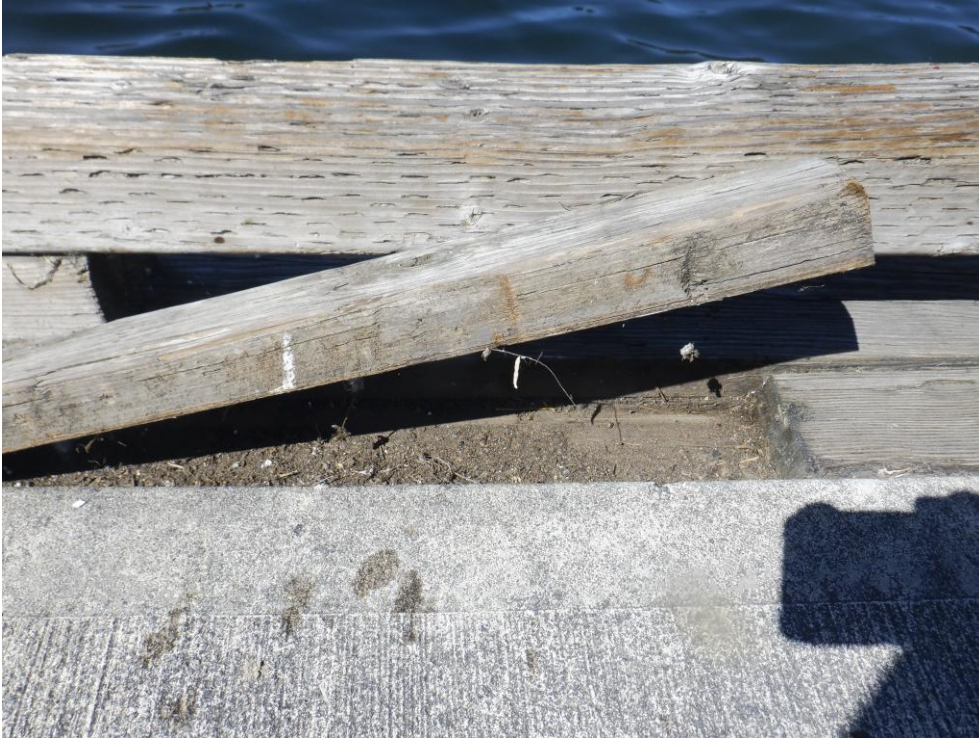
**Figure 3: Detached timber section along fender system.**

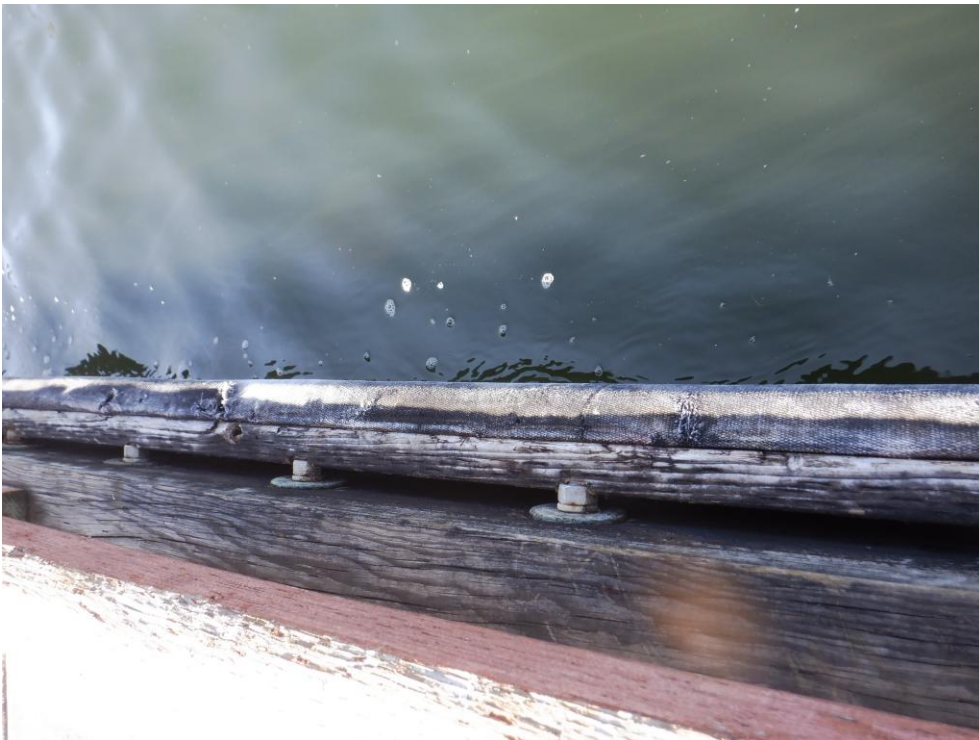
**Figure 4: Broken timber fender section.**

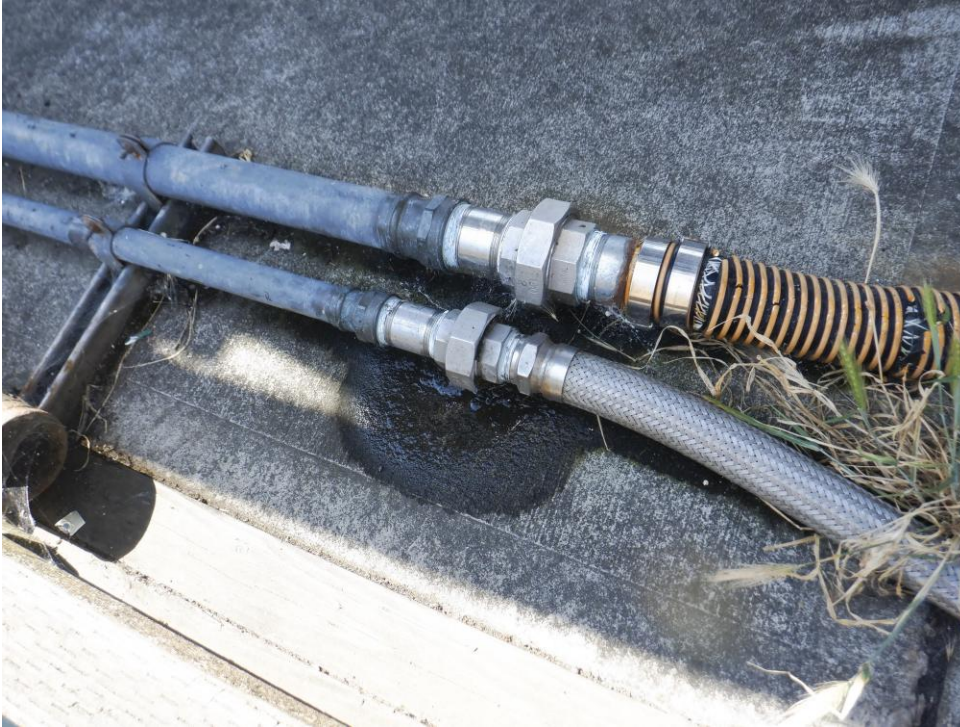
Figure 5: Leaking utilities, located beneath ramp.

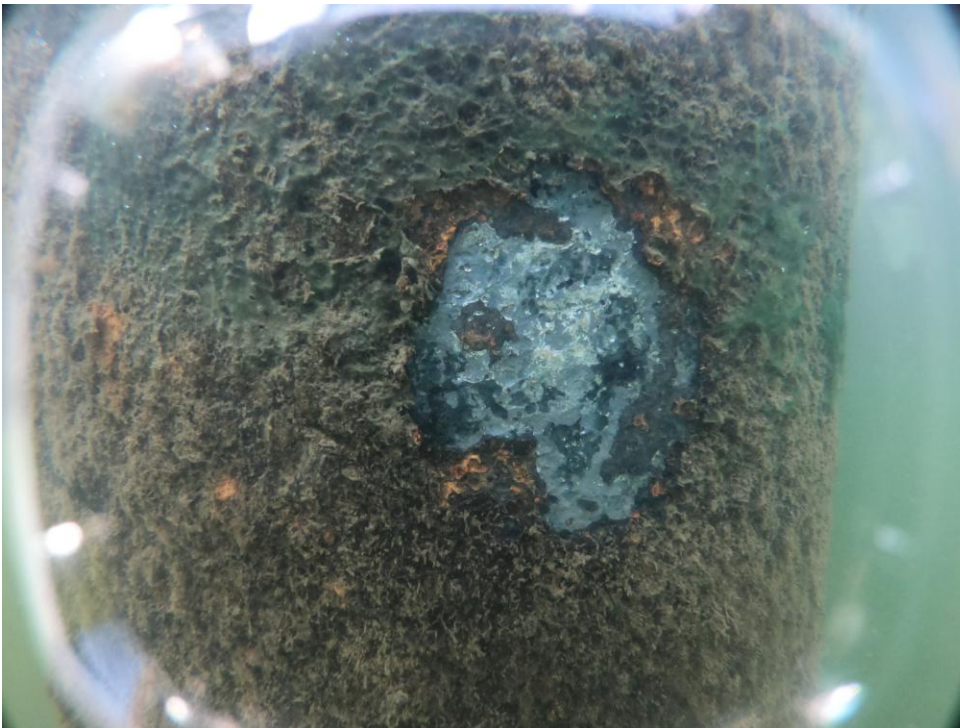
Figure 6: Typical cleaned section of steel pile at water surface elevation.

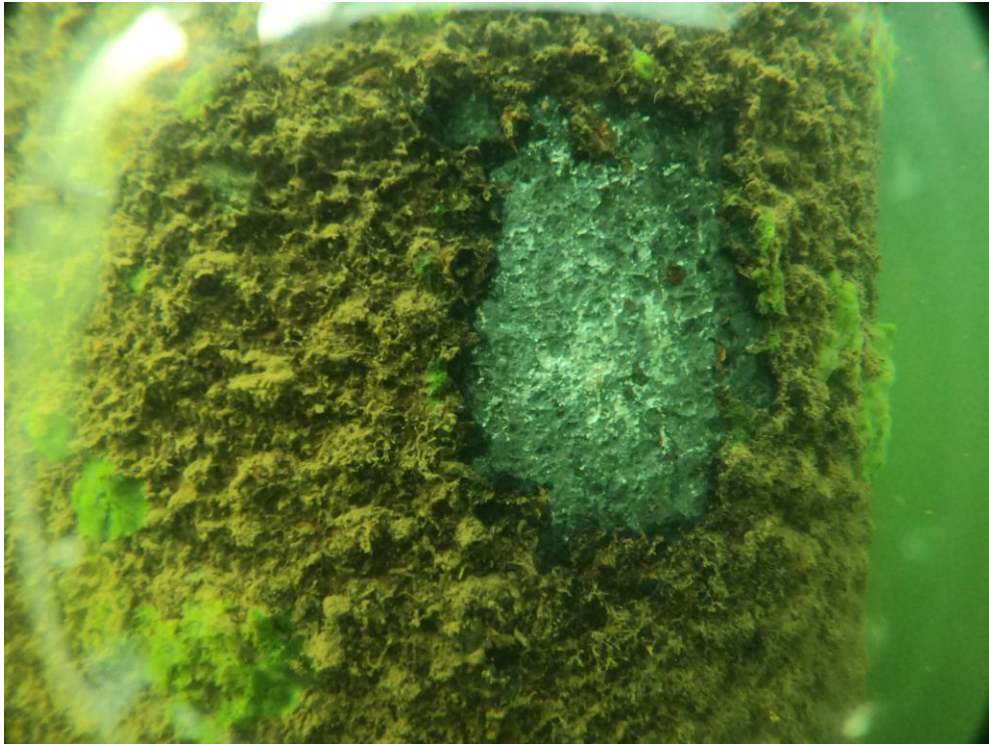
Figure 7: Typical cleaned section of steel pile at mid water.

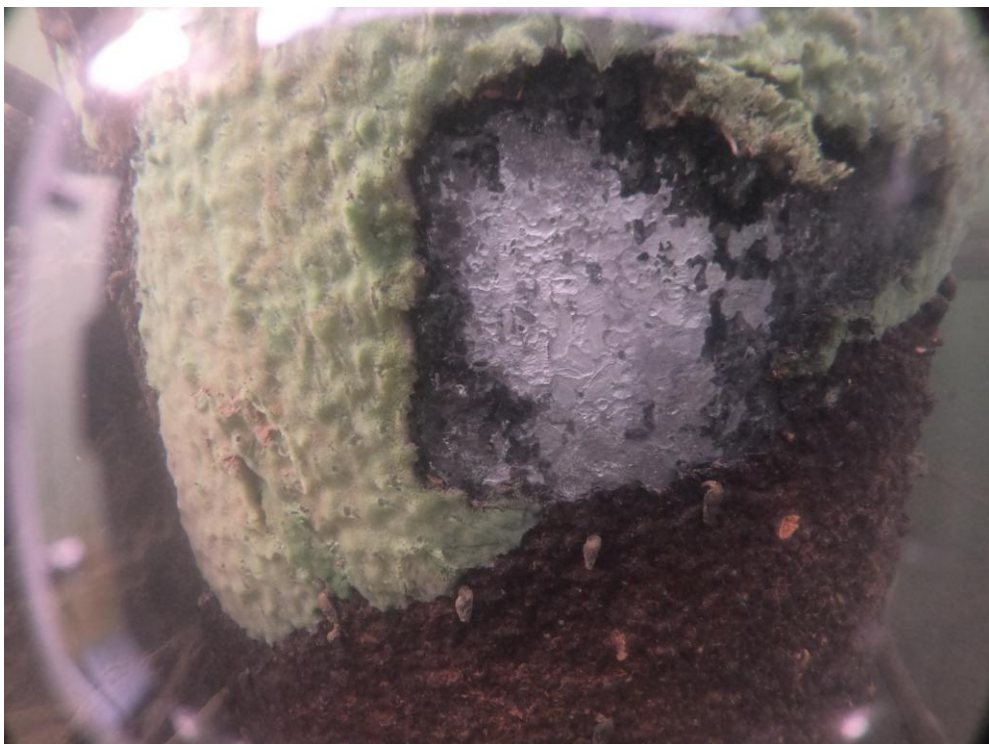
Figure 8: Typical cleaned section of steel pile at mudline.

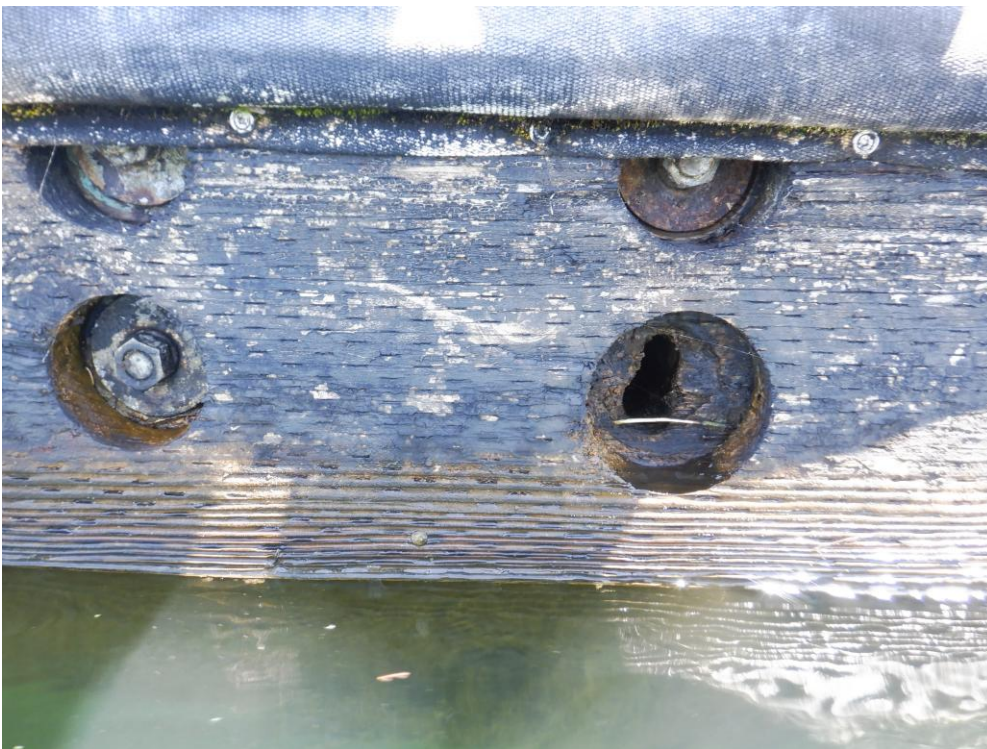
Figure 10: Missing tie rod at float section 9 from North end of dock.

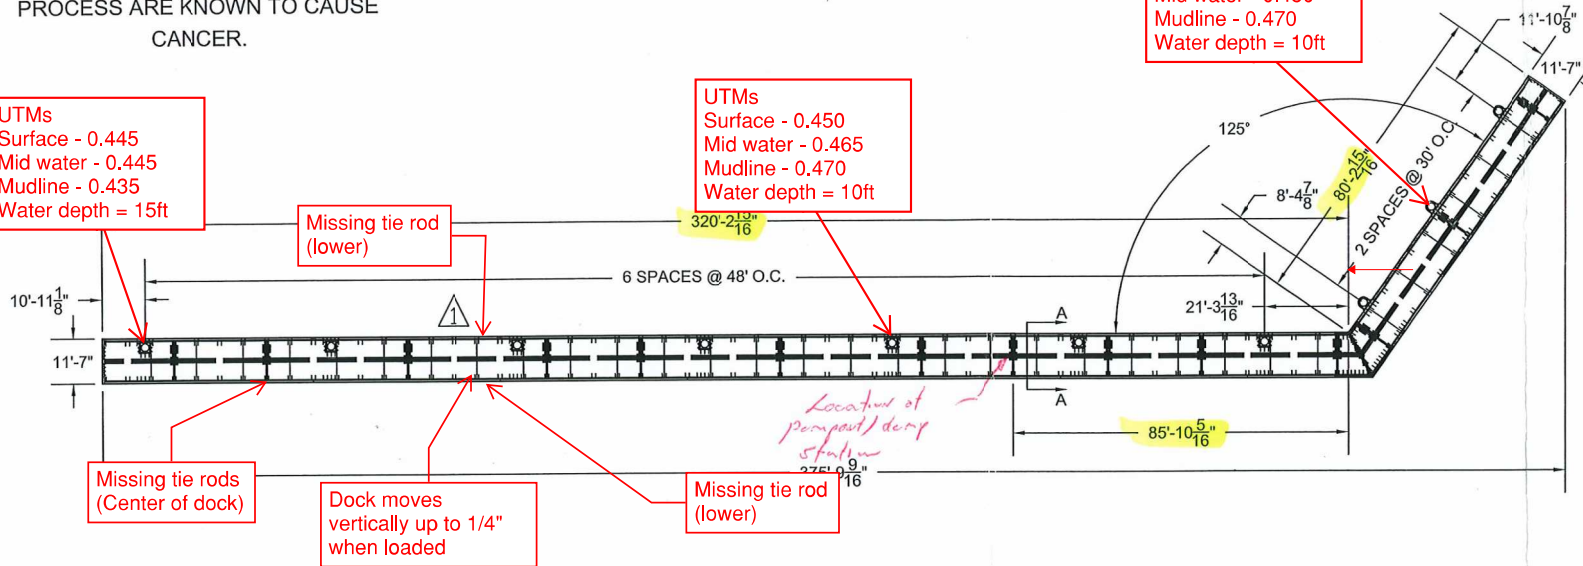
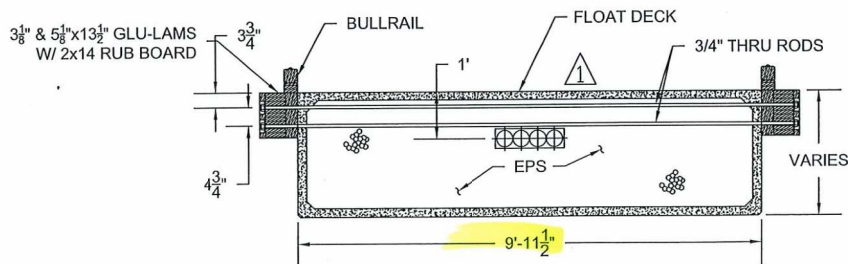
VIEW AA

Missing tie rod  
(lower)

UTMs  
Surface - 0.450  
Mid water - 0.465  
Mudline - 0.470  
Water depth = 10ft

UTMs  
Surface - 0.450  
Mid water - 0.450  
Mudline - 0.470  
Water depth = 10ft

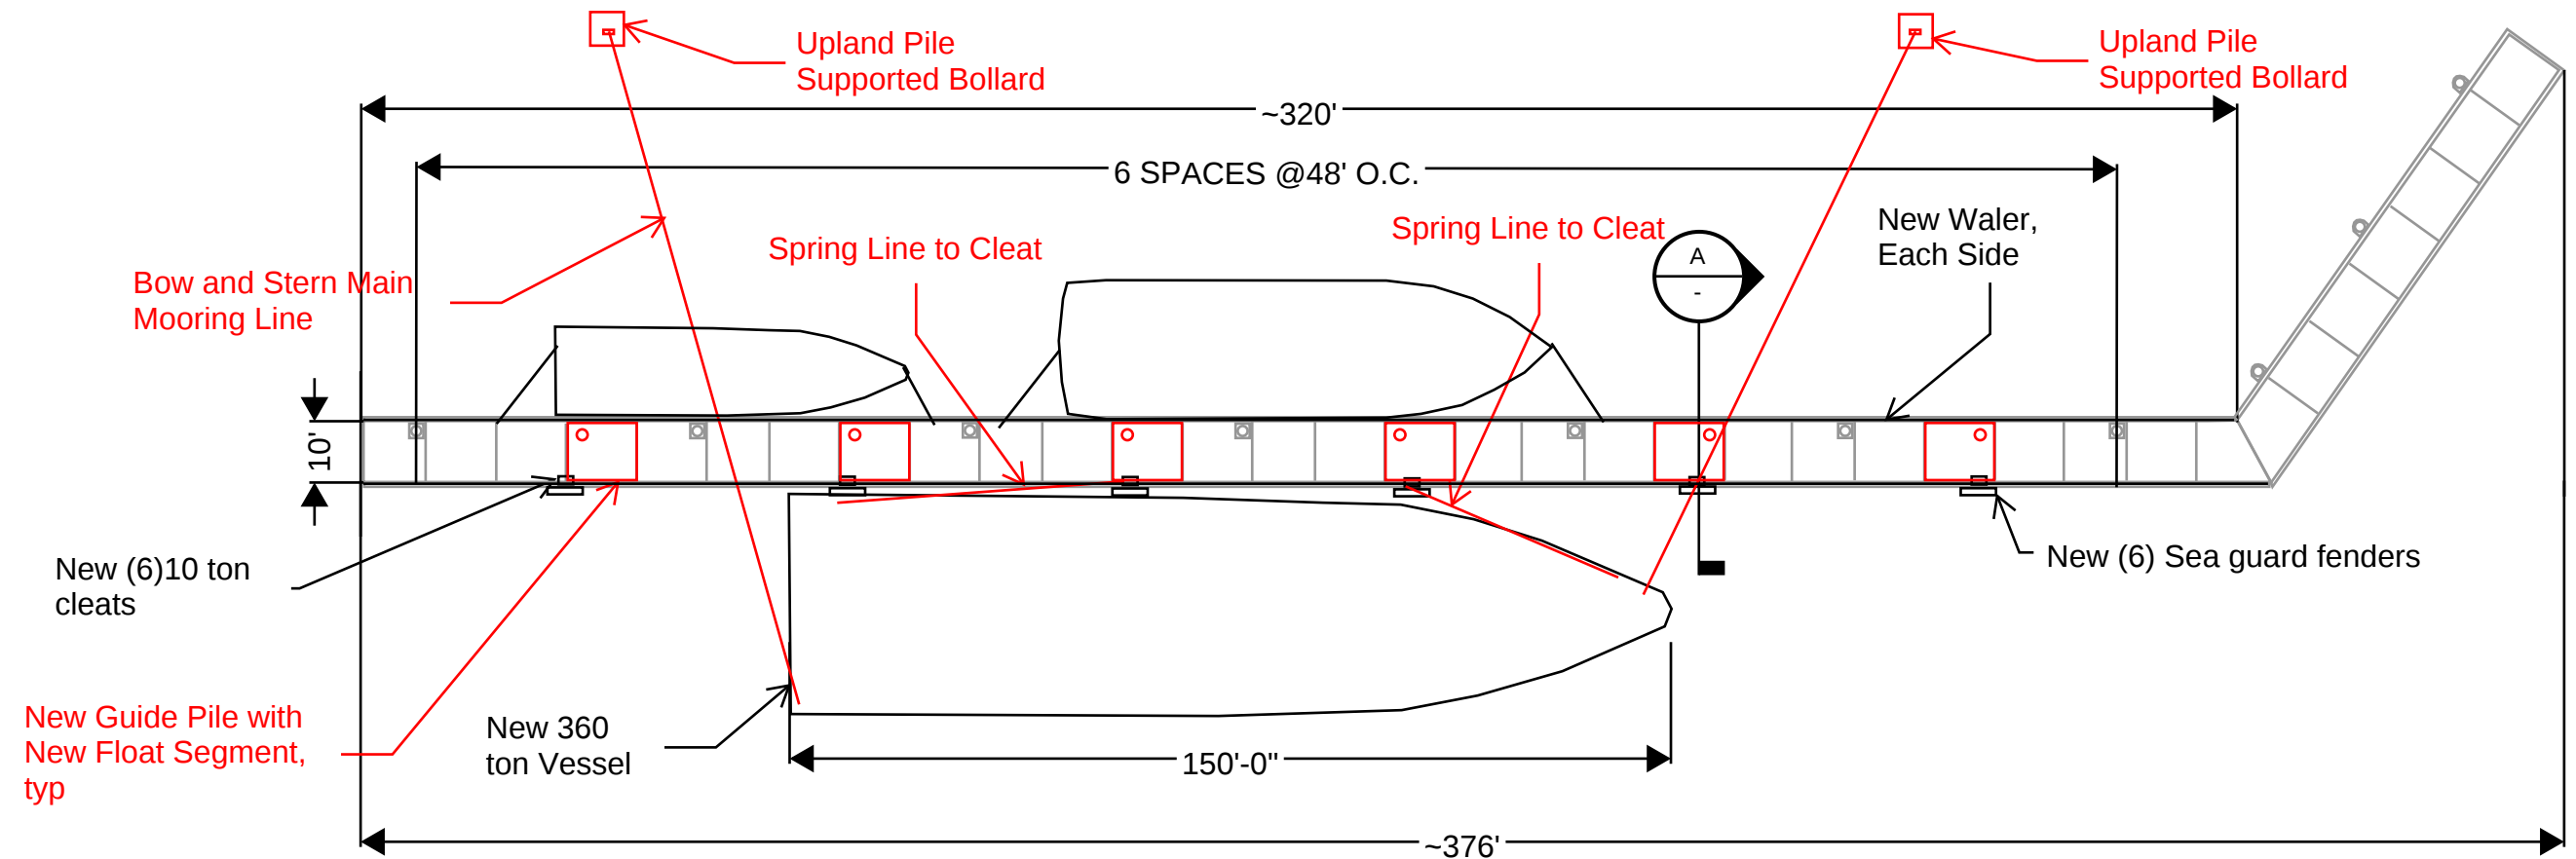
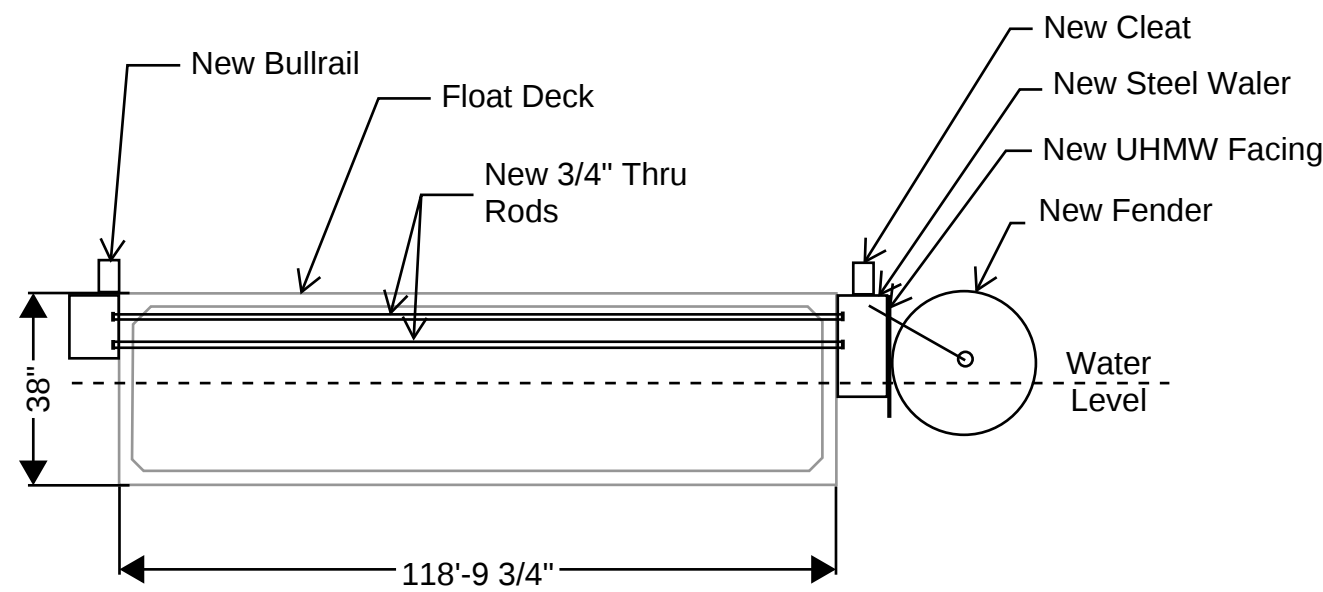
**Plan View**

Elements shown in red are the additional upgrades required to moor Portland Spirit in storm events.

load from the vessel to the dock, as forces due to wind are based on the square of the velocity. We recommend installing additional guide piles and upland bollards in addition to the new walers, cleats and fenders recommended in the previous section. The upgrade concept is shown on Sheets 2 and 3 in Appendix B. Sheet 2 shows installing internal guide piles with replacement of the float segment. Sheet 3 shows an alternative installing external guide piles and it doesn't require replacement of the float segments. However, it restricts the shoreside berthing face.

- Install (6) internal guide piles with replacement of the corresponding float segment, or install (6) external guide piles with restriction of using the shoreside berthing face
- Install (2) upland pile supported bollards

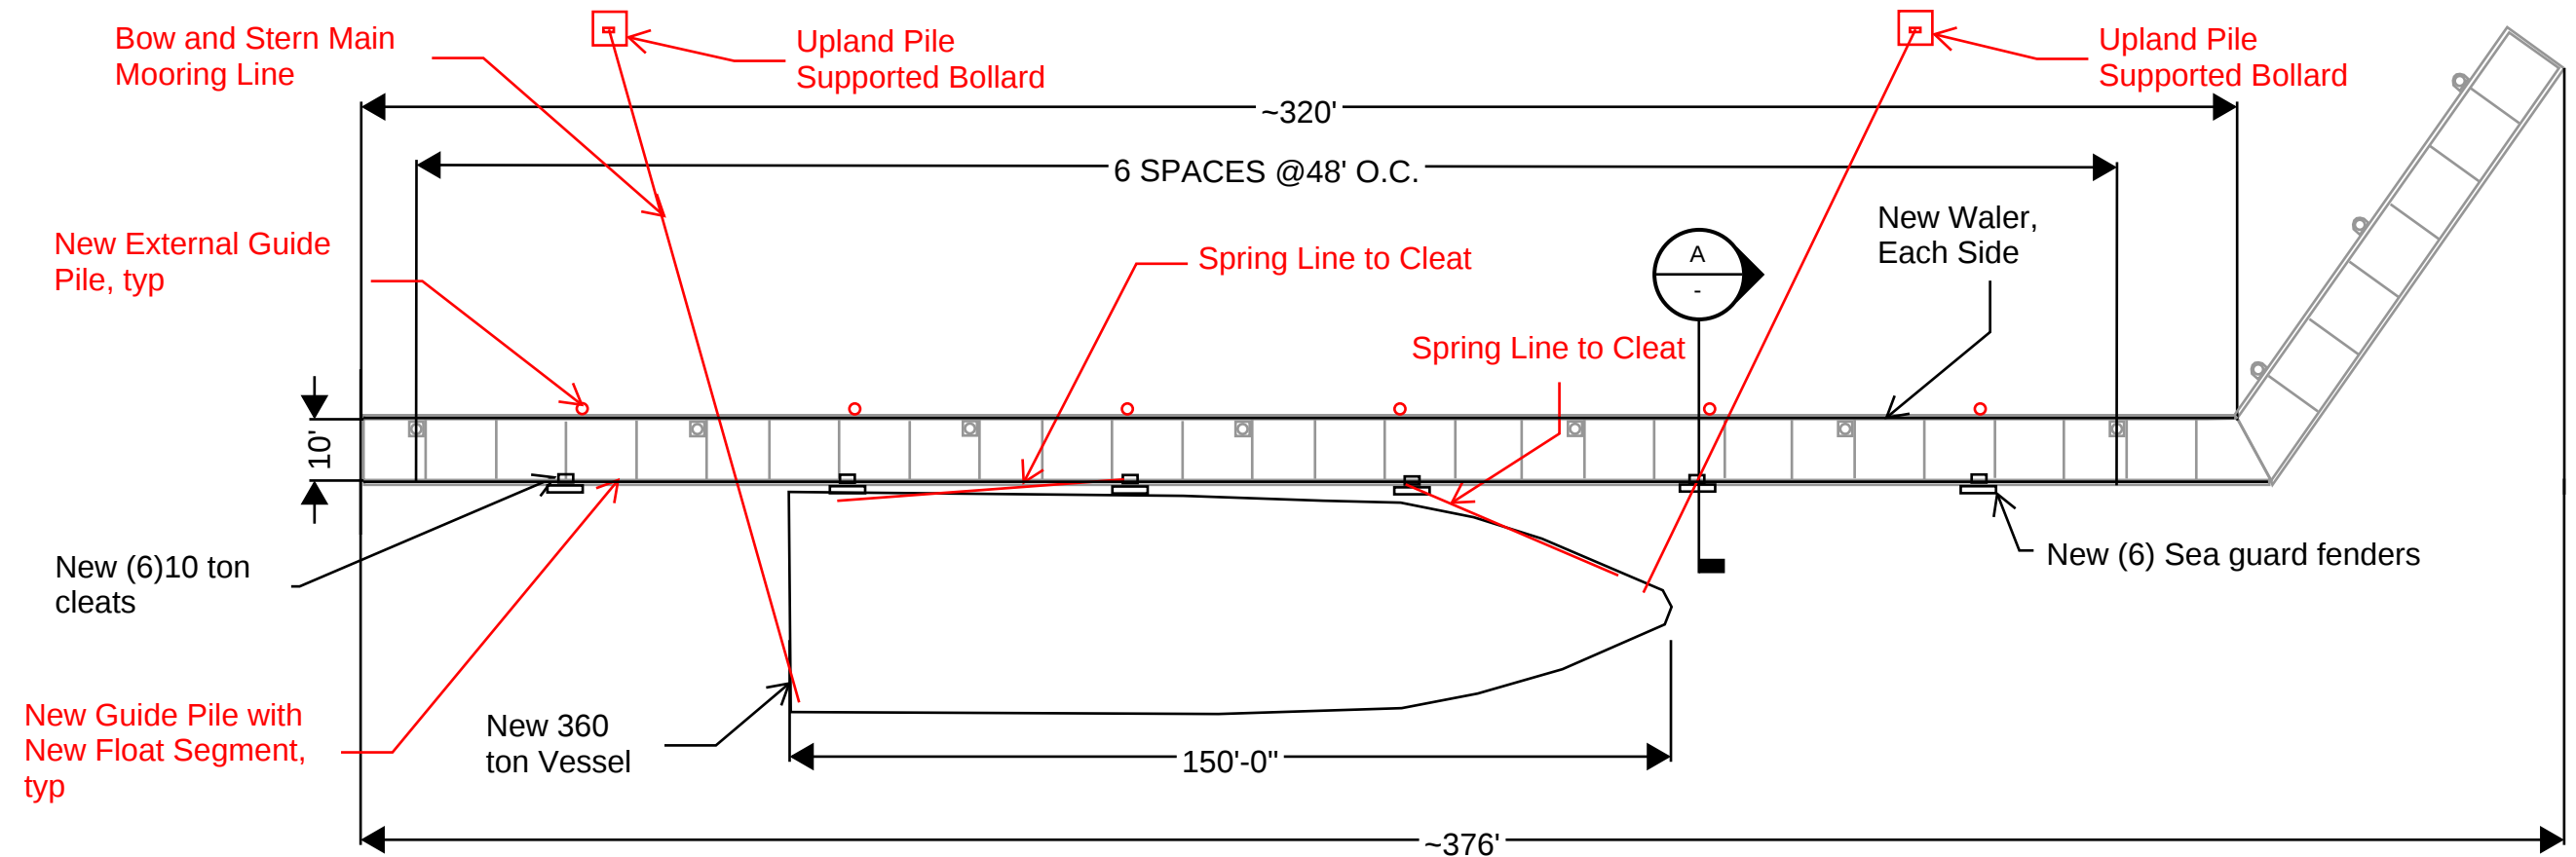
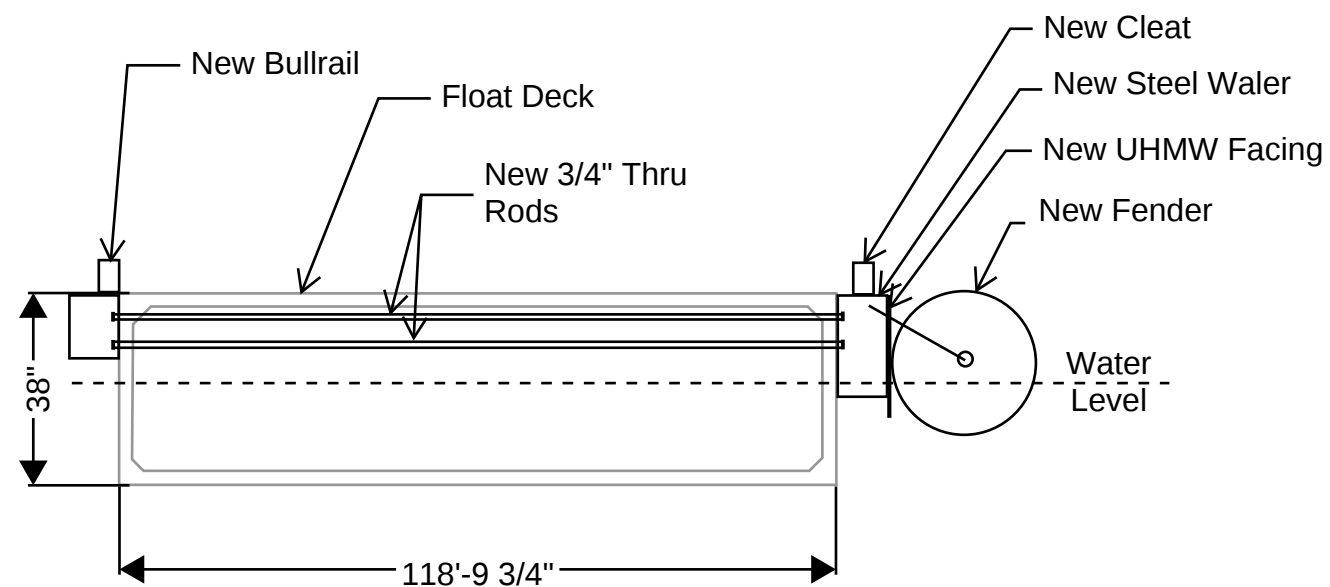
**Plan View**

Elements shown in red are the additional upgrades required to moor Portland Spirit in storm events.
