## **CITY OF OREGON CITY URBAN RENEWAL COMMISSION AGENDA**

## Residential Repair Review

## Residential Repair Report

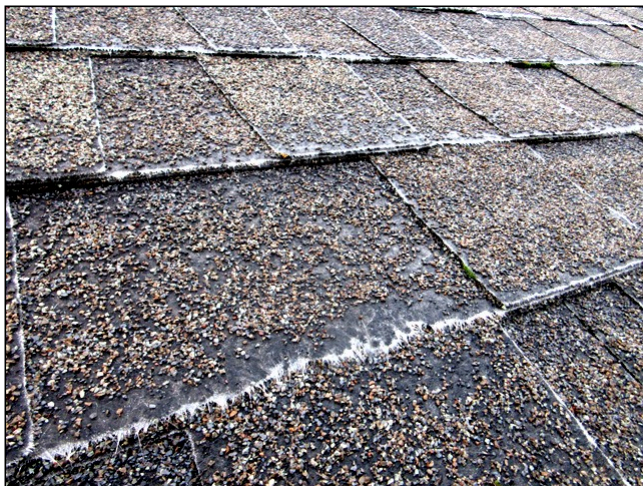
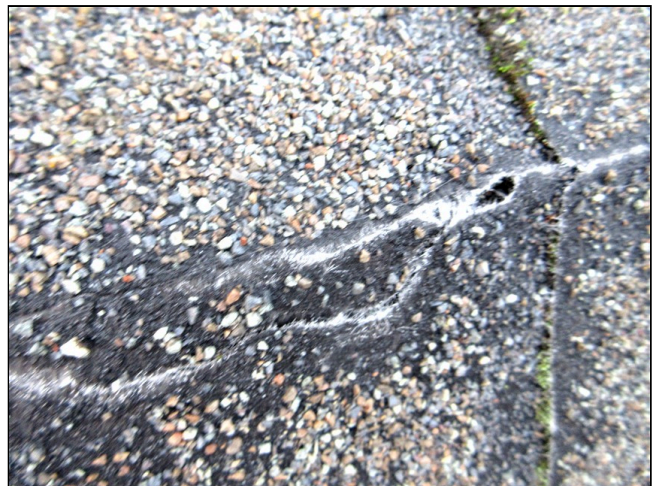
**Old, worn through roof on home & carport needs replacing by a roofing contractor including new vents & flashings.**

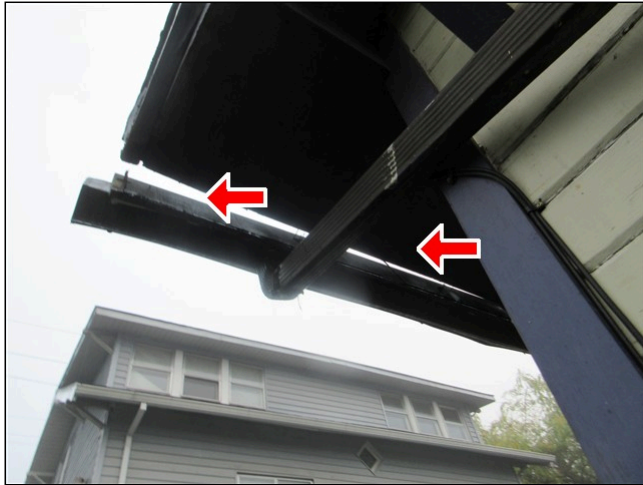
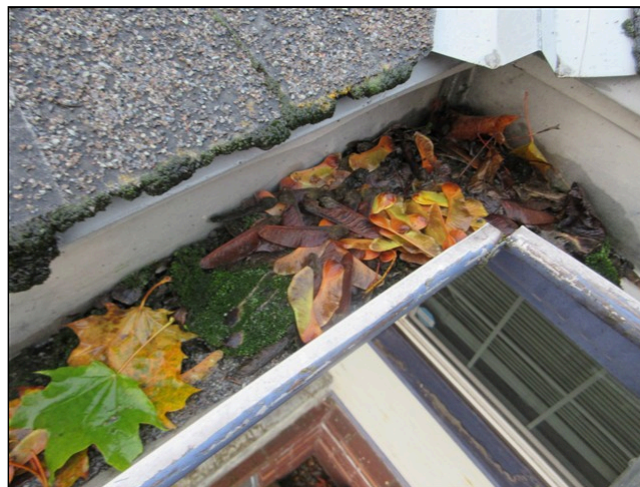
**Damaged, loose & leaking gutters & downspouts need replacing when roof is replaced.**

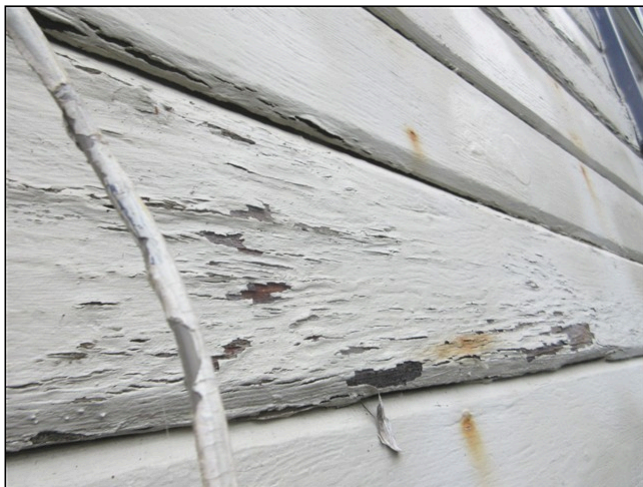
2.0 Item 1(Picture)

**Siding and trim has bubbling, peeling paint that all needs repainting. Rot needs repair at trim on corners, fascia & around windows where needed. Loose trim boards need securing.**

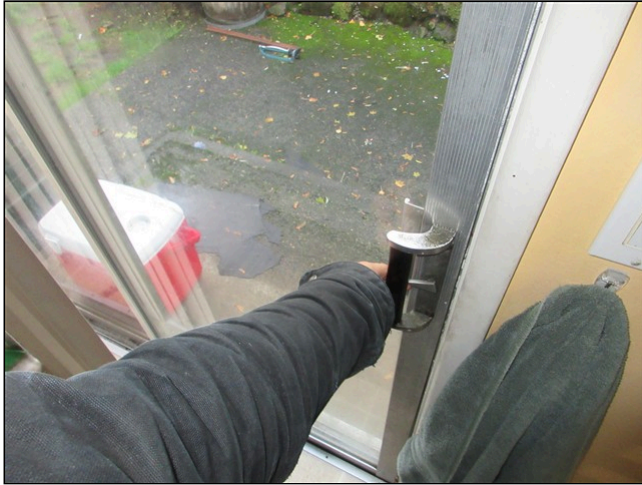
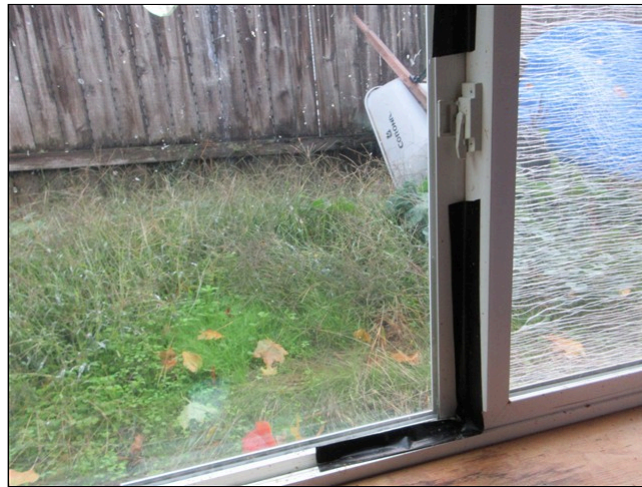
**Old metal sliding glass door needs repair to close & lock. Multiple windows need repairs to lock and be more easily operable.**

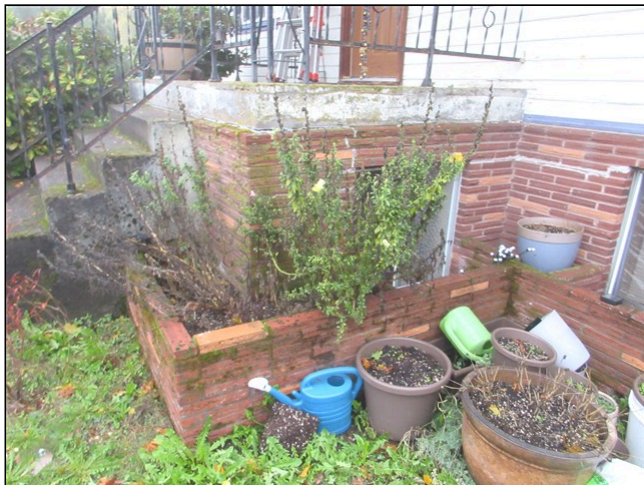
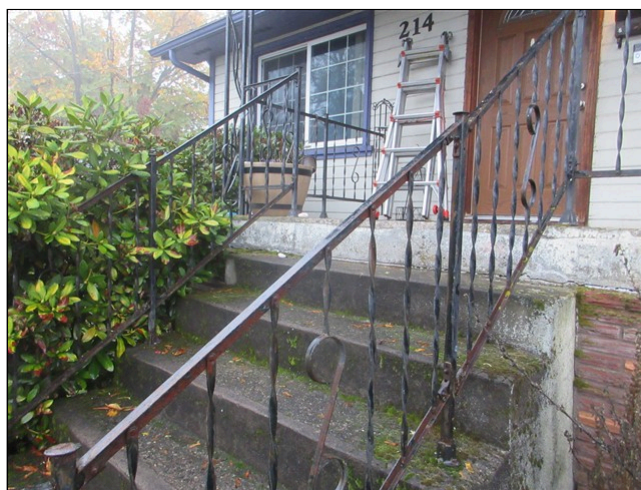
(1) **Extensive cracking was note at front porch and brick lower siding that needs repair/ replacing. Loose, corroded porch handrailing needs repair.**

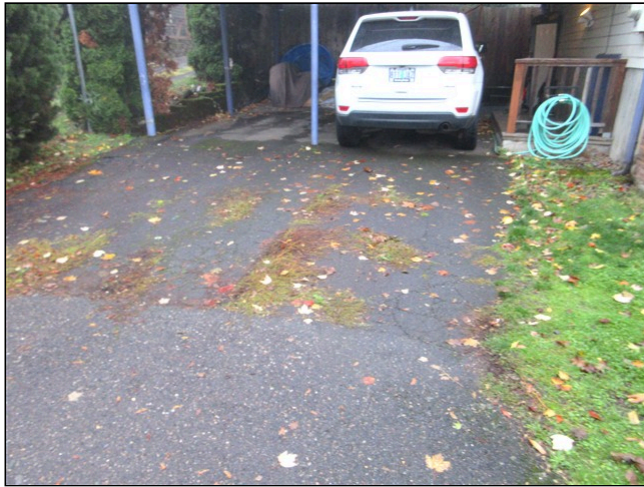
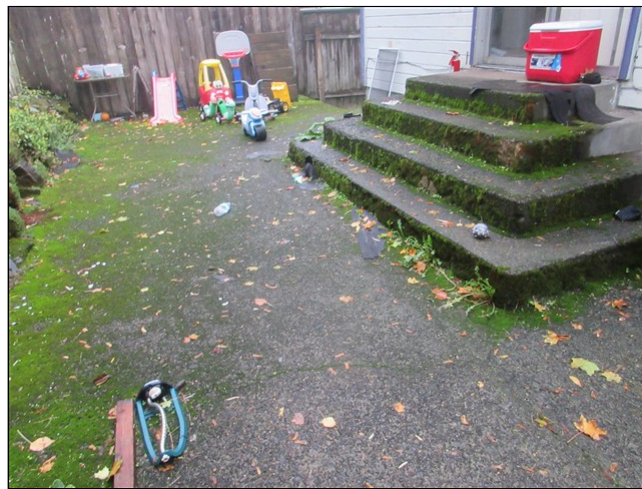
(2) **Broken up driveway needs replacing. Cracked rear patio needs repair. Steps need handrailing installed and flashing installed at connection to siding to keep rot from occurring. Side basement entry steps needs handrailing installed.**

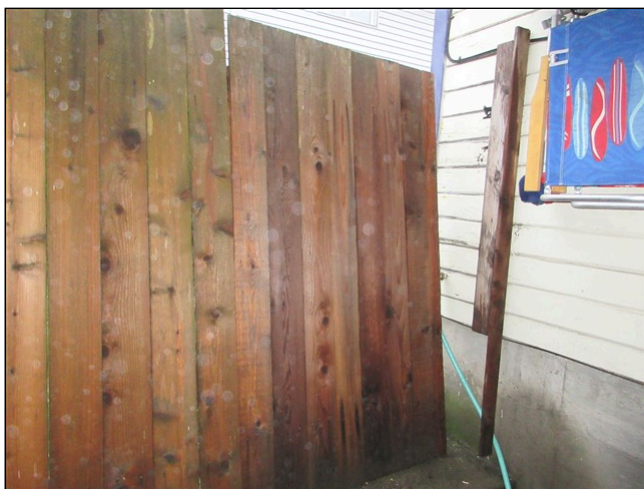
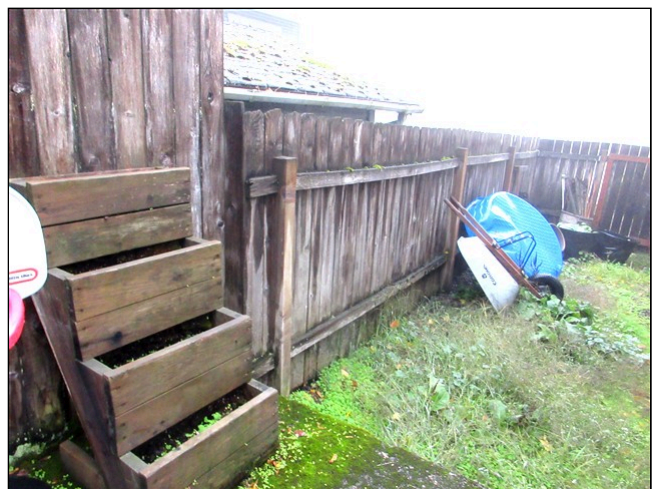
(3) **Rotted sections of fencing and gates need repair.**

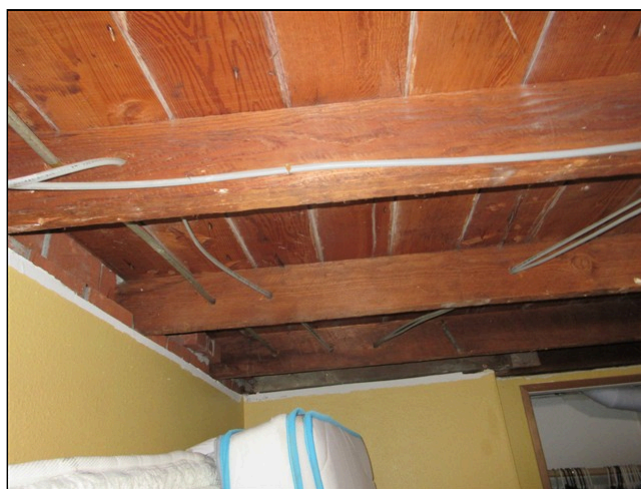
3.0 Item 1(Picture)

**Portions of ceiling drywall in basement have been removed and needs installation to patch.**

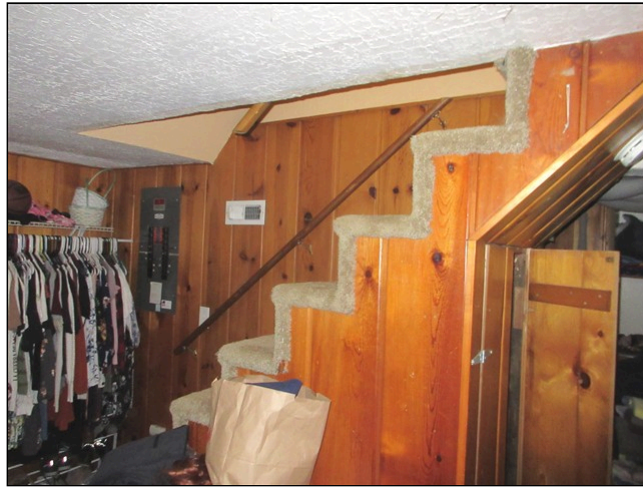
3.3 Item 1(Picture)

**Staircase in basement needs handrailing and balusters installed.**

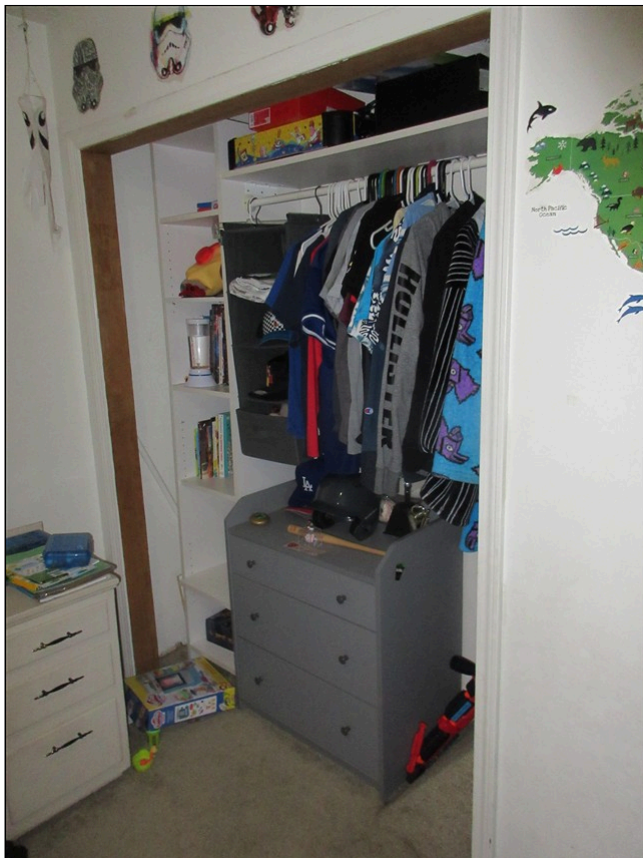
3.5 Item 1(Picture)

**Missing closet doors throughout home need installation.**

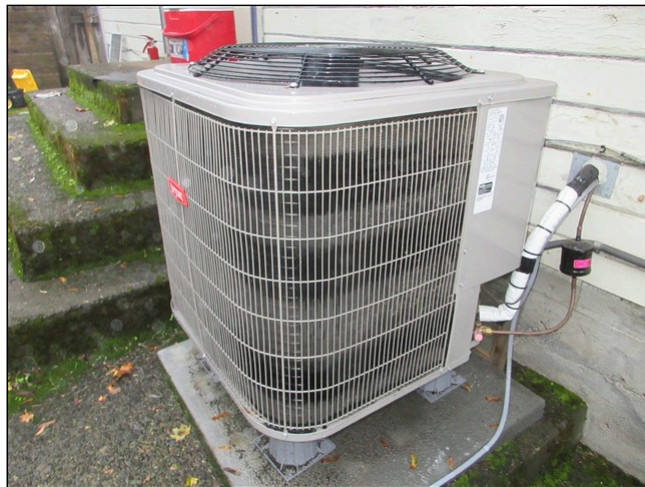
4.0 Item 1(Picture)

**Furnace & AC units need servicing and cleaning by a heating contractor to maintain including cleaning out ducting. Loose registers need securing.**

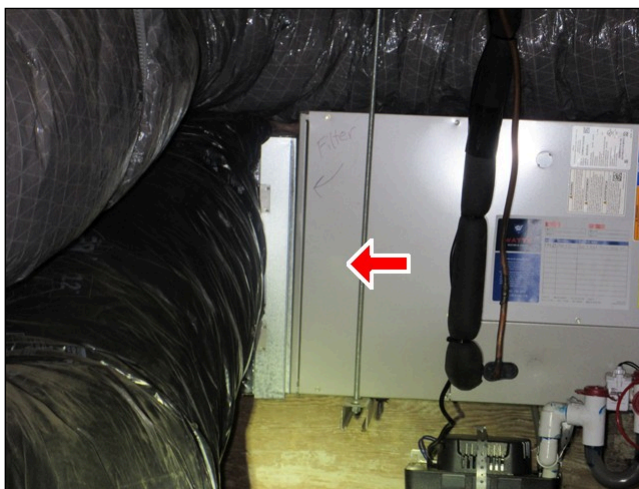
4.3 Item 1(Picture)

**Important: Furnace needs filter replaced regularly to maintain system.**

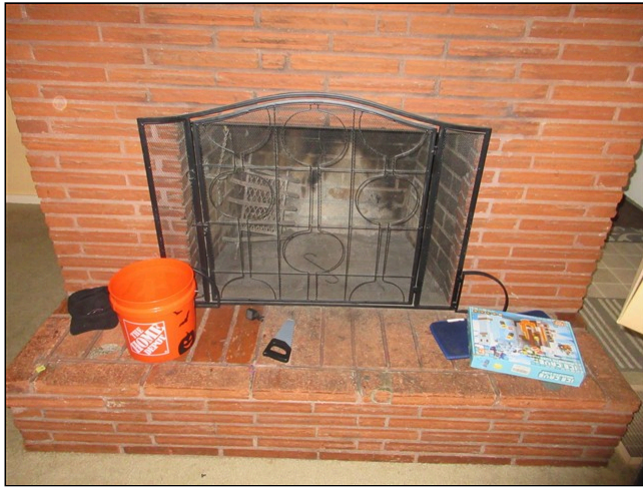
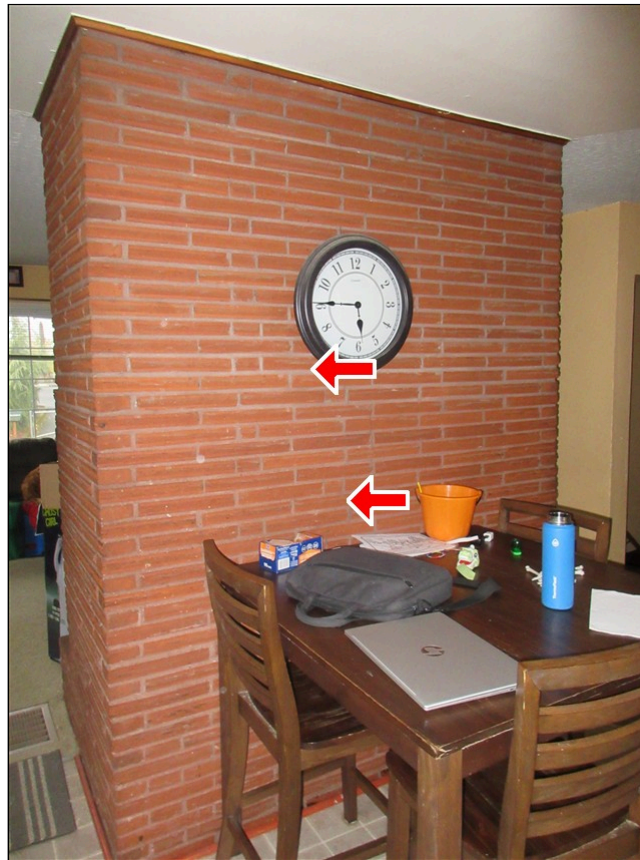
**Fireplaces need flues cleaned out and dampers repaired to function. Cracks in chimney need repair.**

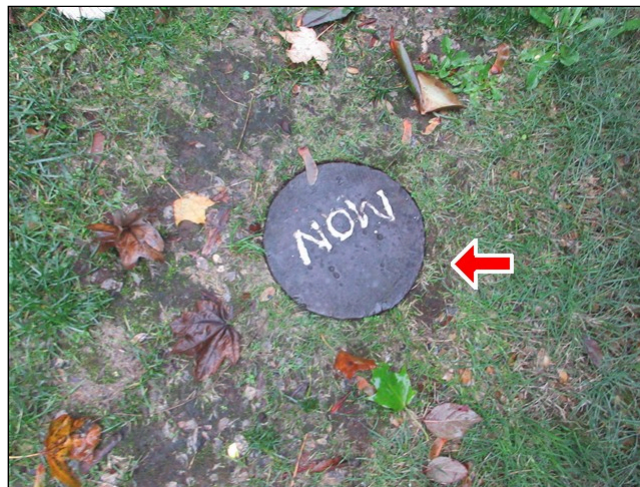
5.0 Item 1(Picture)

**(1) Due to age of home, I recommend a sewer scope, buried oil tank search & radon test be done by a contractor. Any buried oil tank found will need decommissioning by a deq contractor.**

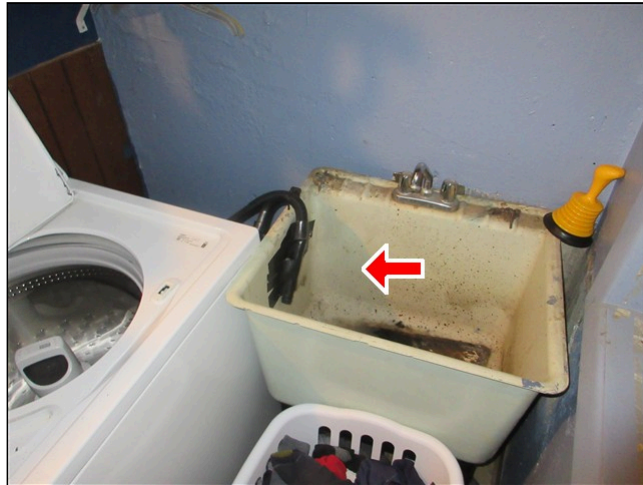
5.0 Item 2(Picture)

**(2) Washing machine drains into sink and needs dedicated 2" drain installed so cross contamination doesn't occur.**

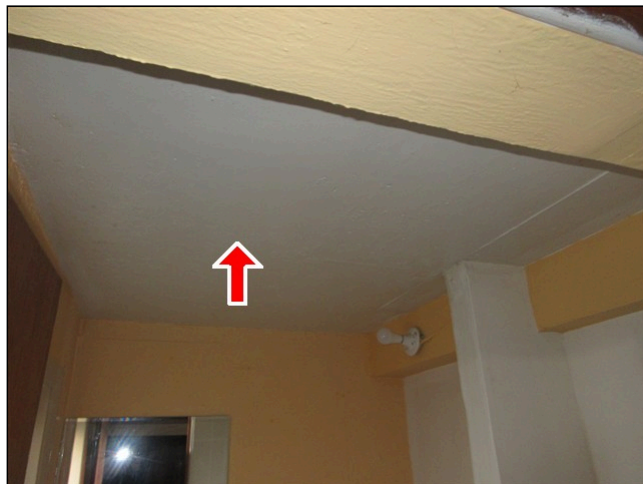
5.0 Item 5(Picture)

(3) **Basement bathroom needs AAV installed on sink drain to vent correctly. Loose sink faucet needs securing. Missing vent fan needs installation to exhaust moisture to exterior.**

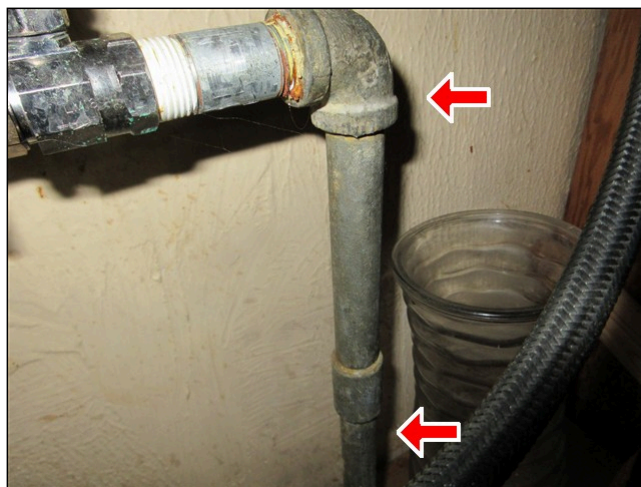
5.1 Item 1(Picture)

**Old water supply piping throughout house is old galvanized type that rusts over time and leaks or causes pressure problems without warning. Due to corrosion and poor pressure, I recommend all galvanized piping be replaced with PEX.**

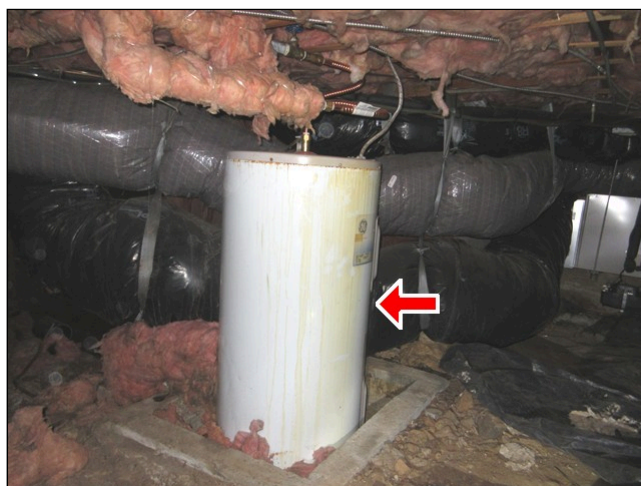
5.2 Item 1(Picture)

**Old waterheater in crawlspace is rusted through and needs replacing.**

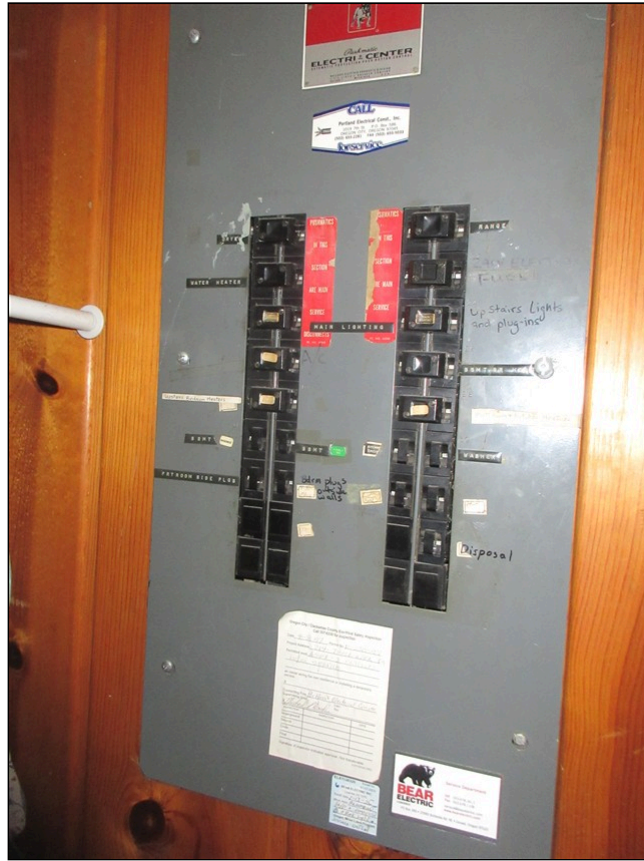
6.1 Item 1(Picture)

**Old pushmatic electrical panel has multiple breakers that don't reset easily and need replacing. However, push button type electrical panels are no longer manufactured and functionally obsolete. Recommend electrical panel be replaced.**

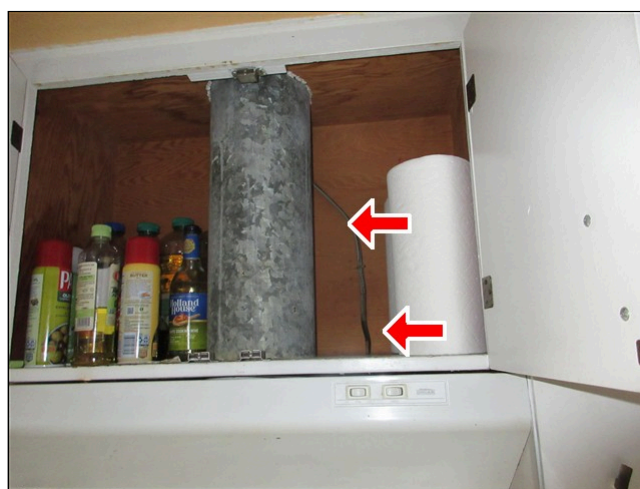
6.2 Item 5(Picture)

**Loose exterior lights need securing. Exposed wiring under kitchen sink, over kitchen hood & at floor needs enclosing in conduit. Non functioning gfci outlets in kitchen need repair.**

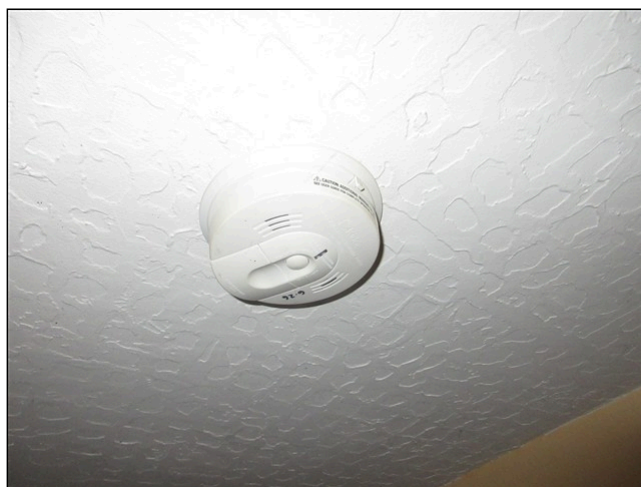
6.6 Item 1(Picture)

**Expired smoke detectors need replacing throughout house.**

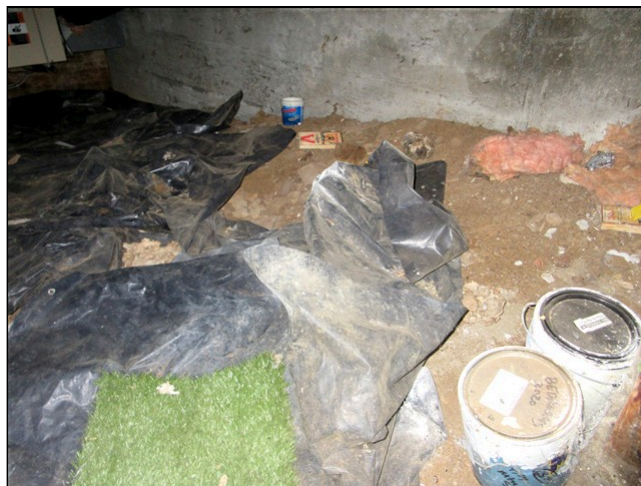
9.6 Item 1(Picture)

**Evidence of rodent activity was noted in crawlspace & attic and will need controlling by a pest professional. Damaged vapor barrier plastic needs replacing.**

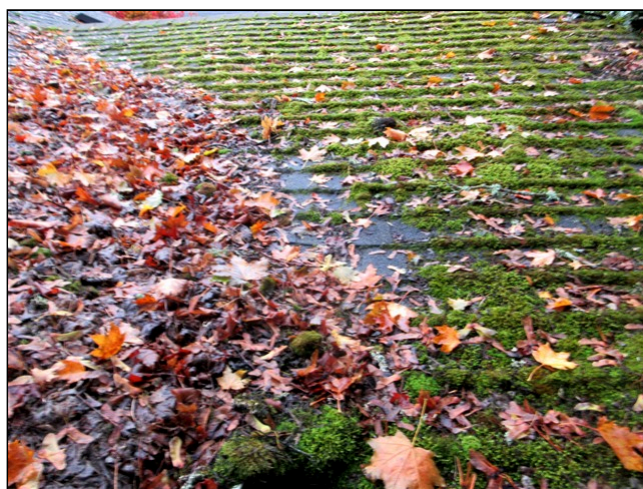
1.0 Item 1(Picture)

**Roof has heavy wear due to excessive moss growth and tree damage. Recommend roof be torn off and replaced by a roofing contractor including new flashings/vents.**

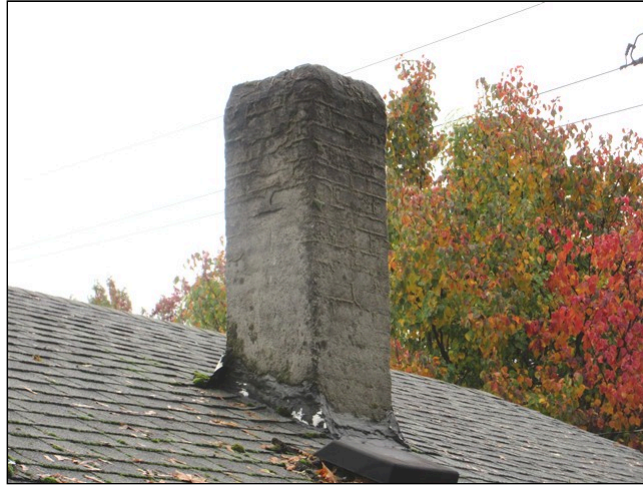
1.2 Item 1(Picture)

**Eroded, cracked chimney needs repair and new exhaust cap installed. Flashing at base needs replacing to keep from leaking.**

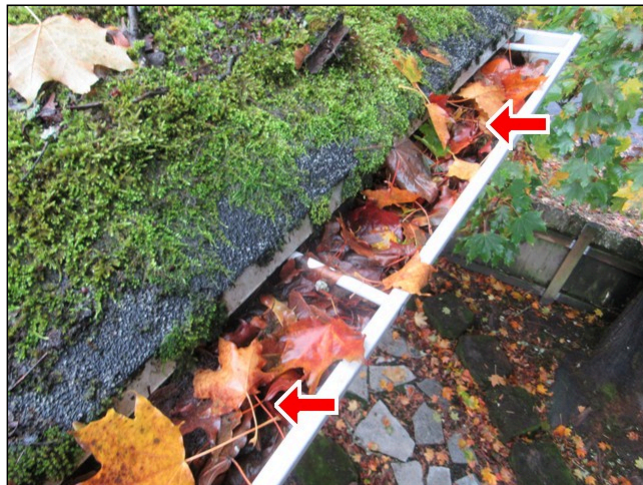
1.3 Item 1(Picture)

**Clogged gutters & downspouts need cleaning out.**

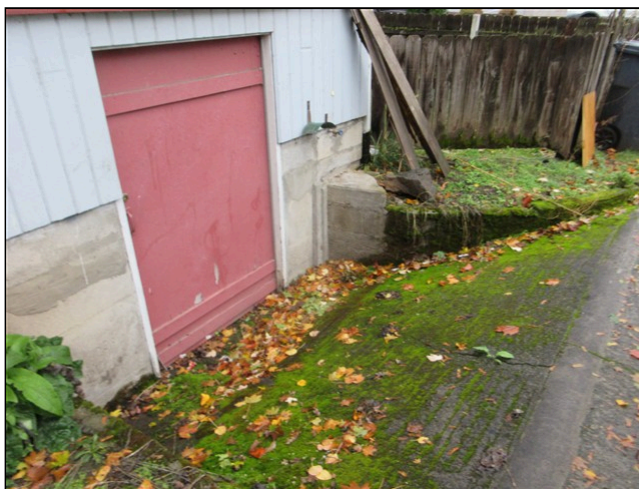
2.2 Item 1(Picture)

**Basement entry door needs ground drain installed at base of door to keep water from flooding basement or ramp removed and replaced with steps.**

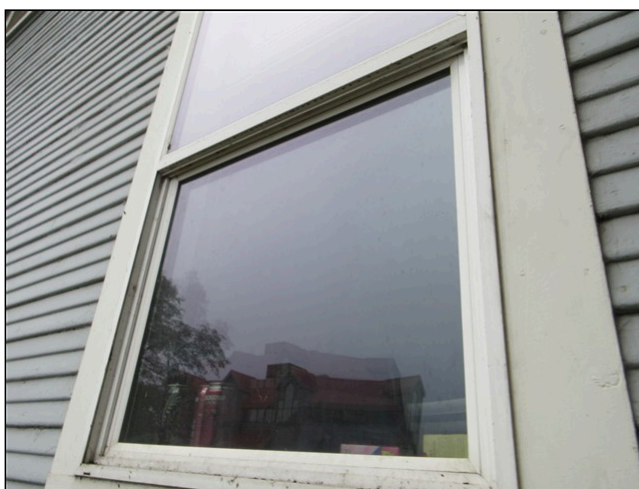
2.3 Item 1(Picture)

**Missing window screens need installation.**

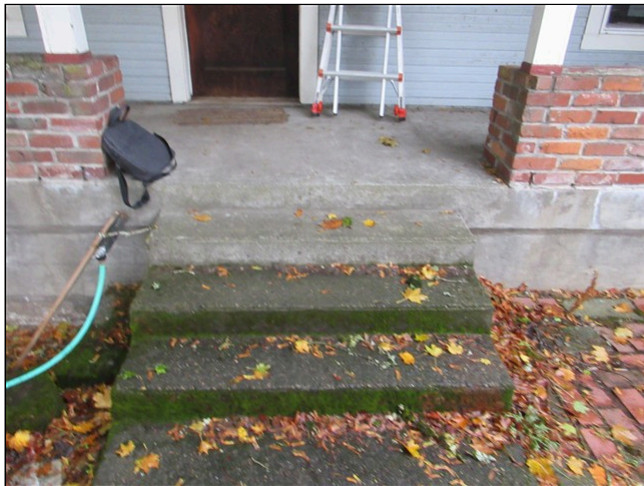
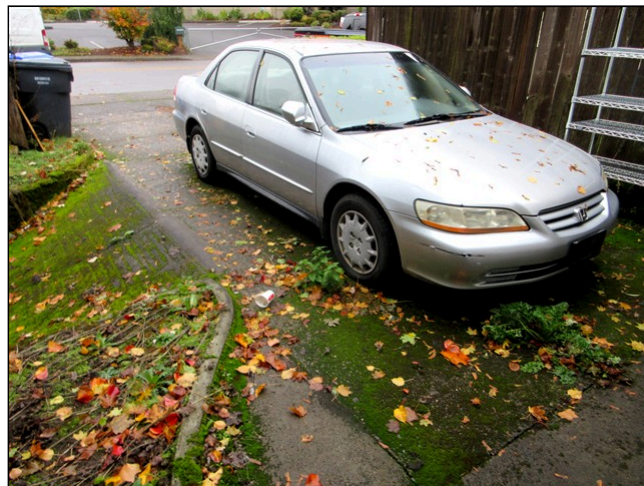
(2) **Front porch needs handrailing installed. Rear entry steps have broken away from house and needs replacing. Broken up driveway needs replacing.**

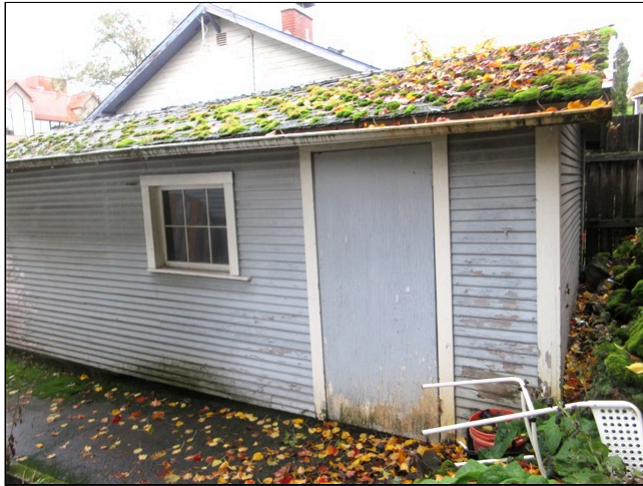
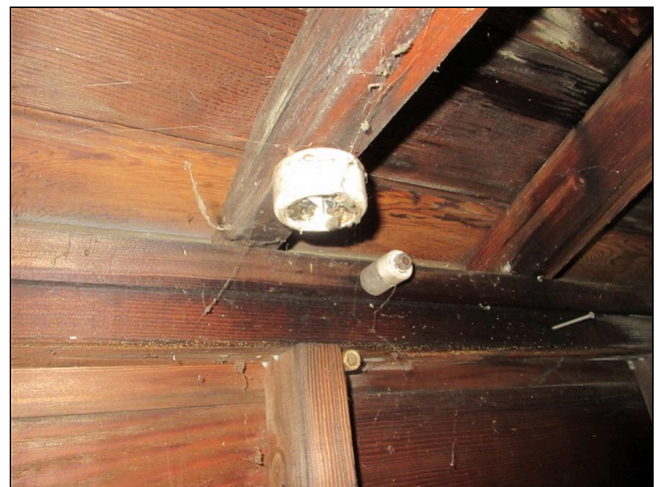
**Old garage structure needs repairs including tear off and replacement of worn through roof. Broken leaking gutters/downspouts need replacing. Entry door needs replacing to be operable. Siding and trim needs repair where rotted at base and building repainted. Siding to ground contact at base of building needs digging out to keep 3-4" spacing in place. Lower walls & sill plate at foundation is rotted and needs repair. Electrical has been decommissioned and no longer functions.**

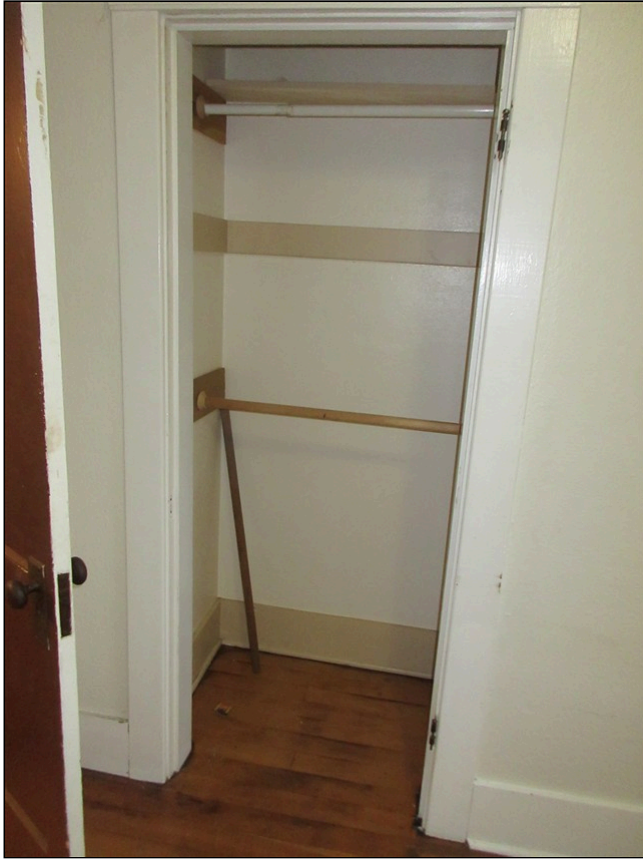
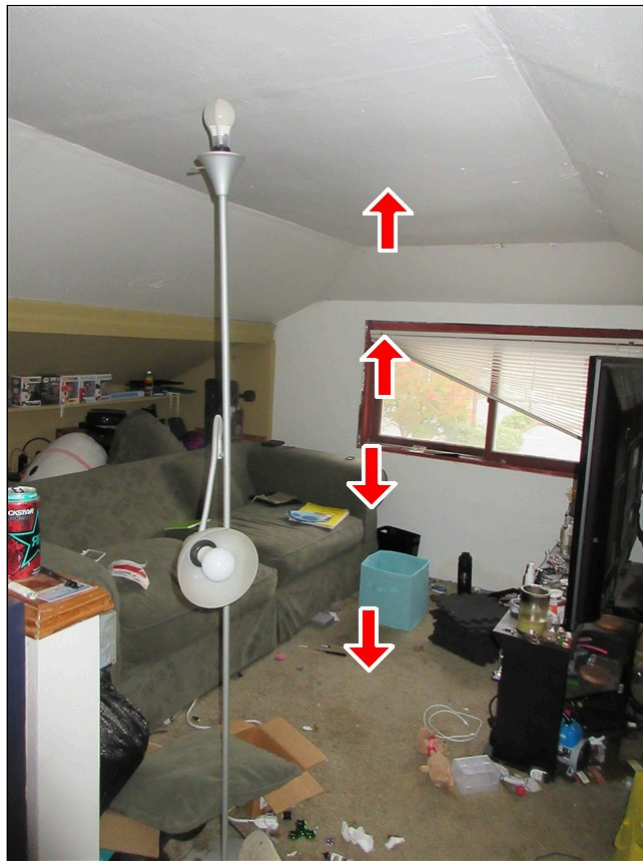
**Missing closet doors need installation where needed. Note: Top floor ceiling height is under**

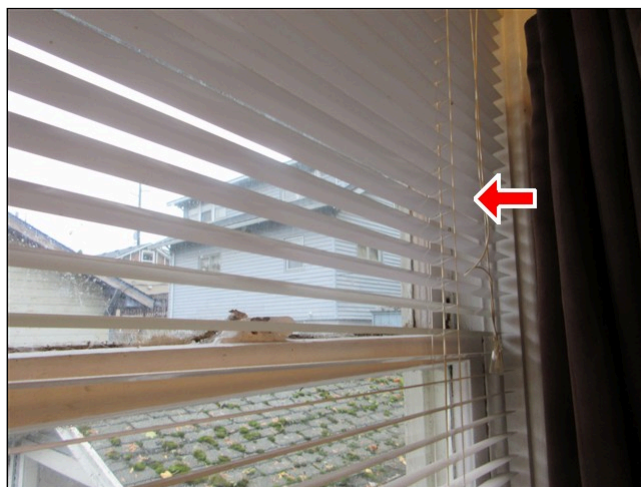
4.6 Item 1(Picture)

**Old wood windows need repairs due to not being operable or have broken sash cords.**

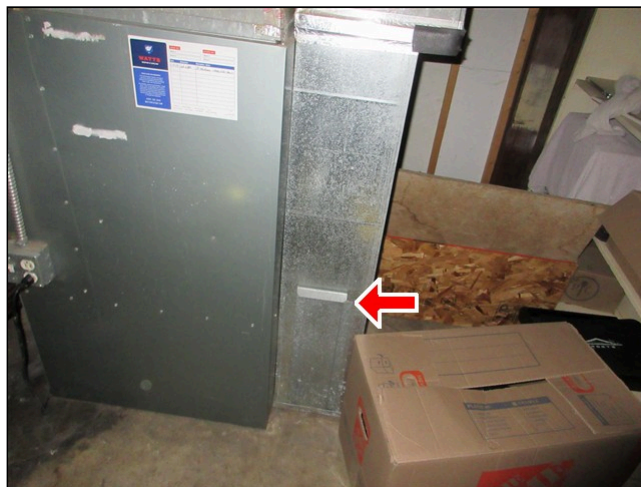
5.3 Item 1(Picture)

**Important: Furnace needs filter replaced regularly to maintain system.**

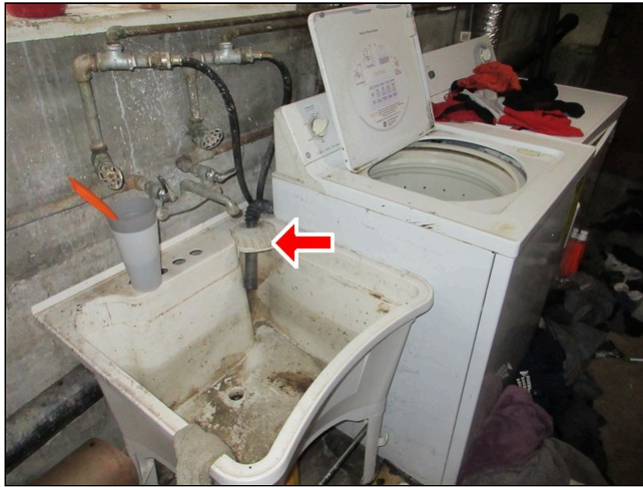
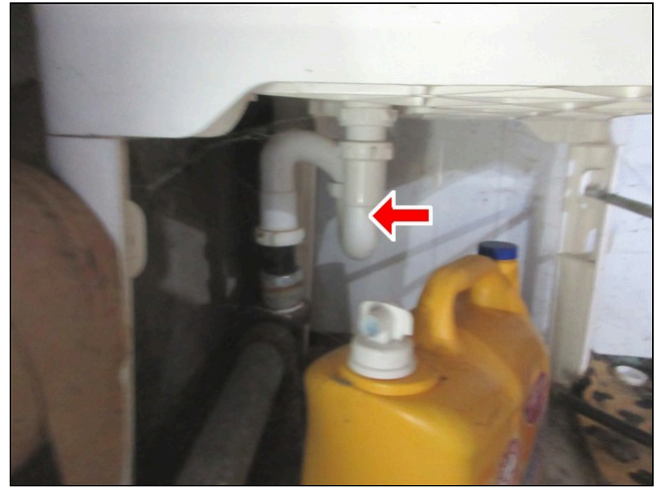
(2) **Washing machine drains into sink and needs repair to drain into dedicated 2" drain to keep cross contamination from occurring. Sink drain need incorrectly installed P trap repaired and needs AAV vent installed.**

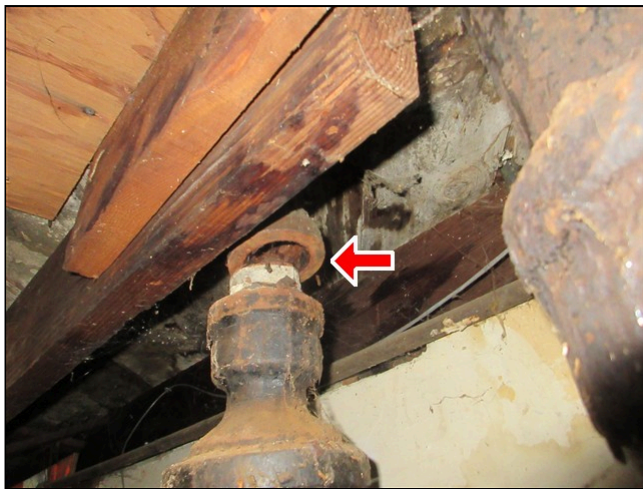
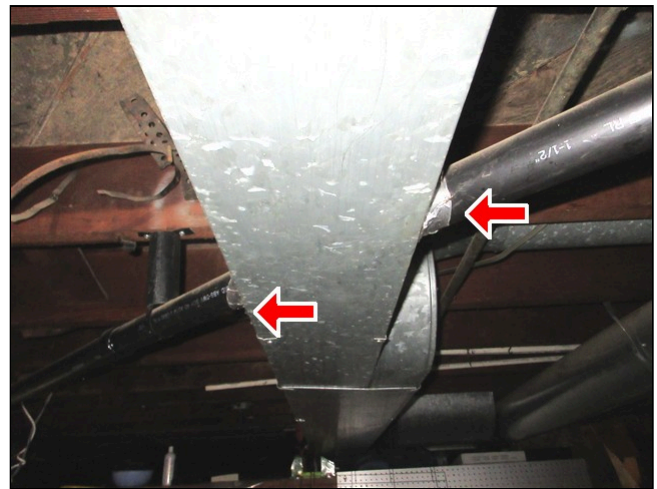
(3) **Disconnected plumbing vent at basement ceiling needs repair. Plumbing drain that extends through hvac ducting needs relocating.**

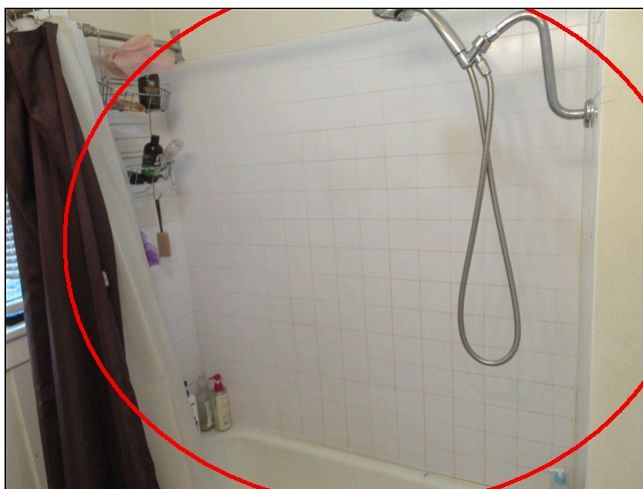
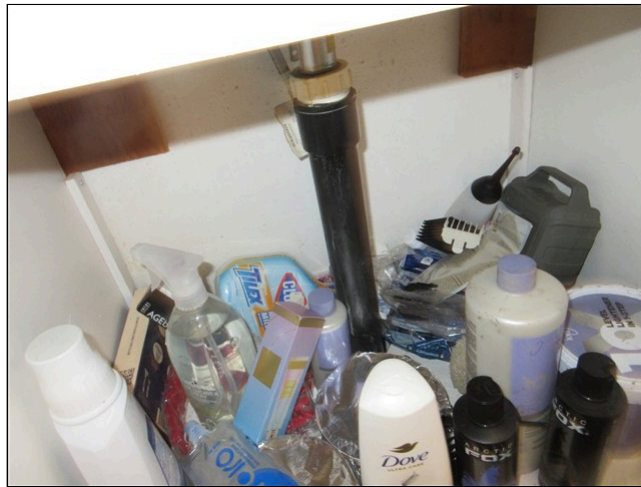
**(4) Main floor hallway bathroom needs leaking shower tile surround replaced and leaking valve handles repaired. Loose toilet needs reinstallation with new wax ring to keep from leaking. Sink needs drain p trap installed with AAV vent under sink instead of through floor.**

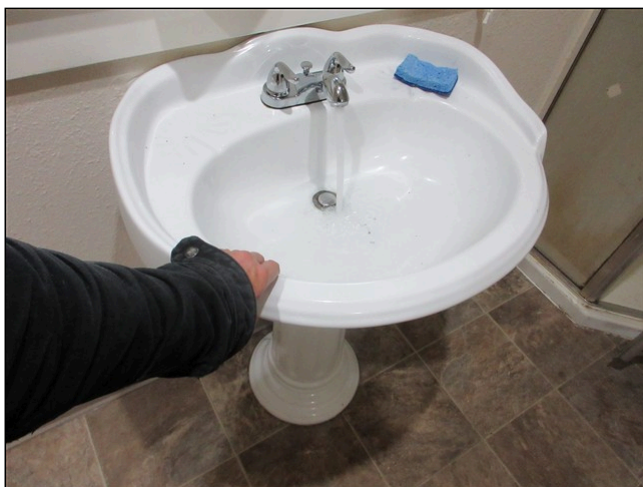
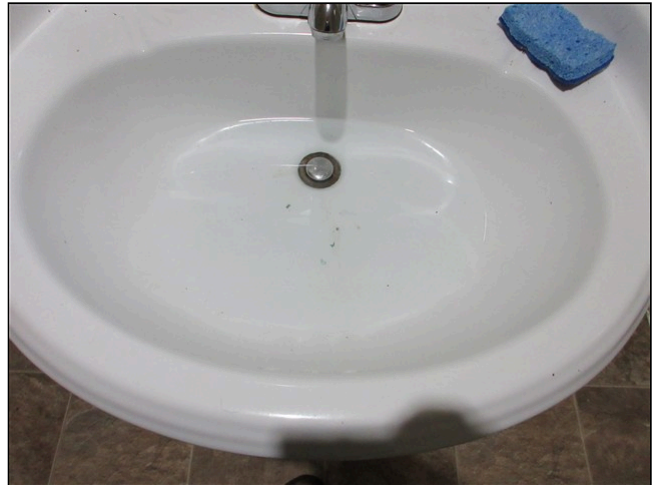
(5) **Bedroom bathroom needs loose sink pedestal secured and loose toilet reinstalled with new wax ring to keep from leaking. Holes were noted in shower surround/pan and will need complete replacement. Leaking showerhead needs repair. Clogged sink drain needs clearing.**

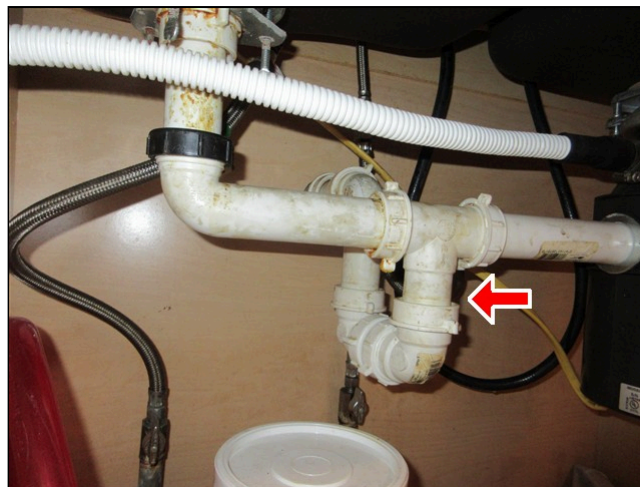
6.0 Item 14(Picture)

(6) **Kitchen sink drain needs correct P trap installed.**

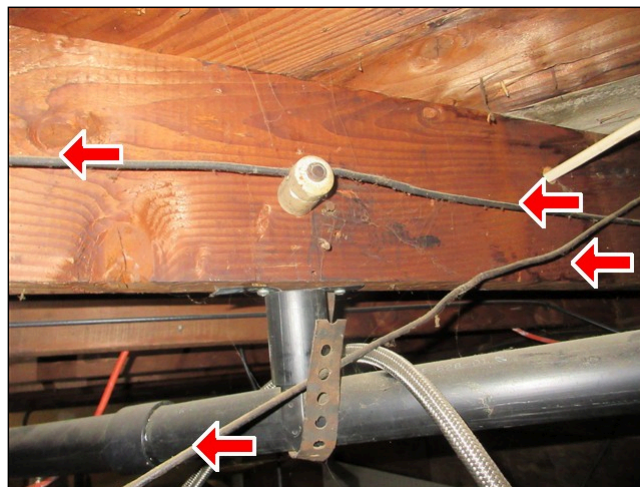
7.2 Item 1(Picture)

**Old knob & tube was noted in portions of house which is frayed and unsafely spliced. Knob & tube is consider functionally obsolete and should be replaced for safety.**

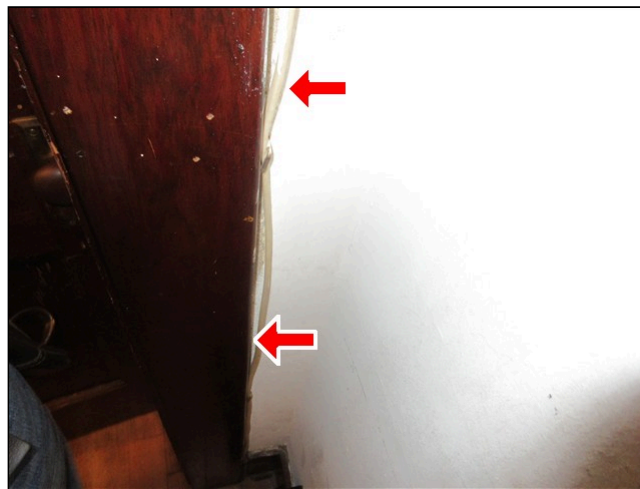
7.3 Item 3(Picture)

**Non functioning lights in basement need repair. Exposed wiring in stairwell of basement needs enclosing in conduit.**

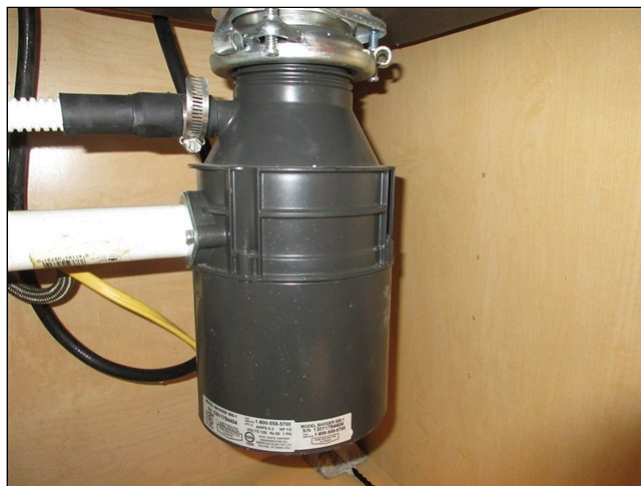
8.3 Item 1(Picture)

**Broken garbage disposal needs replacing.**

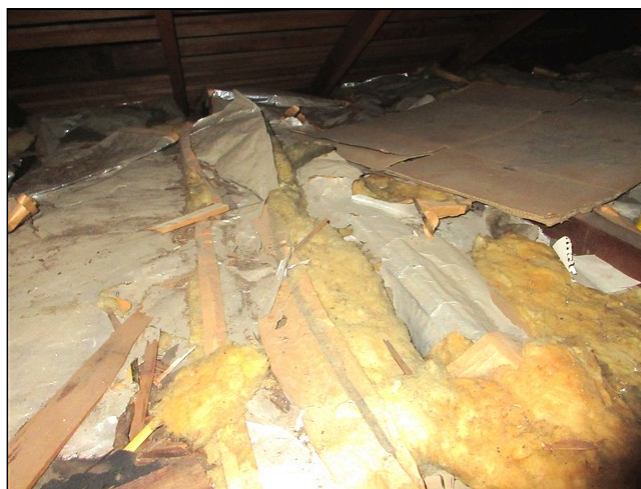
9.0 Item 1(Picture)

**Attic insulation is installed upside down and needs repair so foil backing faces heated portion of home.**

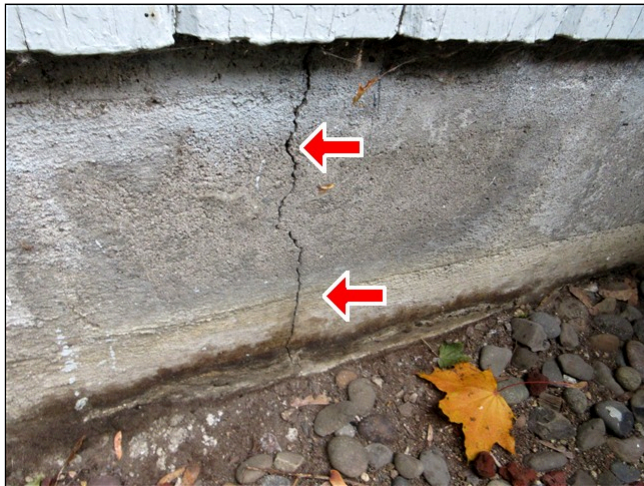
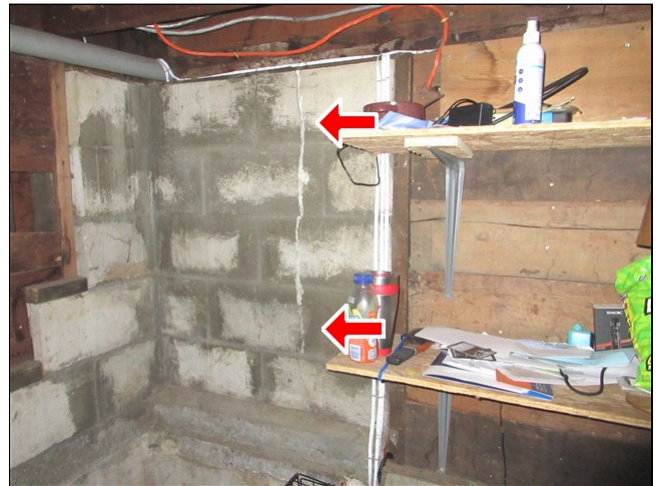
**Cracks in foundation need patching where needed.**

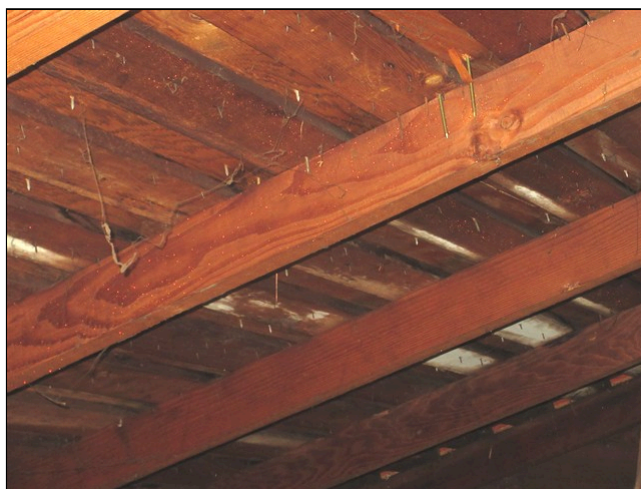
10.5 Item 1(Picture)

**Mold growth was noted in attic and needs removal by a mold remediation contractor.**
