# CITY OF OREGON CITY HISTORIC REVIEW BOARD AGENDA

Commission Chambers, Libke Public Safety Facility, 1234 Linn Ave, Oregon City  
Tuesday, October 26, 2021 at 7:00 PM

2. Preservation Grant 21-04: Window Repair on the George and Bertha Storey House at 910 Pierce Street

3. GLUA 21-00052 / HR-21-00020 Modification of HR 20-00001
4. GLUA 21-00055 / HR-21-00021: Historic Review for Roof Alterations at 610 Jefferson Street
5. GLUA 21-00059 / HR-21-00022: Historic Review for Metal Roof Alteration of a Designated Structure at 602 Jefferson Street

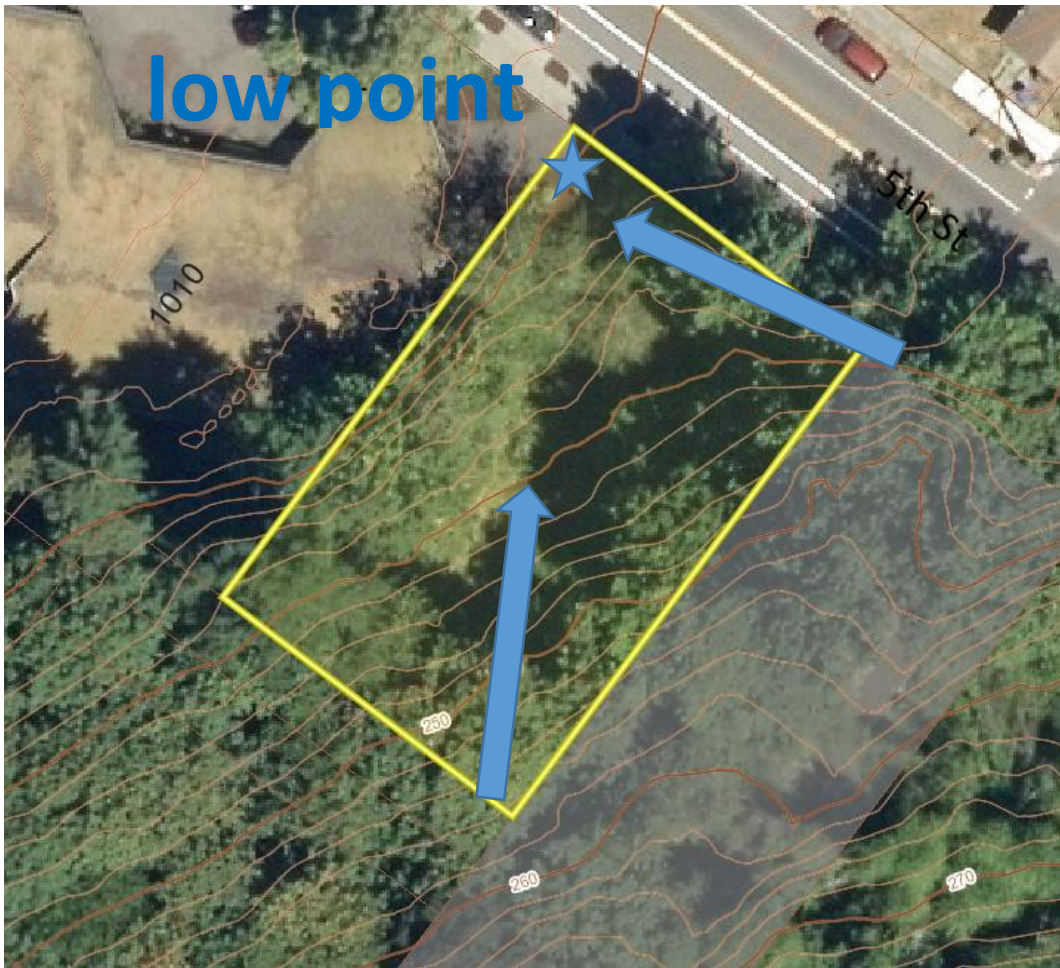
Figure 2-Aerial photo and topography- arrow showing cross-slope

The site is located in the McLoughlin Conservation District in the Mixed-Use Corridor Zone. The property is approximately 9500 square feet and has 77 feet of frontage on 5<sup>th</sup> Avenue. It also borders unimproved JQ Adams Street, which is heavily forested and includes a pedestrian walkway up to the Barclay Hills and Rivercrest neighborhoods. The site is crossed slope upward from 5<sup>th</sup> and to the back of the lot (see figure 2)

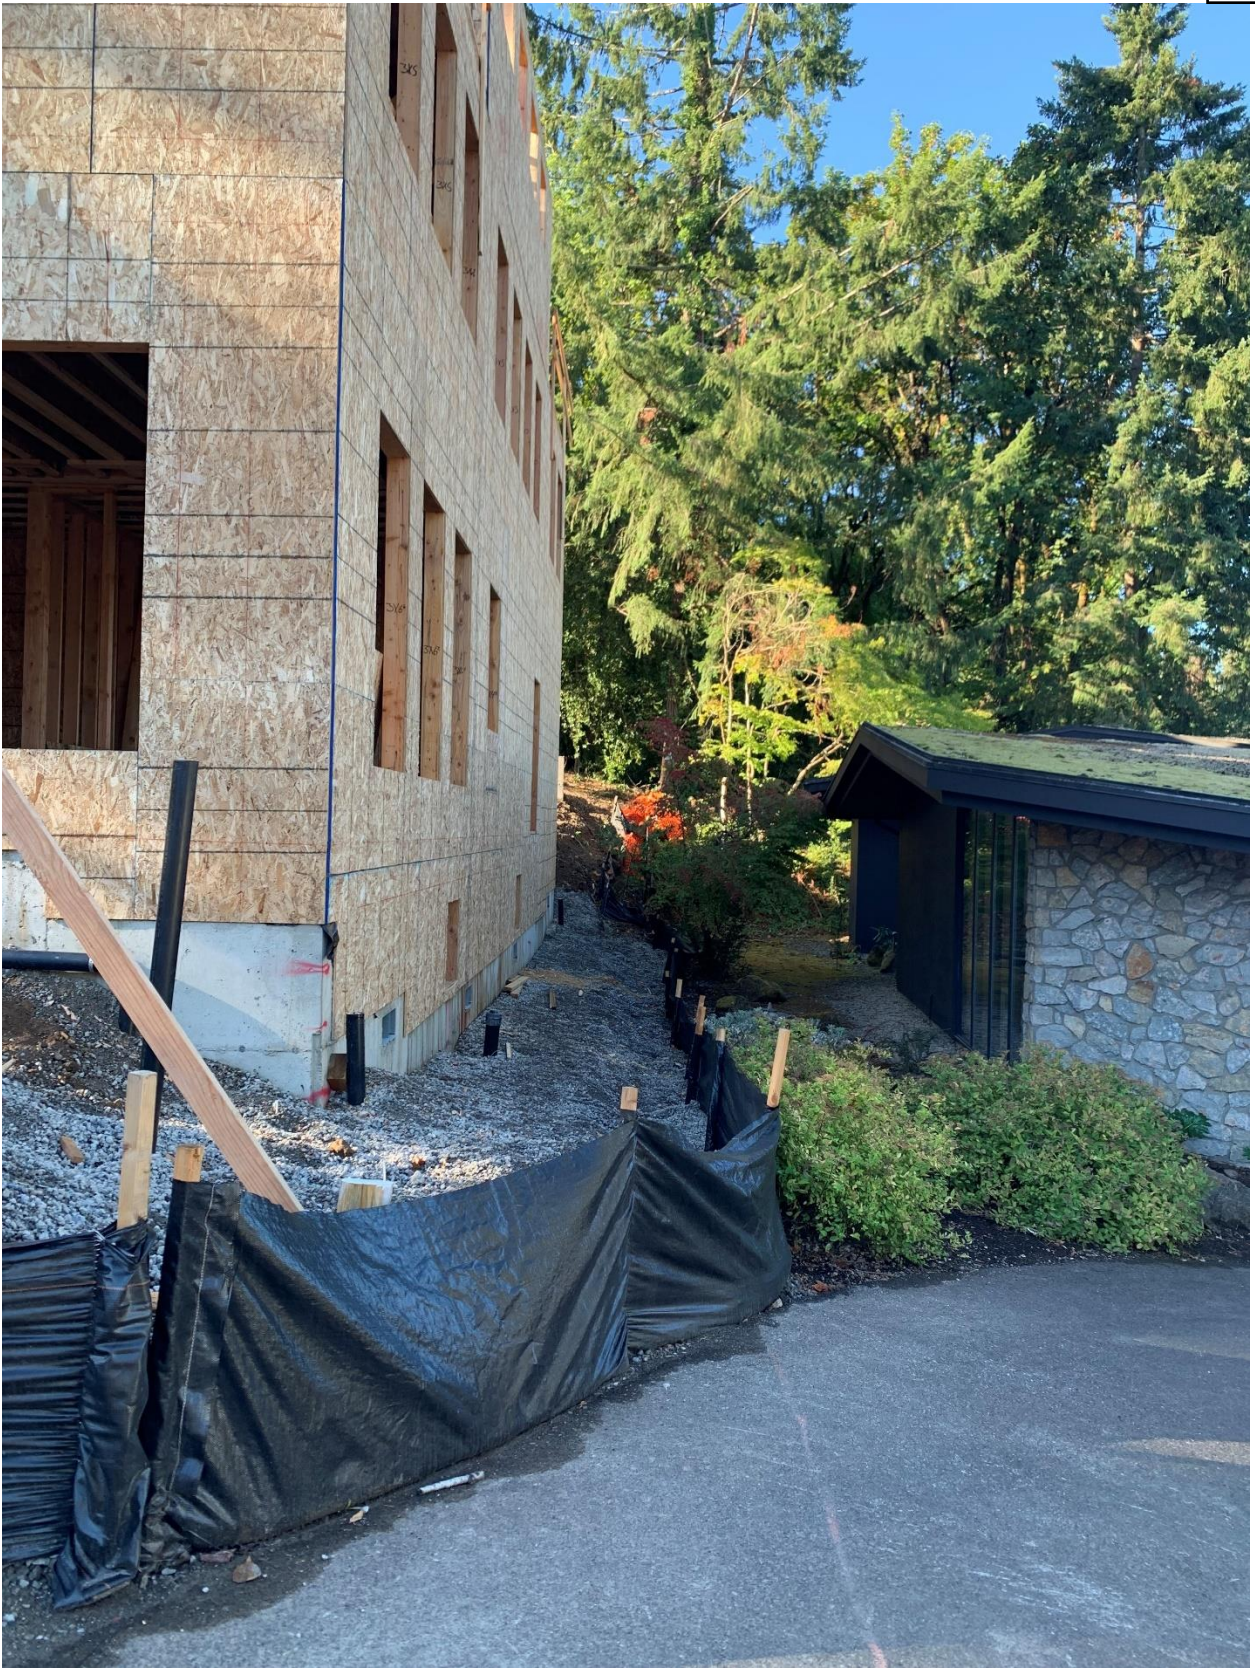
Figure 4 Existing condition of exposed foundation- September 21, 2021

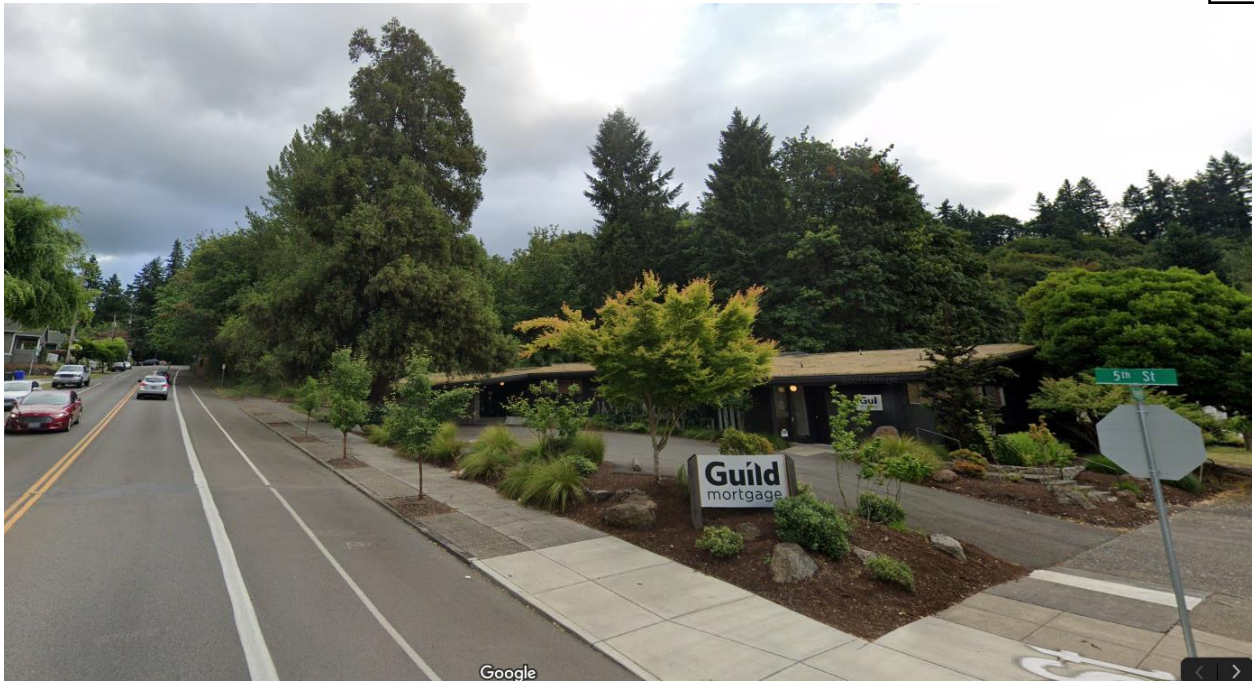
Figure 5 Neighboring building at 1010 5<sup>th</sup> Street; a modern commercial building with a low shed roof, roughly U-shaped. The offices are sited in the eastern portion of the building, with a small courtyard framed by the low roof on the west side. The building is primarily clad with stone veneer, but some portions have vertical groove plywood siding. The windows are fixed aluminum sash and are located primarily on the east and west sides of the building. It is not a designated structure in the Mcloughlin Conservation District. (Google Maps- taken prior to construction)

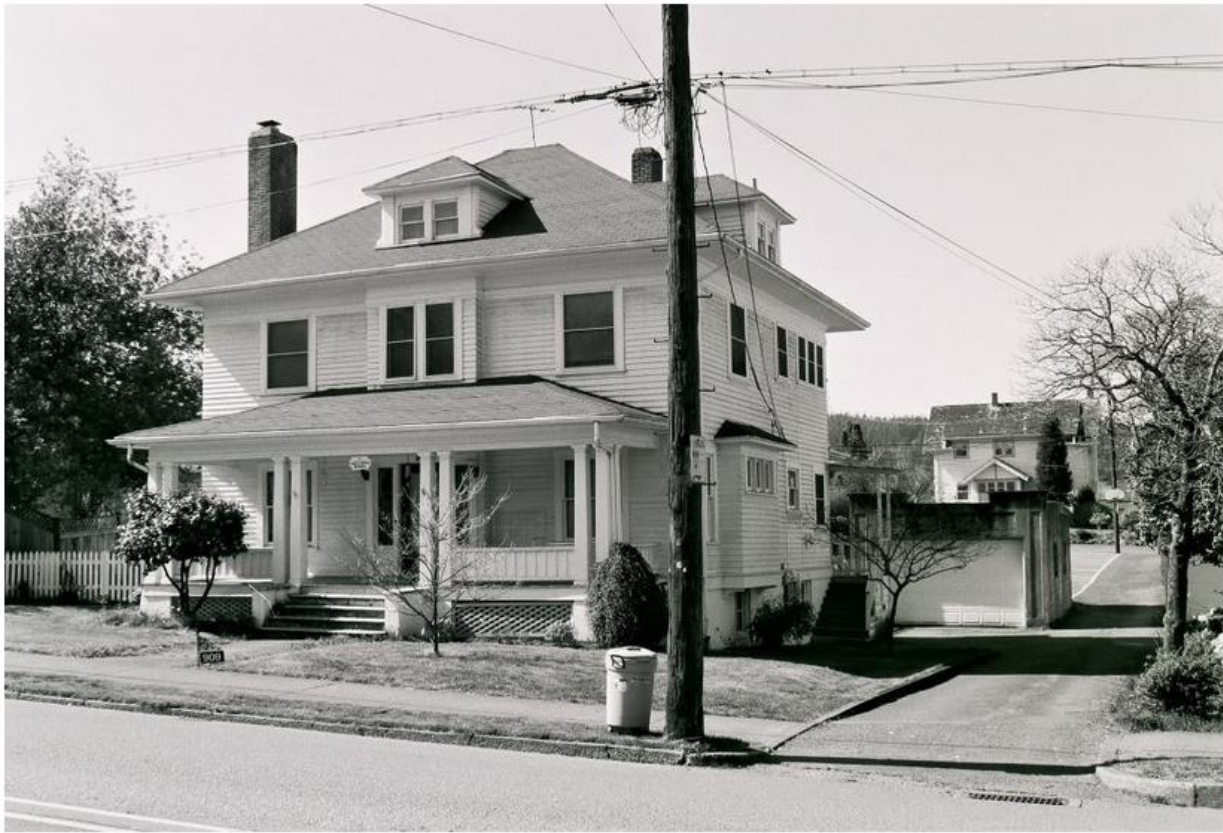
*Figure 8 -909 Washington Street- Charles Caufield House. An example of a side porch and stair with a 3 ½ to 4-foot foundation height on a sloping site.*

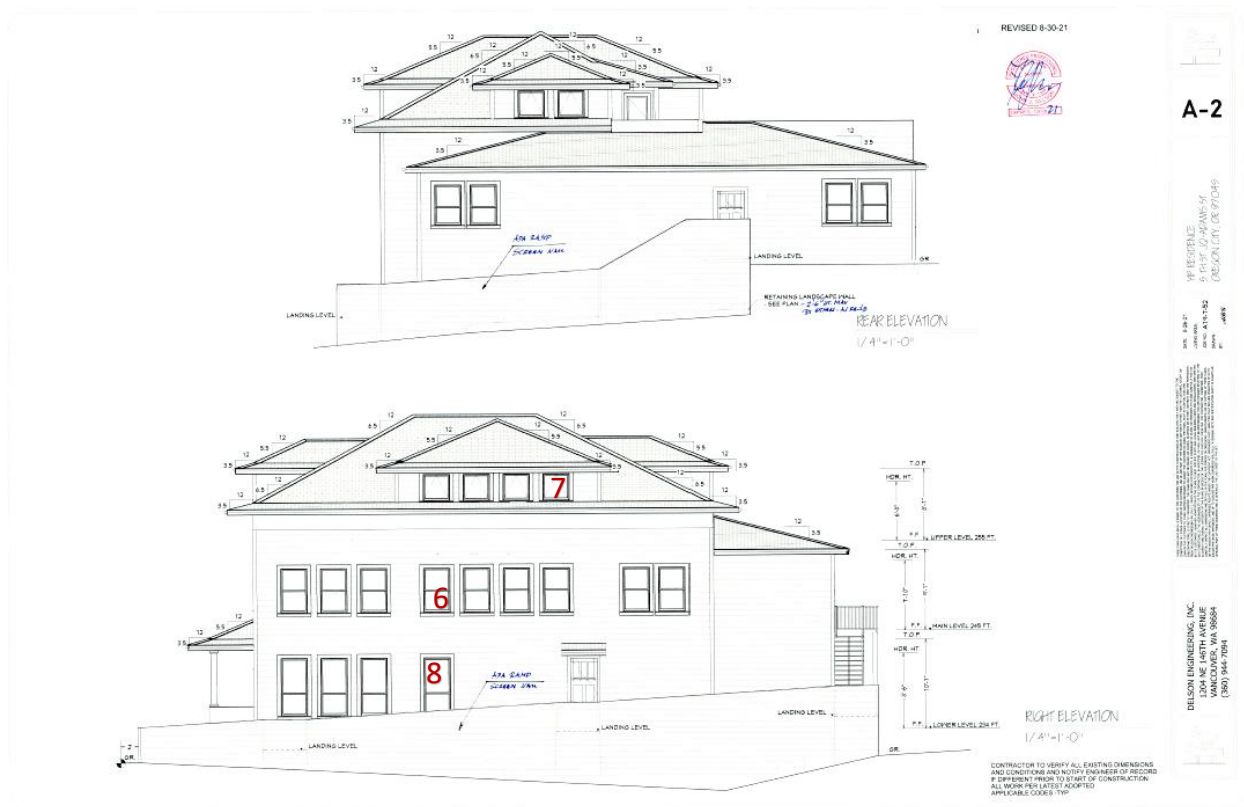
Figure 17- Proposed HR 21-00020 Left elevation (uphill side) & Rear elevation with proposed elevation. - window #s correspond to Conditions of Approval

Window alterations are identified by number and further discussed in the narrative and proposed Conditions of Approval.

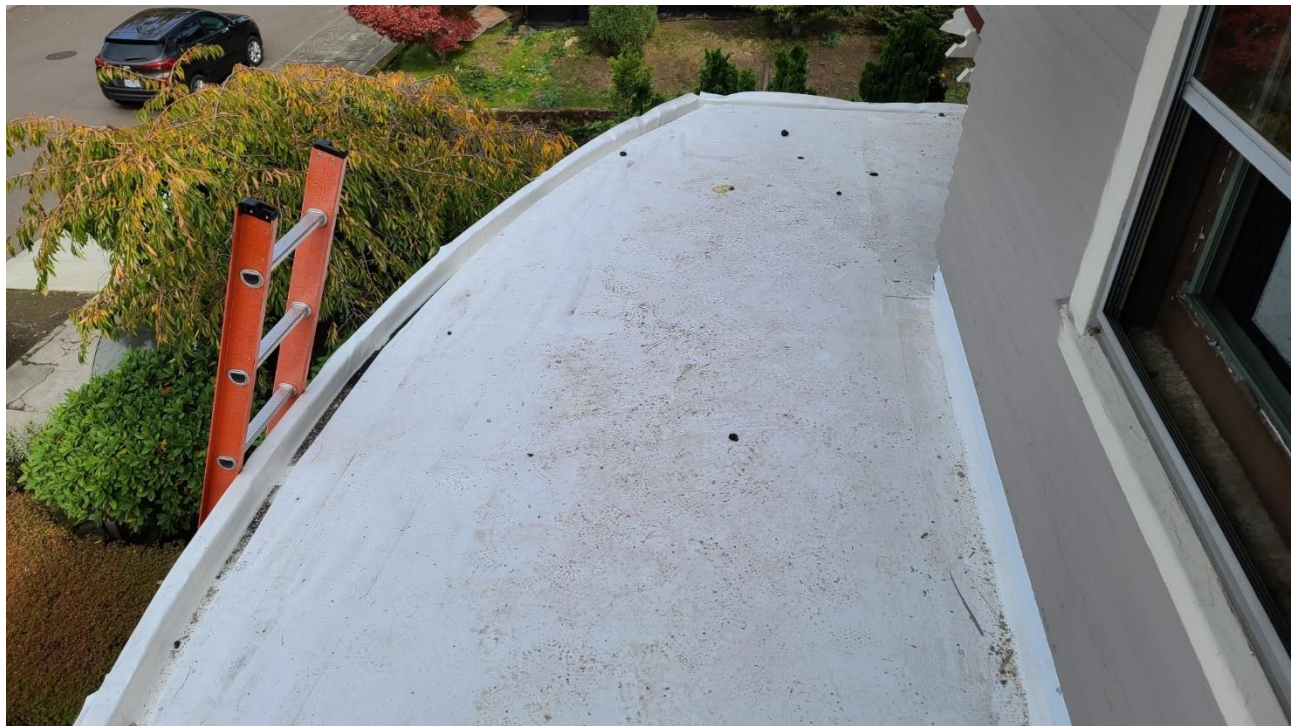
Figure 5. Roof work partially finished on front porch

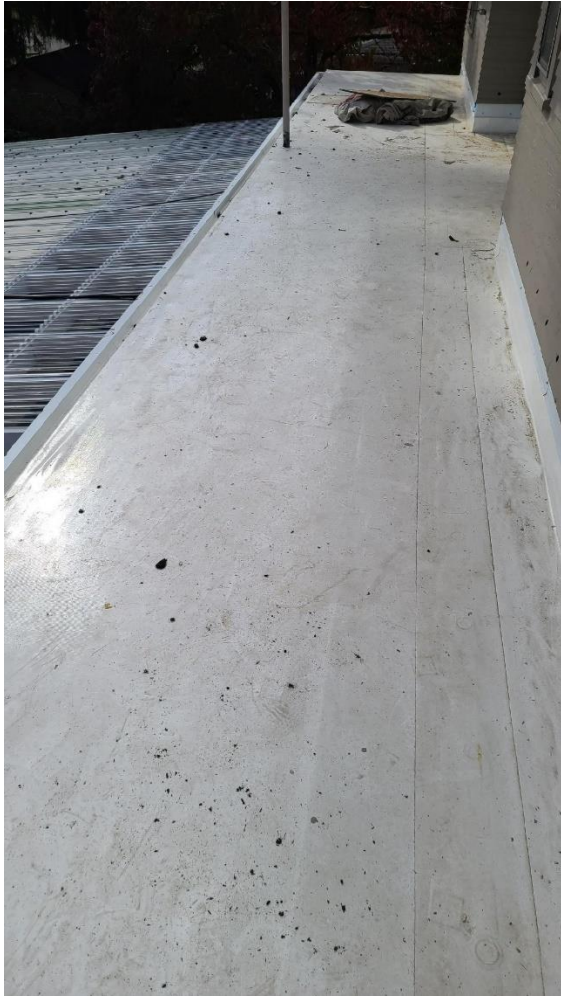
Figure 6. Roof work on rear porch.

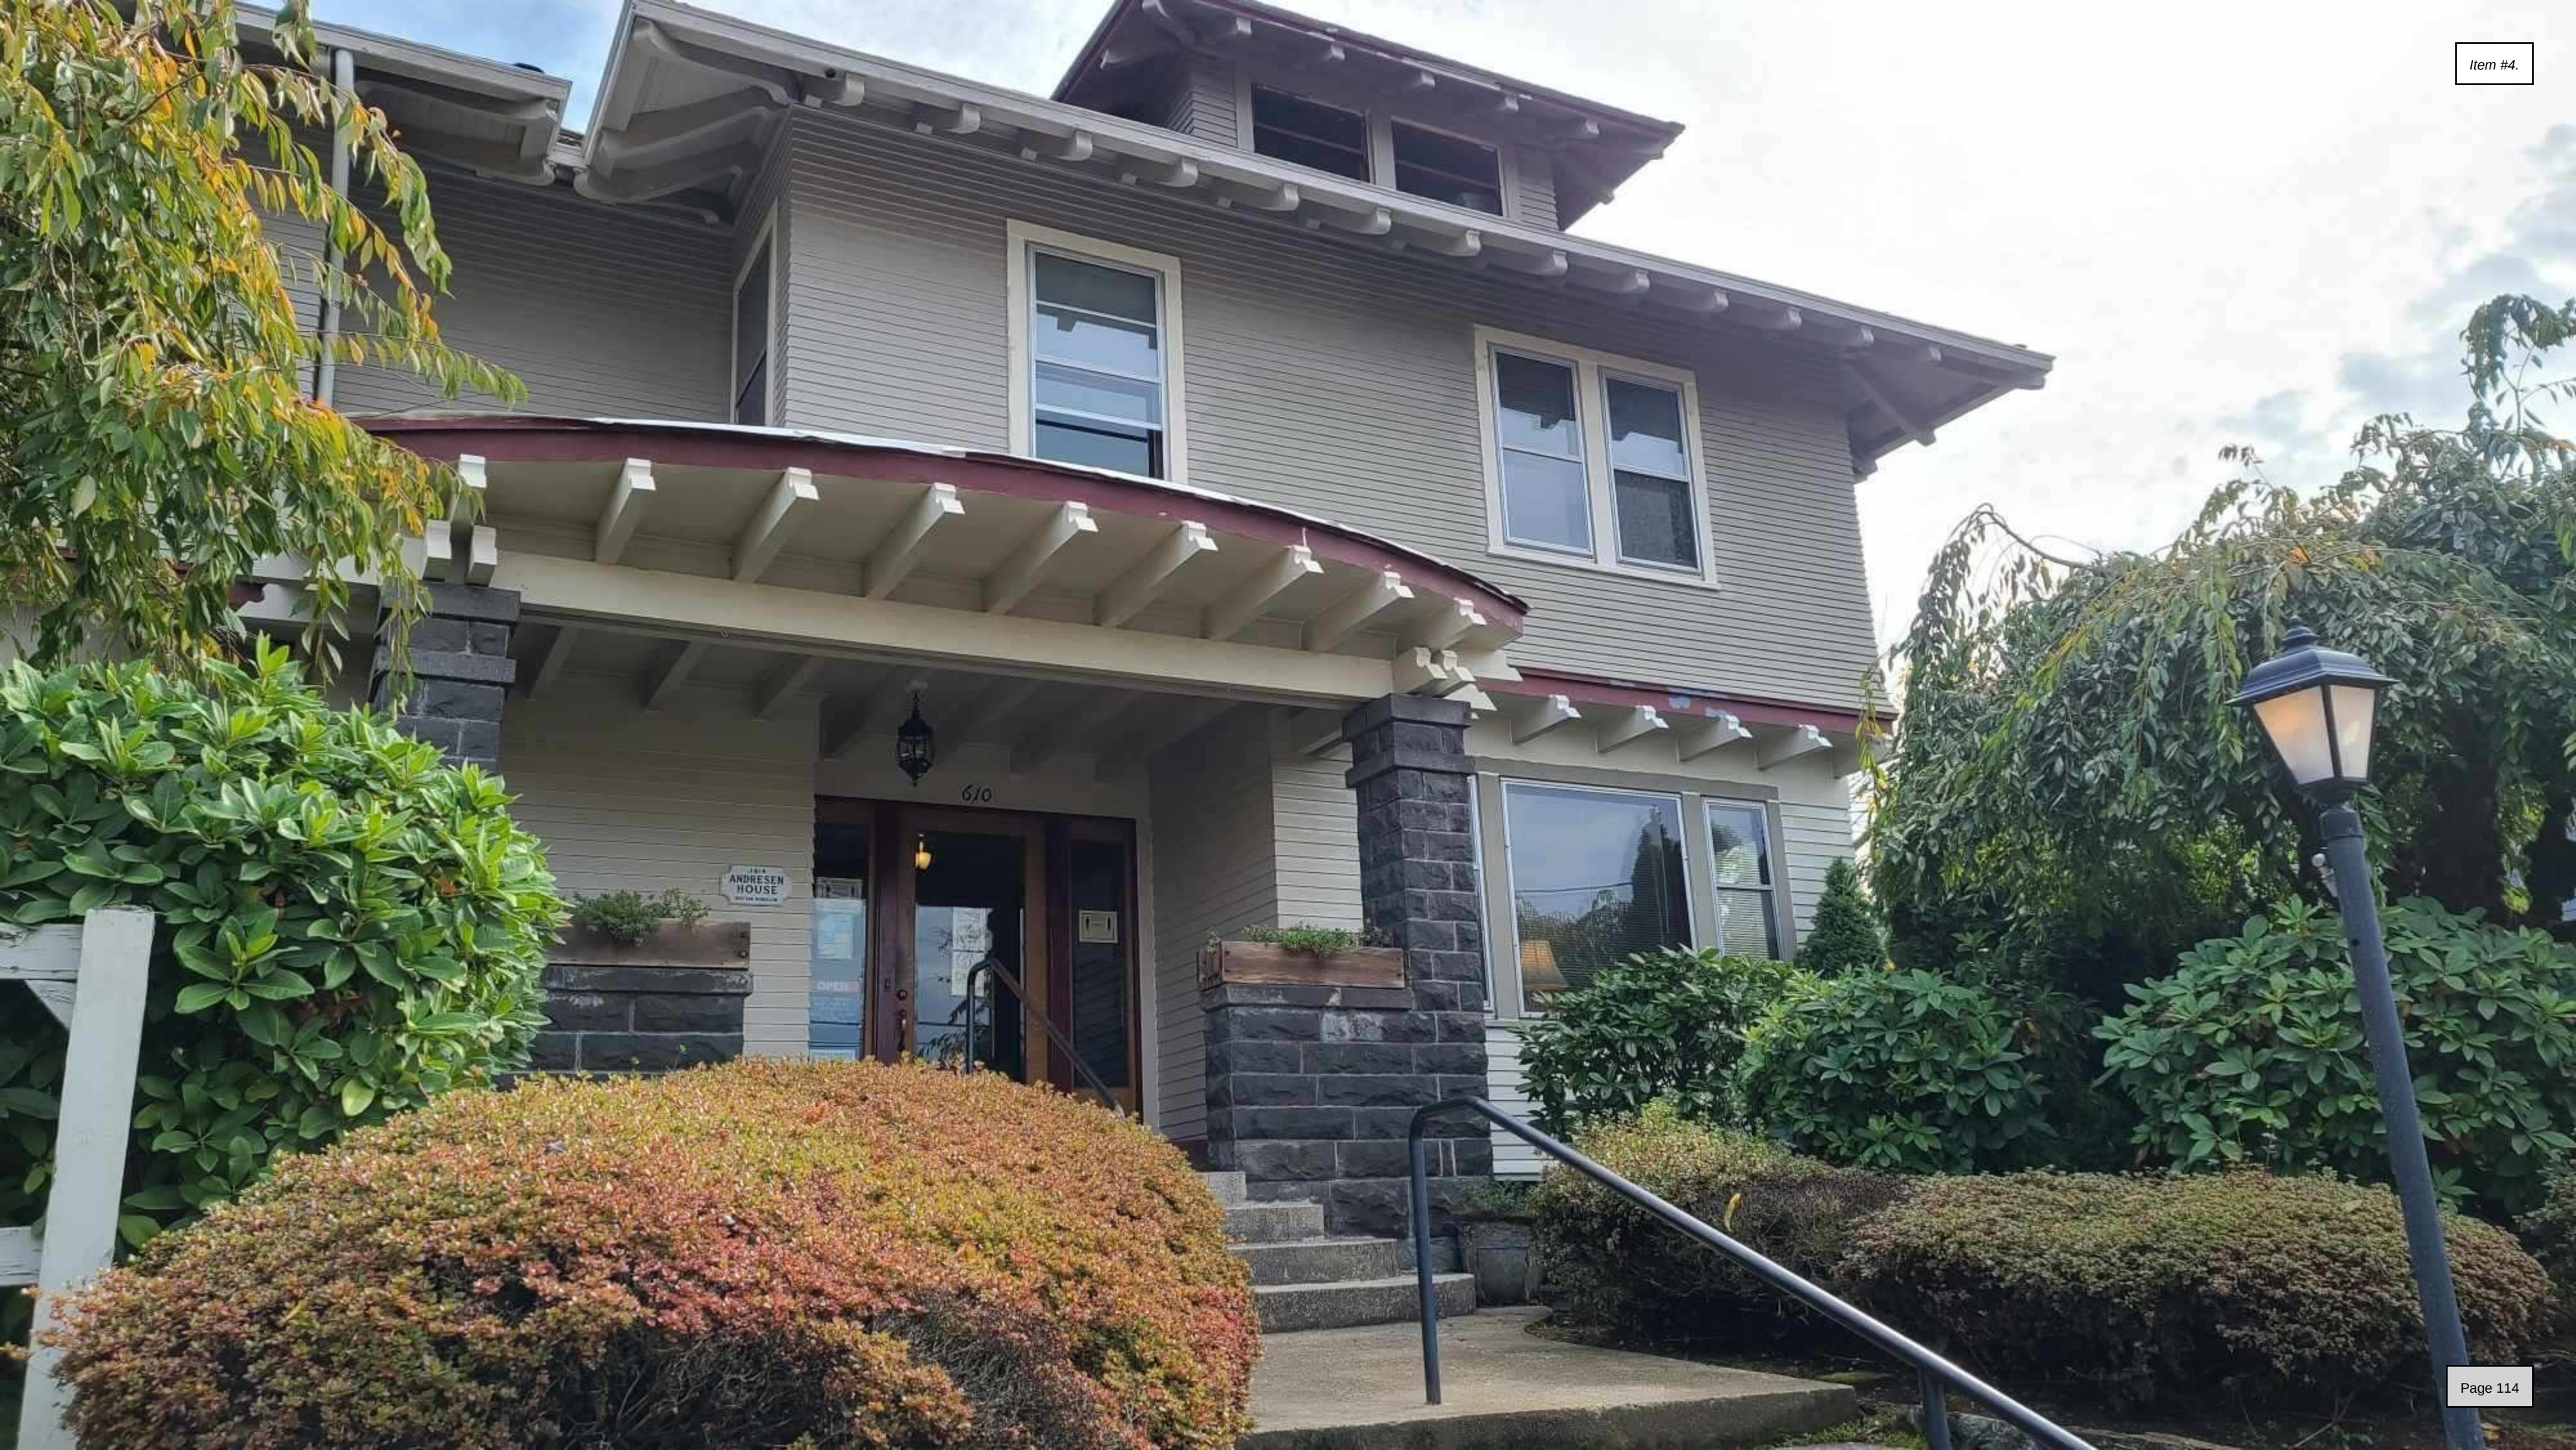
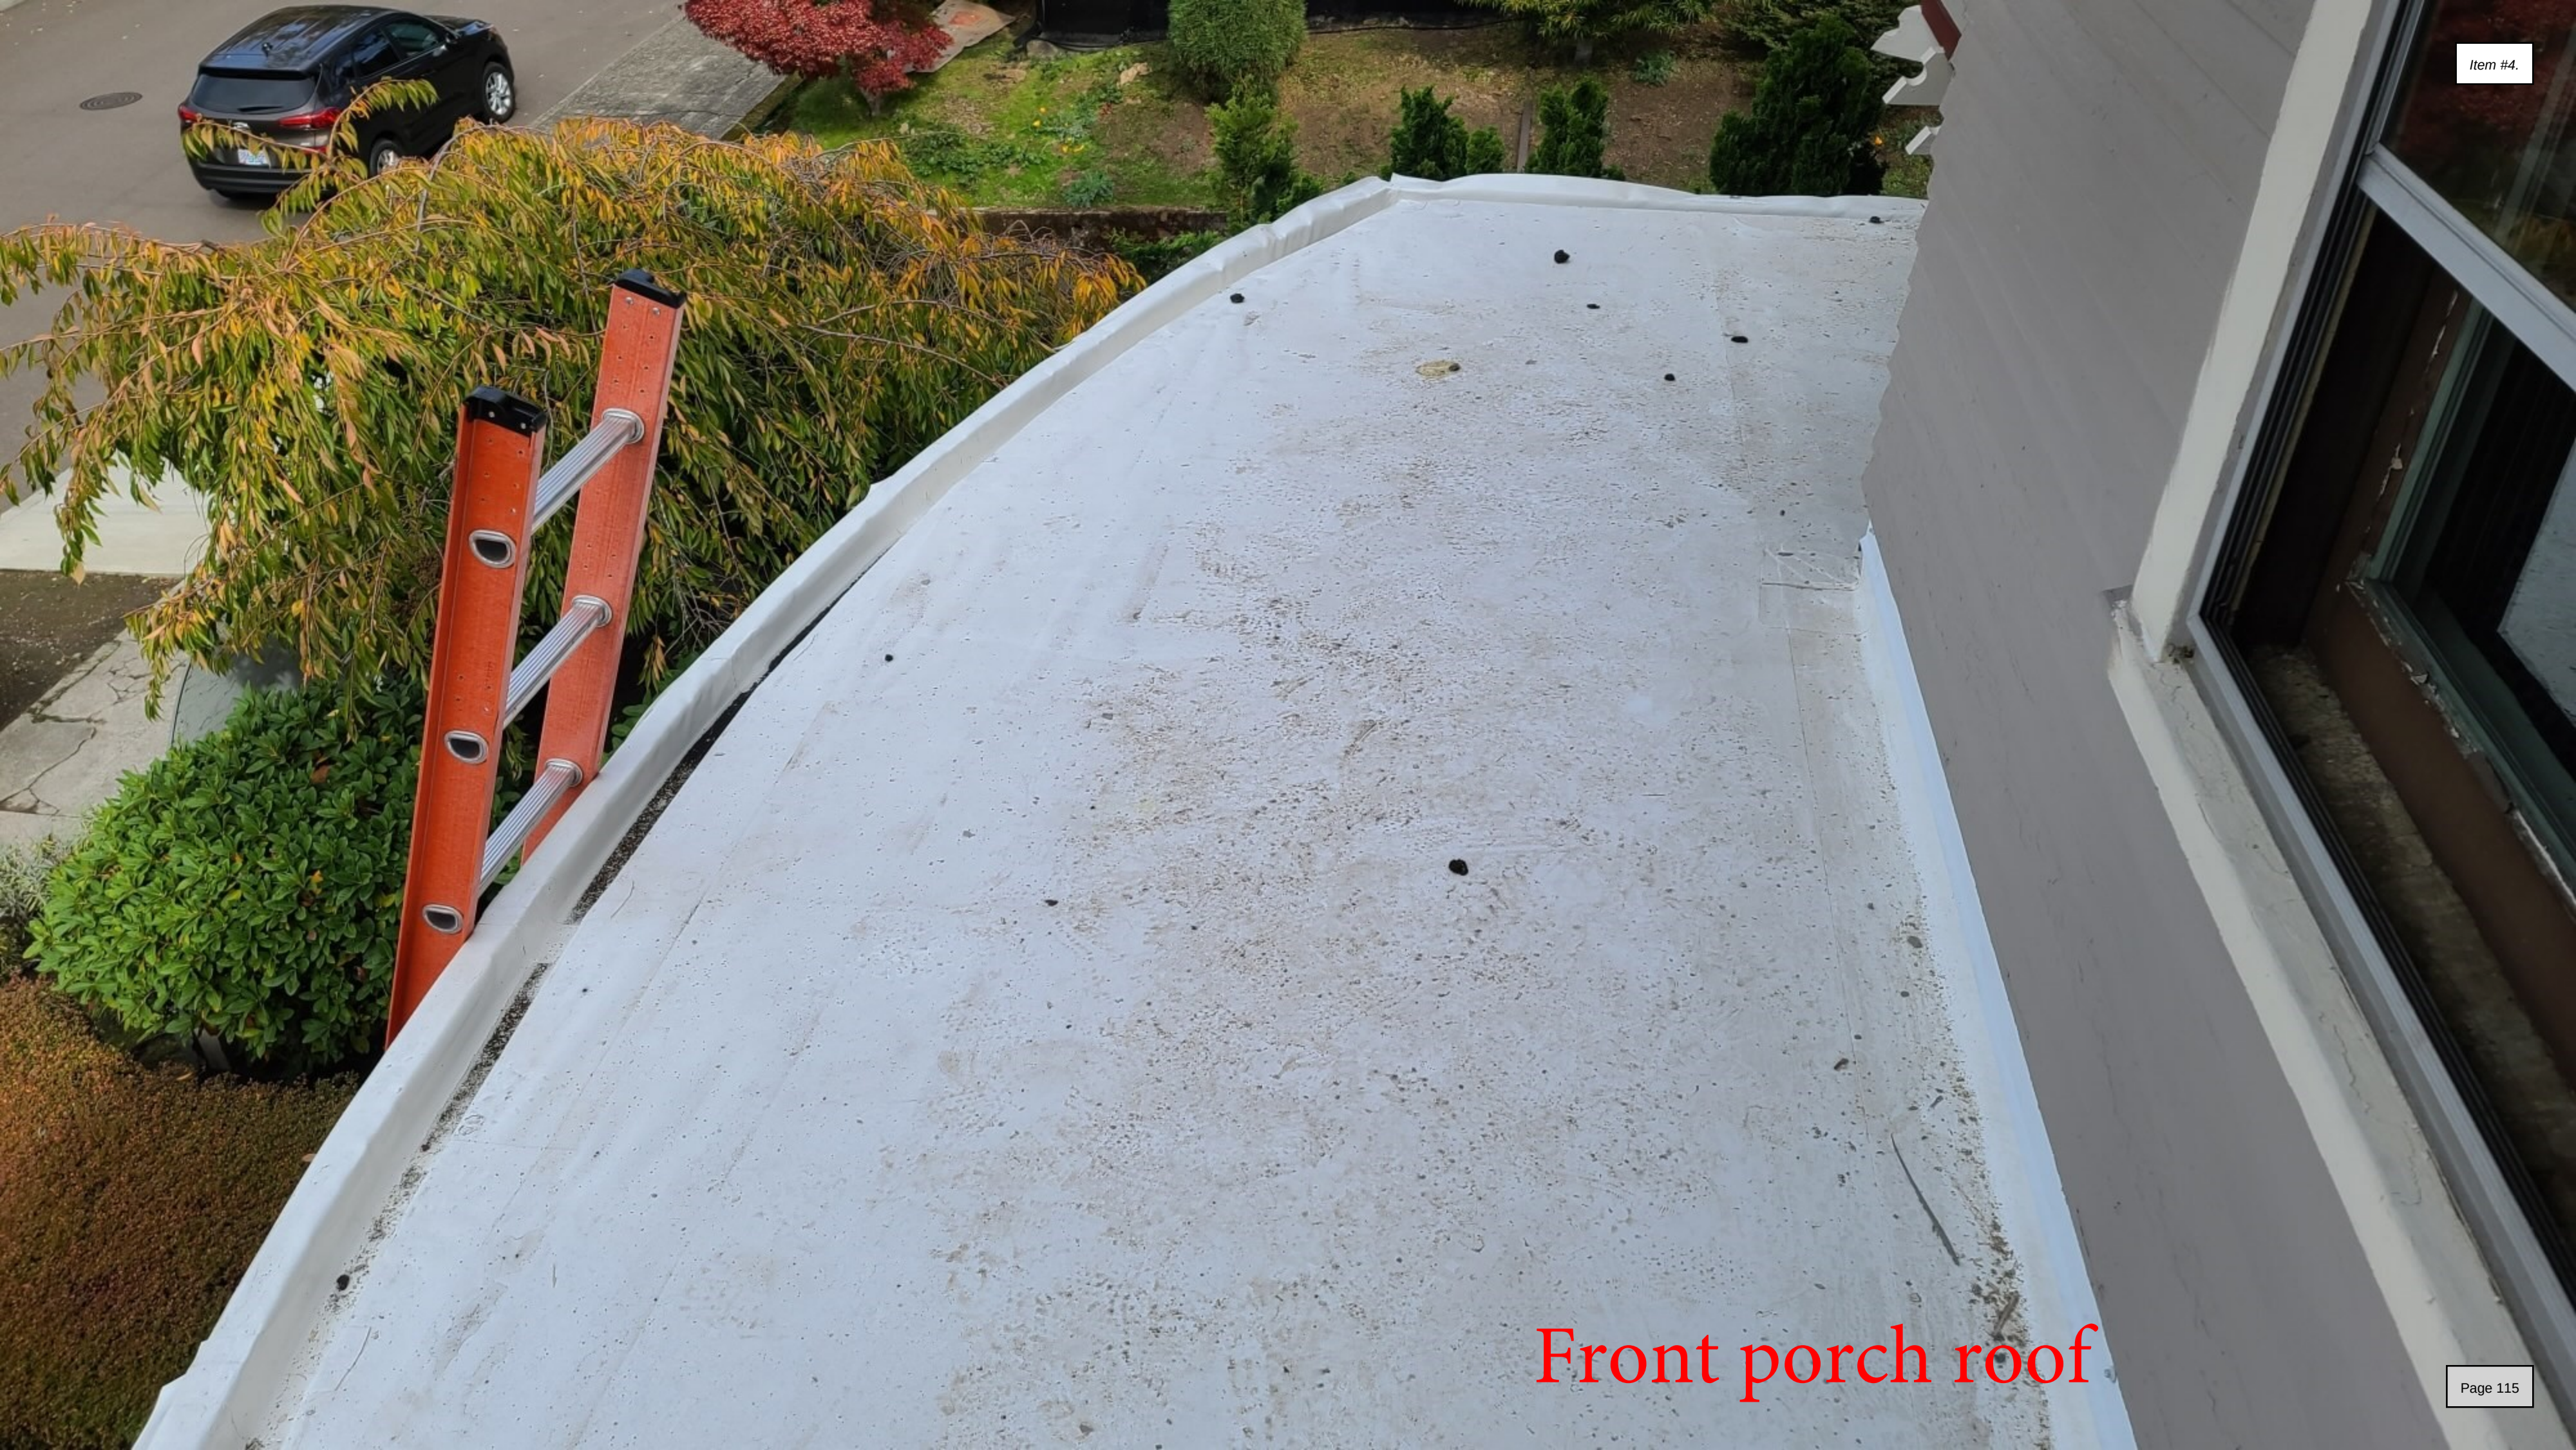
**REAR PORCH  
ROOF - APPROX  
400 SQ. FT.**

Front porch roof

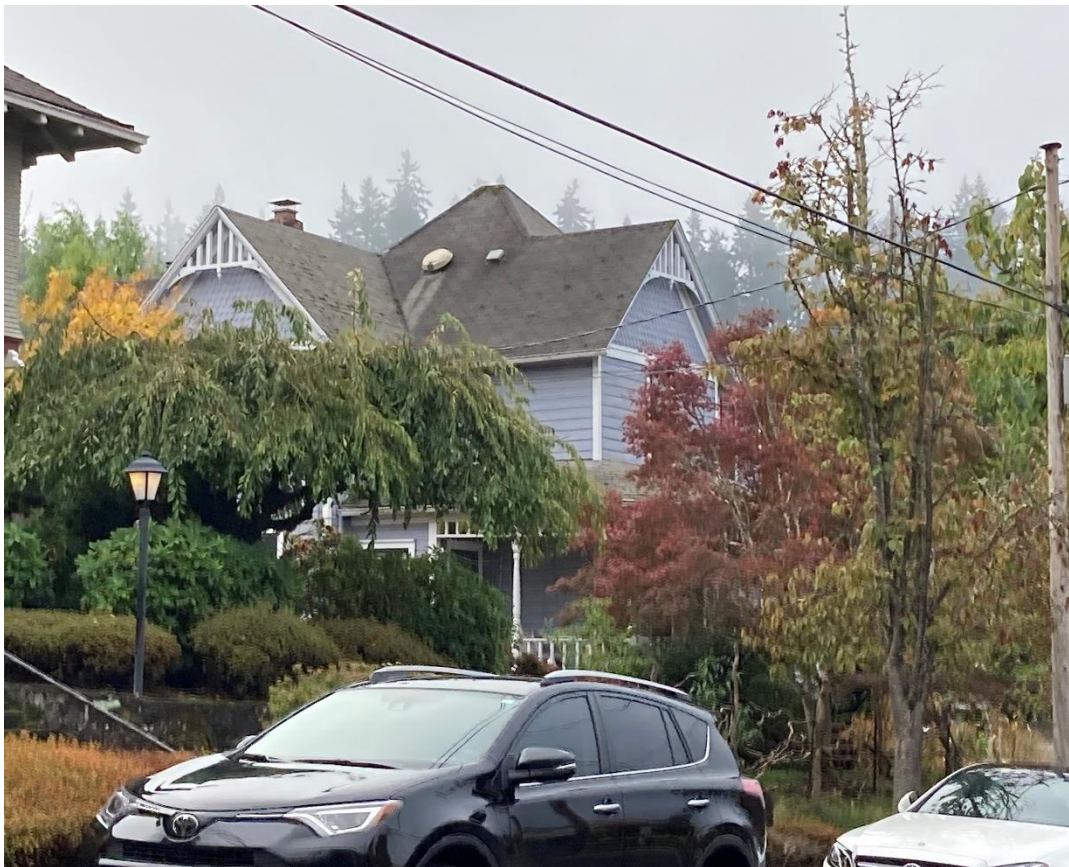
Figure 3. View of roof from Jefferson Street sidewalk (across from 610 Jefferson)

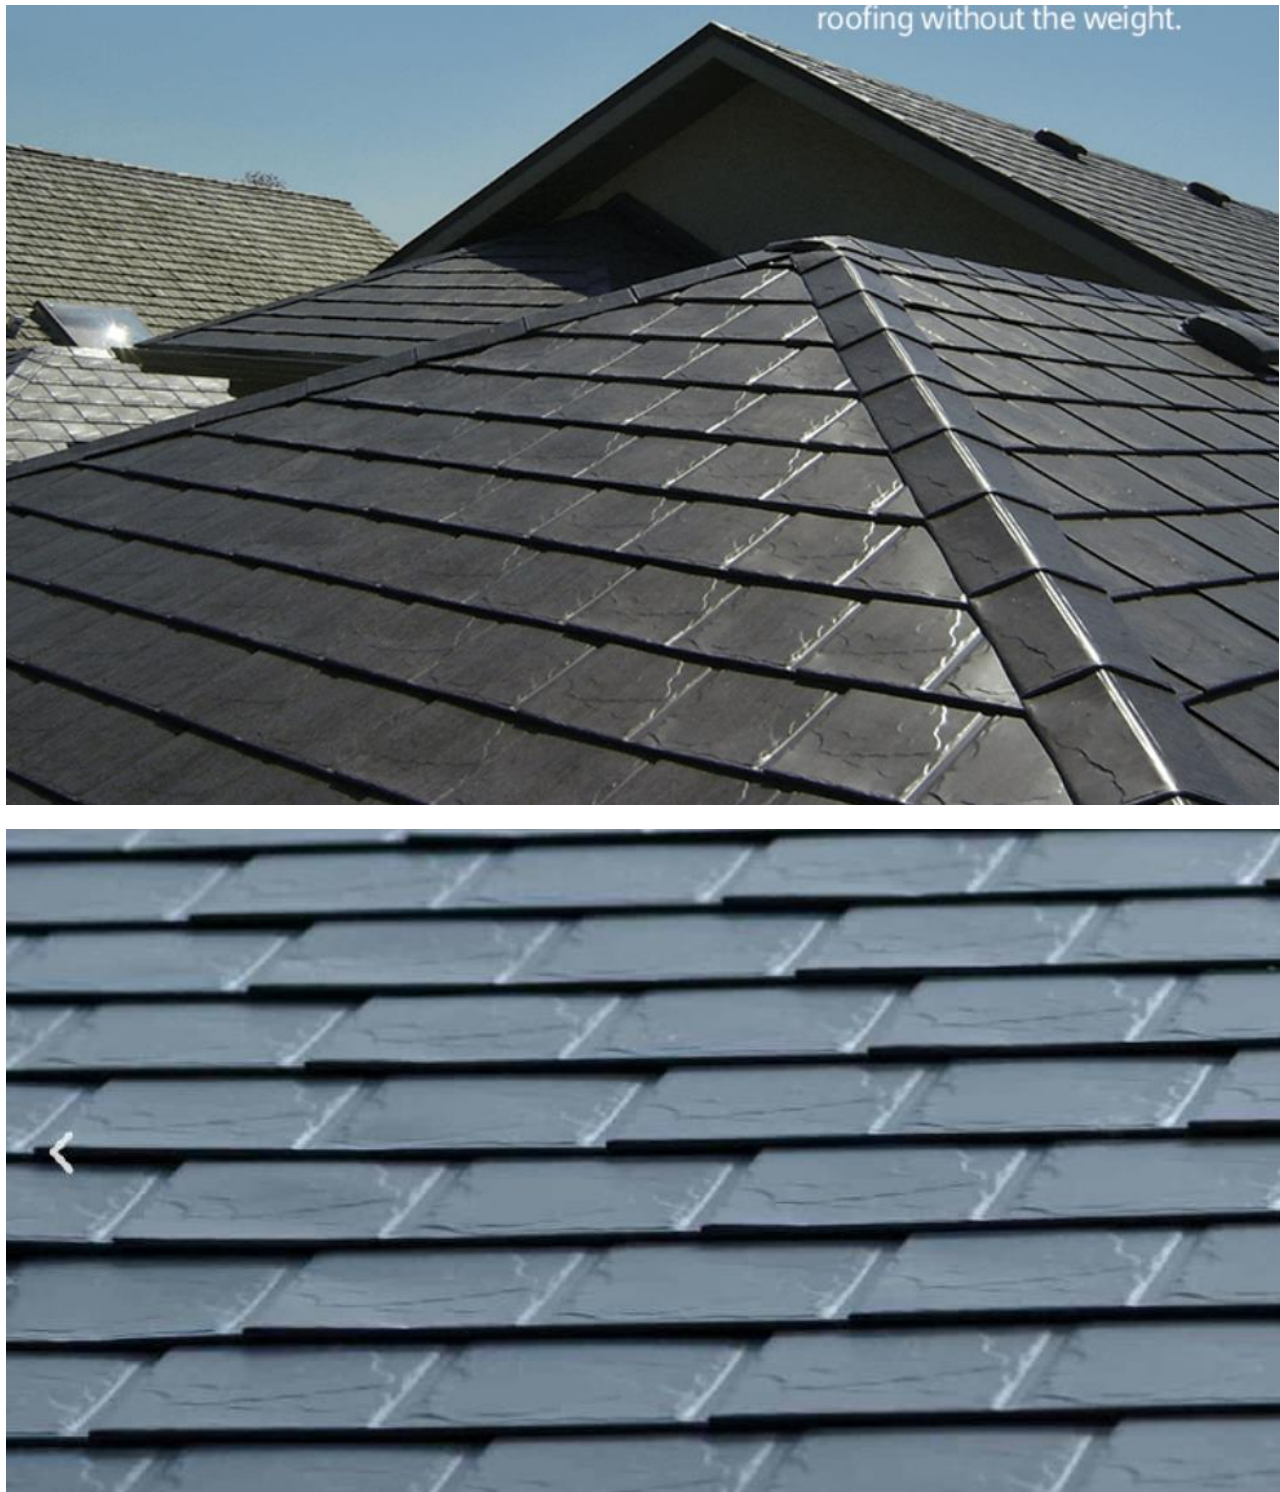
Figure 4. Images from Interlock Roofing product brochure

Traditional slate is very expensive and is also very heavy; in fact some rafters may need to be reinforced. With an Interlock® Slate roof you'll get the longevity and look of natural slate roofing without the weight.

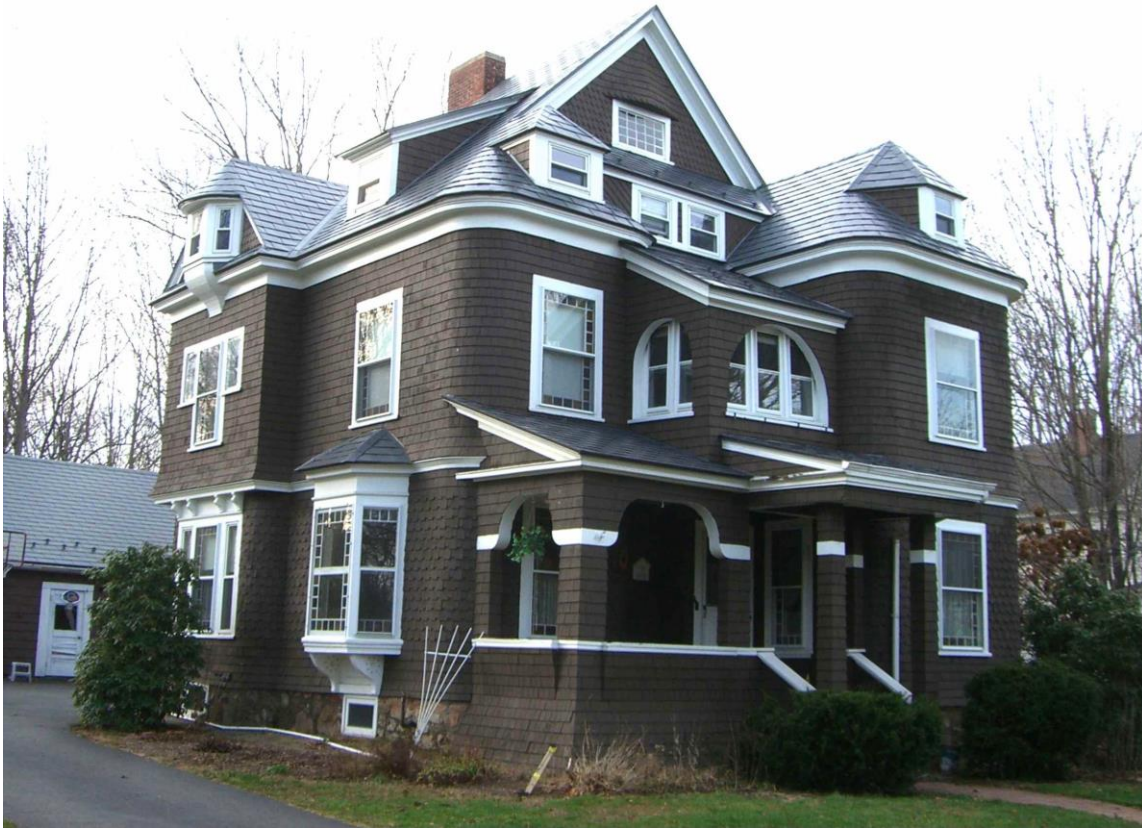
Figure 5. Example of similar roofing material (images provided by applicant)

The applicant provided images to the proposed roof material on other homes. The applicant also provided physical samples of the proposed faux slate product, along with an alternative faux cedar shingle product. The applicant has indicated that the slate product is preferred over the shingle.

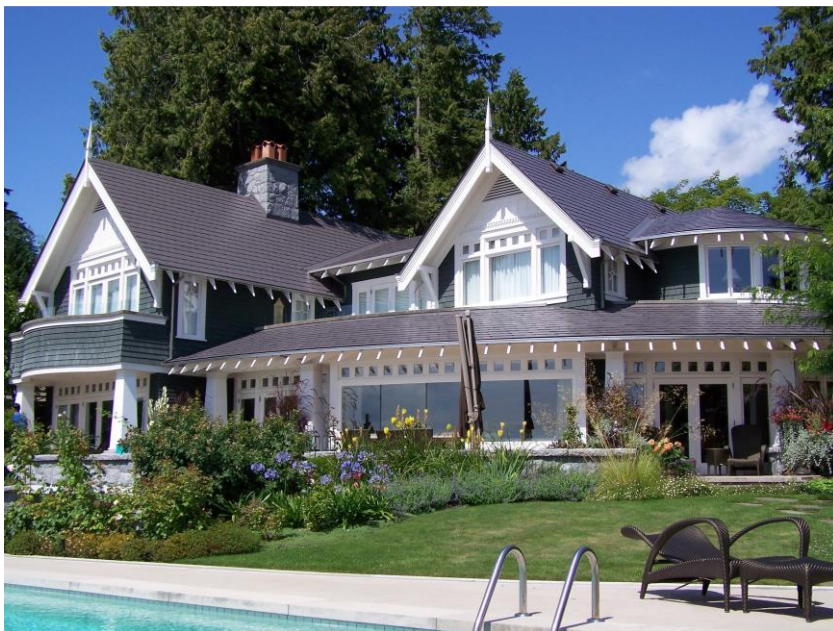
Figure 6. Example of similar roofing material (images provided by applicant)

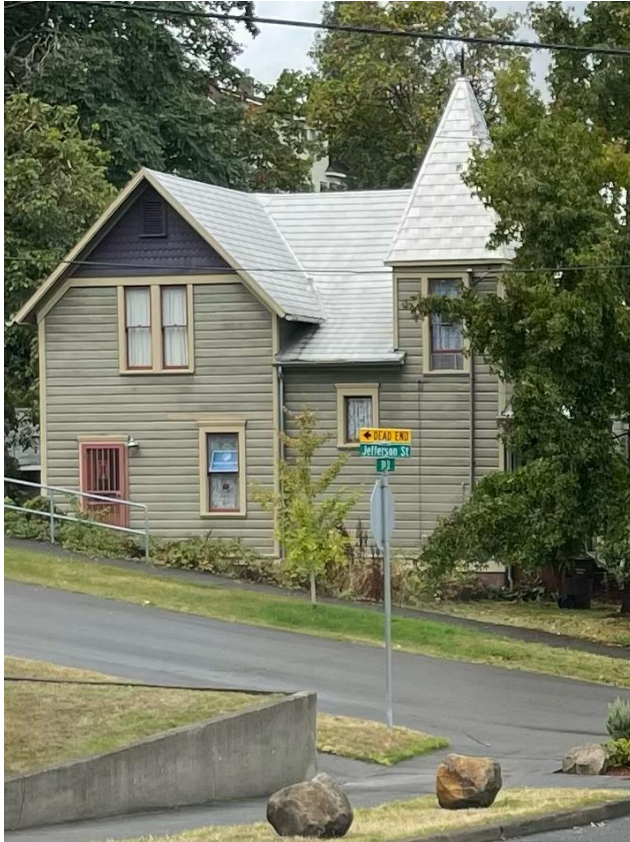
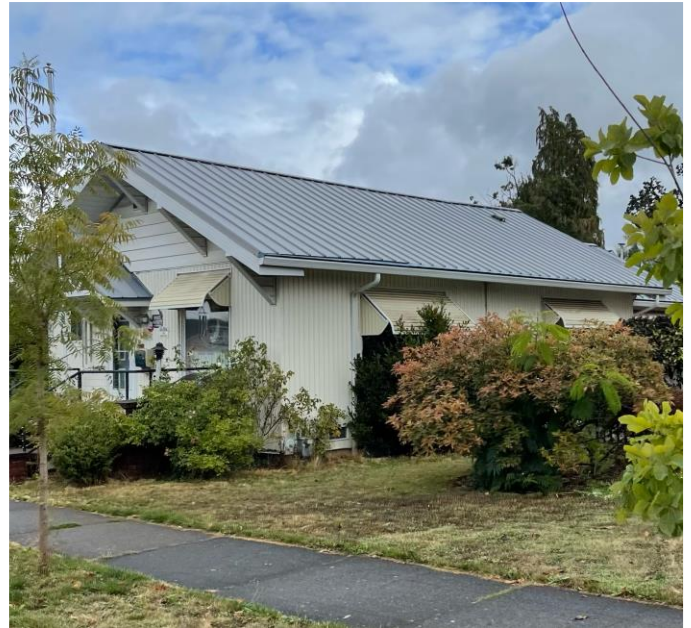
Figure 7 and 8. Local homes with metal roofs  
(images provided by applicant)
