# CITY OF OREGON CITY HISTORIC REVIEW BOARD AGENDA

Commission Chambers, Libke Public Safety Facility, 1234 Linn Ave, Oregon City  
Tuesday, October 26, 2021 at 7:00 PM

2. Preservation Grant 21-04: Window Repair on the George and Bertha Storey House at 910 Pierce Street

3. GLUA 21-00052 / HR-21-00020 Modification of HR 20-00001
4. GLUA 21-00055 / HR-21-00021: Historic Review for Roof Alterations at 610 Jefferson Street
5. GLUA 21-00059 / HR-21-00022: Historic Review for Metal Roof Alteration of a Designated Structure at 602 Jefferson Street

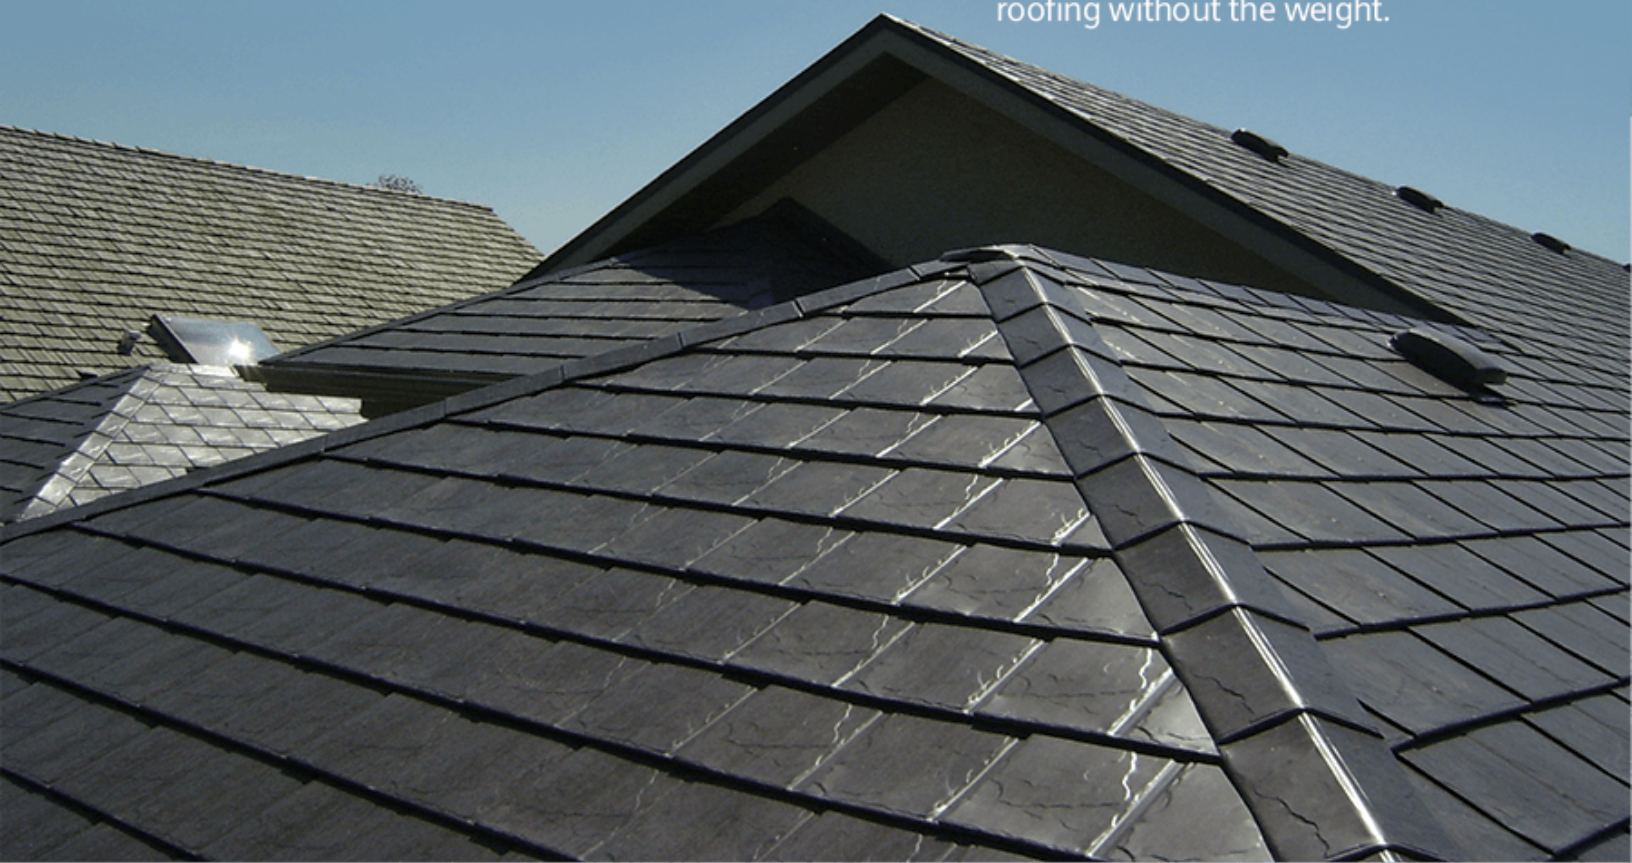
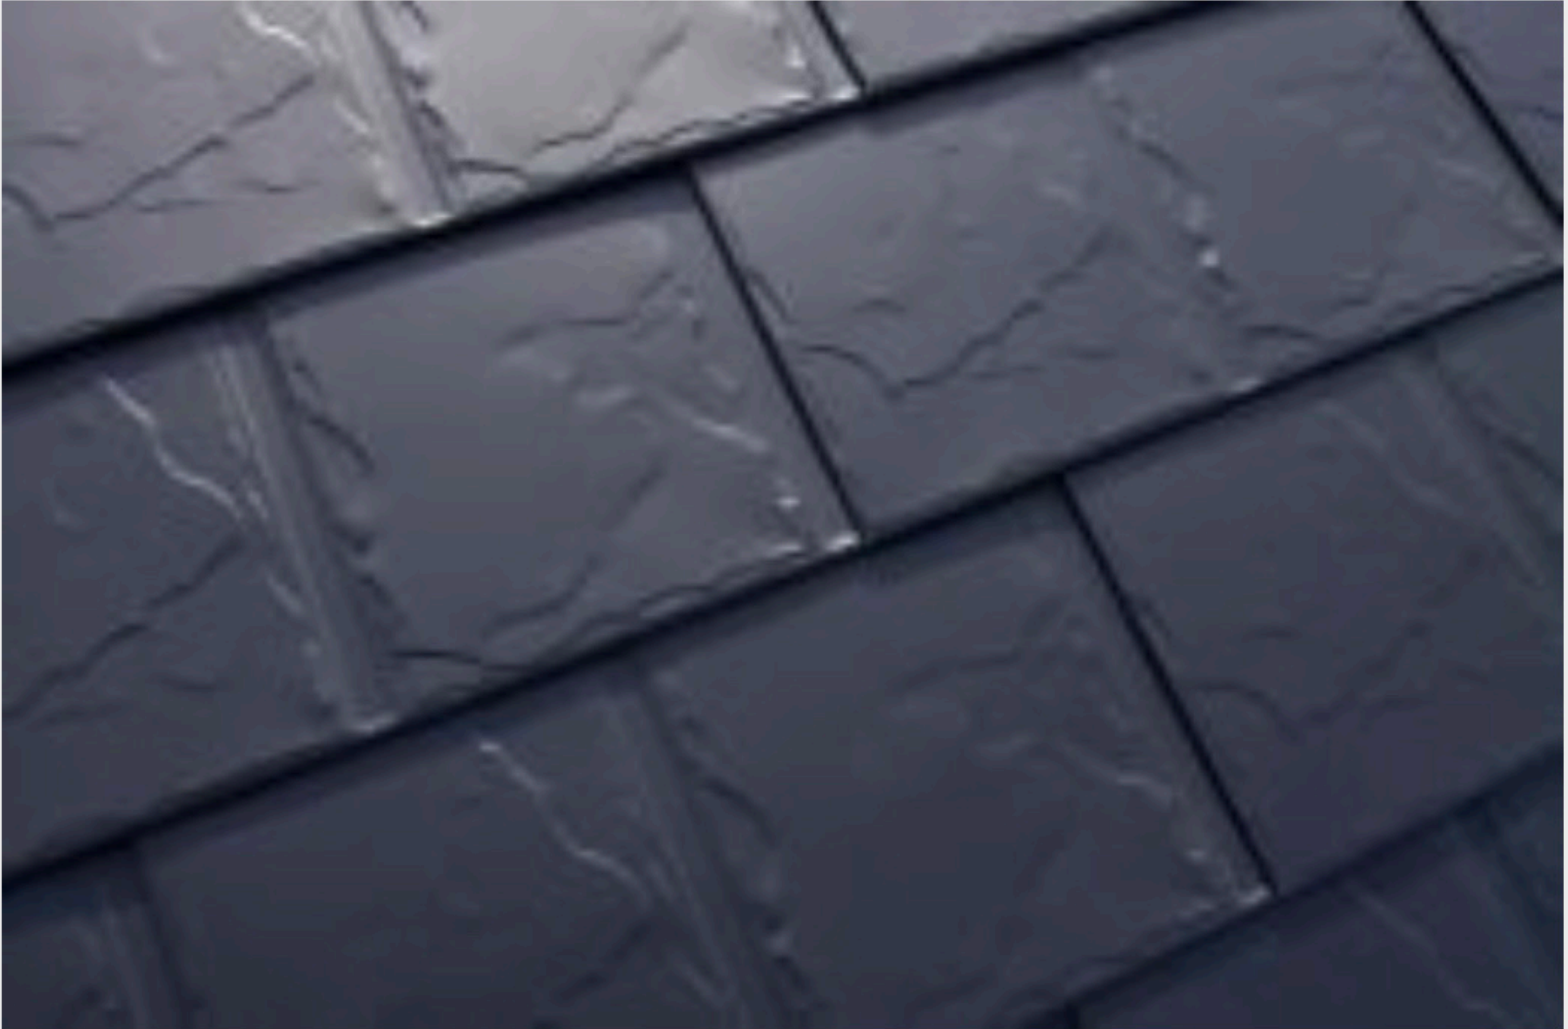
Traditional slate is very expensive and is also very heavy; in fact some rafters may need to be reinforced. With an Interlock® Slate roof you'll get the longevity and look of natural slate roofing without the weight.

Due to damage sustained in the ice storm earlier this year our roof needs to be replaced. We are proposing to do so with a roof that resembles black slate tile that would have been available at the time the house was constructed. Though this modern product from Interlock Roofing is made of aluminum, the overall aesthetic of the slate tile will add period appropriate charm to both the home and the neighborhood by keeping with the historic aesthetic and replacing the more modern looking composition shingles.

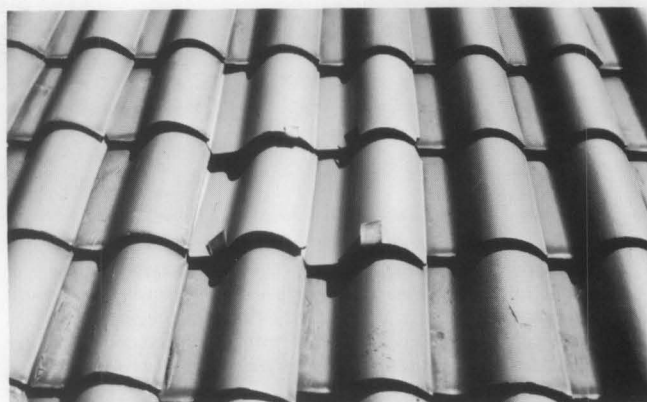
*Repairs on this pantile roof were made with new tiles held in place with metal hangers. (Main Building, Ellis Island, New York)*

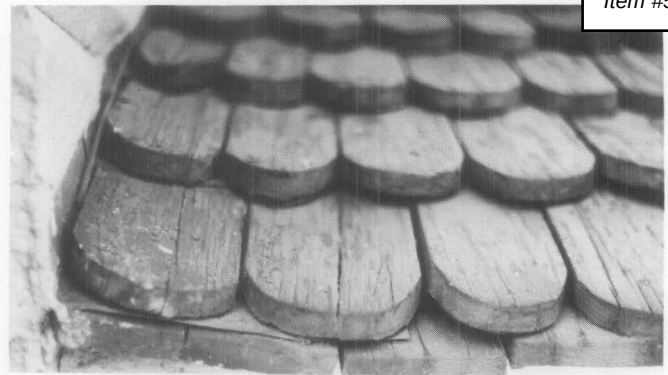
*Replacement of particular historic details is important to the individual historic character of a roof, such as the treatment at the eaves of this rounded butt wood shingle roof. Also note that the surface of the roof was carefully sloped to drain water away from the side of the dormer. In the restoration, this function was augmented with the addition of carefully concealed modern metal flashing. (Mount Vernon, Virginia)*

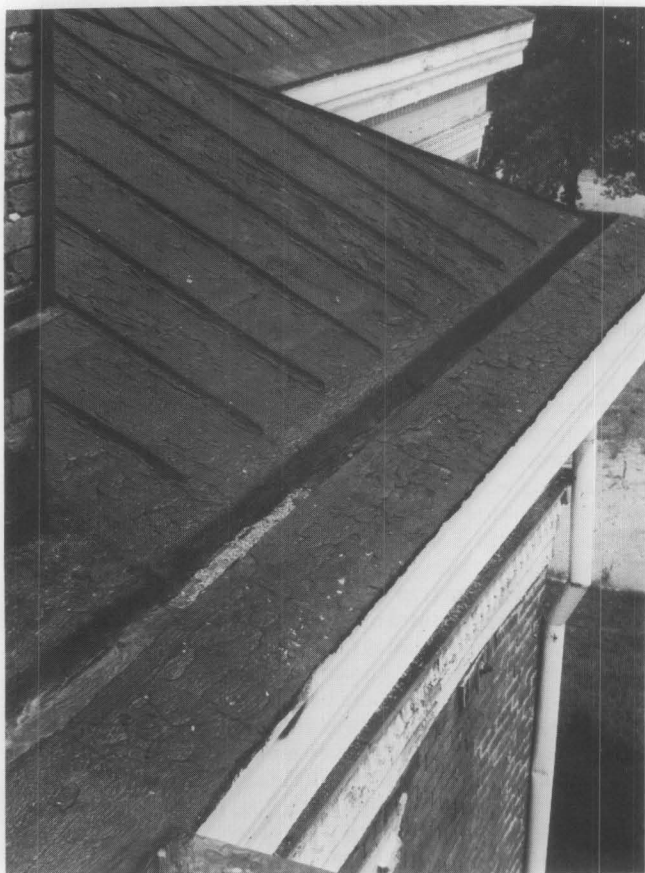
Repeated repair with asphalt, which cracks as it hardens, has created a blistered surface on this sheet-metal roof and built-in gutter, which will retain water. Repairs could be made by carefully heating and scraping the surface clean, repairing the holes in the metal with a flexible mastic compound or a metal patch, and coating the surface with a fibre paint. (Roane County Courthouse, Kingston, Tennessee, photo courtesy of Building Conservation Technology, Inc.)

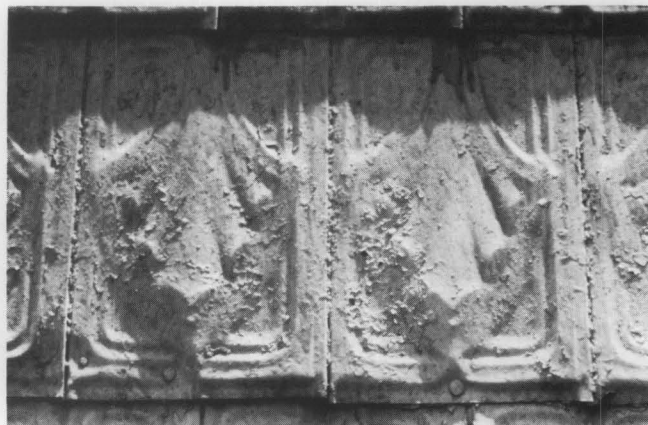
Tin shingles, commonly embossed to imitate wood or tile, or with a decorative design, were popular as an inexpensive, textured roofing material. These shingles  $8\frac{3}{8}$  inch by  $12\frac{1}{2}$  inch on the exposed surface) were designed with interlocking edges, but they have been repaired by surface nailing, which may cause future leakage. (Ballard House, Yorktown, Virginia, photo by Gordie Whittington, National Park Service)

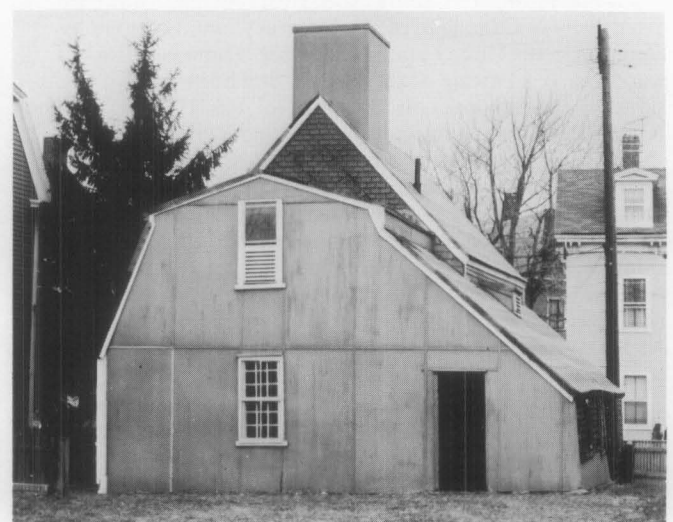
*Temporary stabilization or "mothballing" with materials such as plywood and building paper can protect the roof of a project until it can be properly repaired or replaced. (Narbonne House, Salem, Massachusetts)*

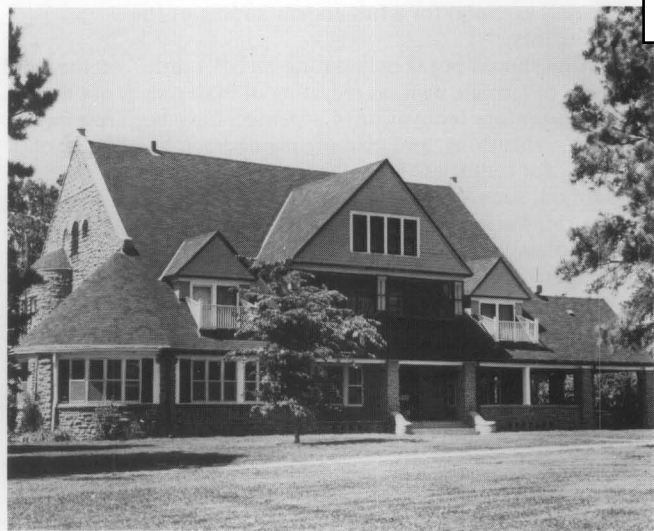
*These two views of the same house demonstrate how the use of a substitute material can drastically affect the overall character of a structure. The textural interest of the original tile roof was lost with the use of asphalt shingles. Recent preservation efforts are replacing the tile roof. (Frank House, Kearney, Nebraska, photo courtesy of the Nebraska State Historical Society, Lincoln, Nebraska)*

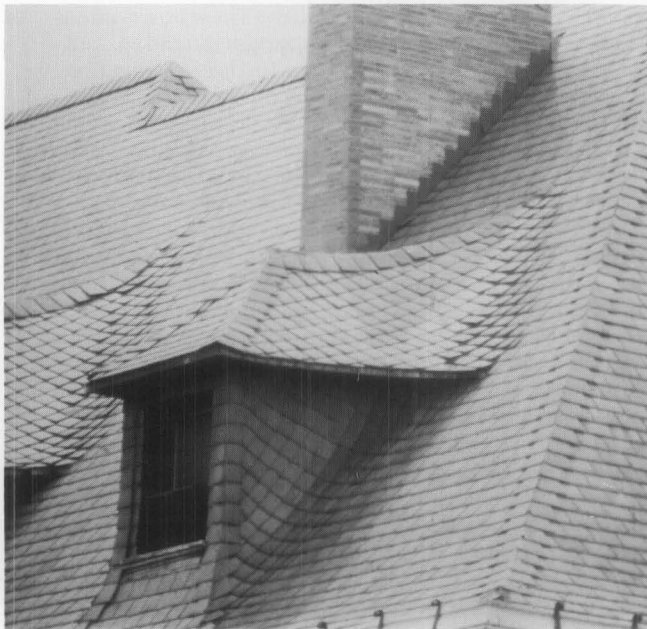
*Because of the roof's visibility, the slate detailing around the dormers is important to the character of this structure. Note how the slates swirl from a horizontal pattern on the main roof to a diamond pattern on the dormer roofs and side walls. (18th and Que Streets, NW, Washington, D.C.)*

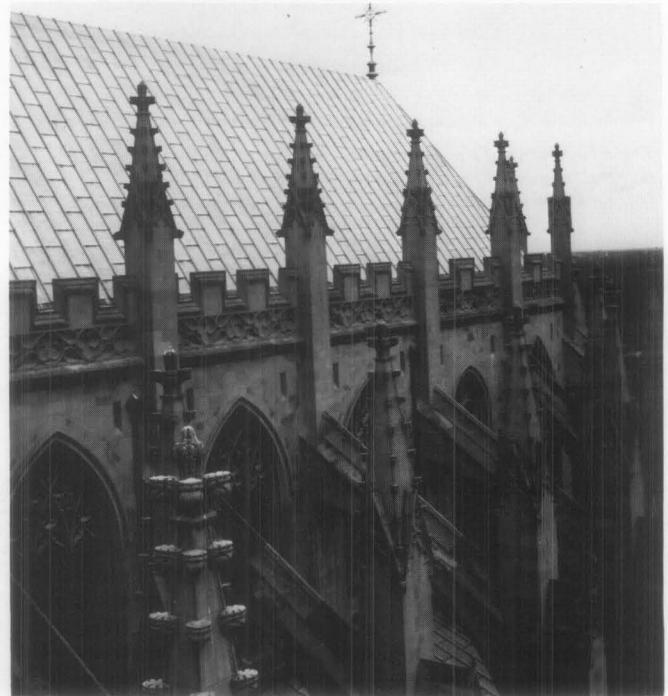
*Good design and quality materials for the roof surface, fastenings, and flashing minimize roofing failures. This is essential on roofs such as on the National Cathedral where a thorough maintenance inspection and minor repairs cannot be done easily without special scaffolding. However, the success of the roof on any structure depends on frequent cleaning and repair of the gutter system. (Washington, D.C., photo courtesy of John Burns, A.I.A.)*

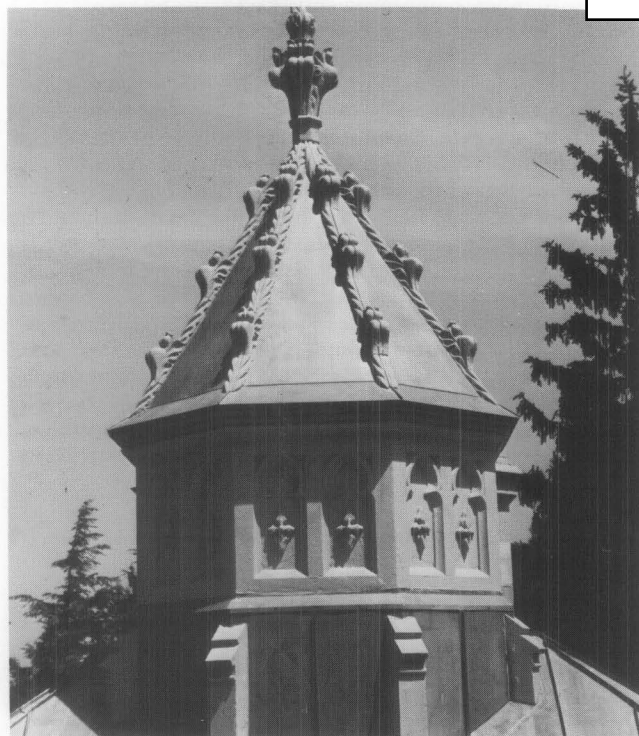
Decorative features such as cupolas require extra maintenance. The flashing is carefully detailed to promote run-off, and the wooden ribbing must be kept well-painted. This roof surface, which was originally tin plate, has been replaced with lead-coated copper for maintenance purposes. (Lyndhurst, Tarrytown, New York, photo courtesy of the National Trust for Historic Preservation)

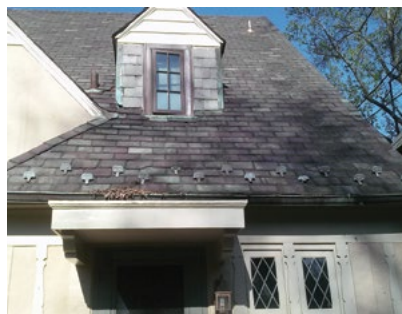
[8] Regular maintenance includes removing leaves that can clog gutters and cause water damage to the exterior and interior walls of a house.

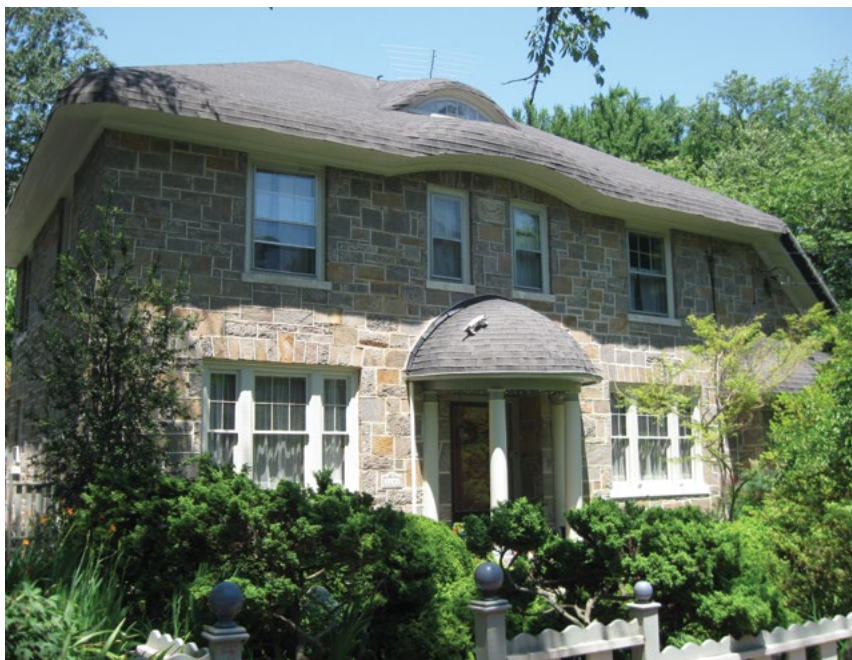
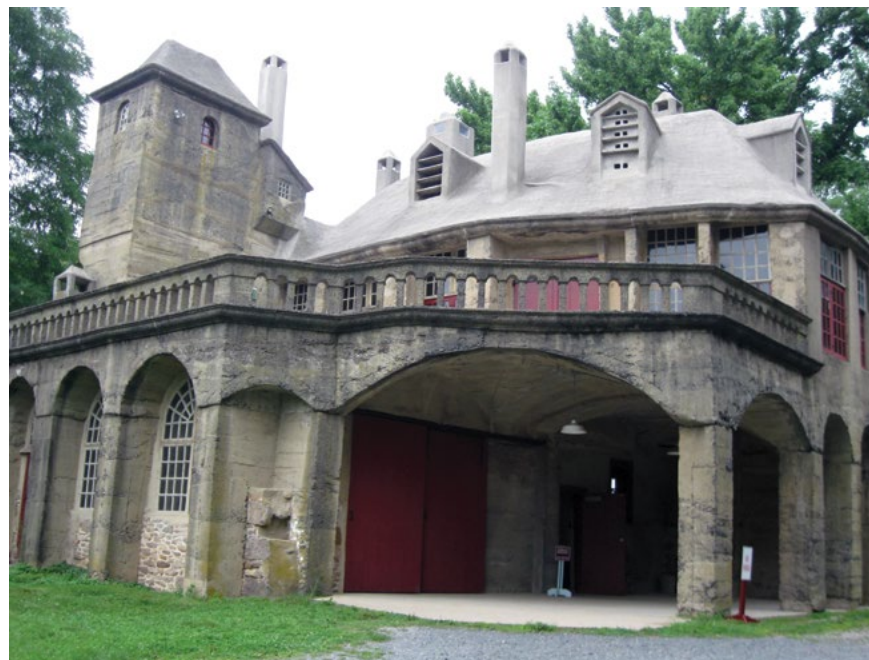
[9] Distinctively-shaped roofs are important in defining the historic character of these early 20<sup>th</sup>-century structures: (a) an asphalt shingle roof on a house; (b) and a concrete roof on Fonthill, Doylestown, PA (1908-1912), designed and built by Henry Chapman Mercer.
