# **CITY OF OREGON CITY**

## **CITY COMMISSION SPECIAL MEETING - REVISED AGENDA**

**Commission Chambers, Libke Public Safety Facility, 1234 Linn Ave, Oregon City**  
**Tuesday, June 11, 2024 at 7:00 PM**

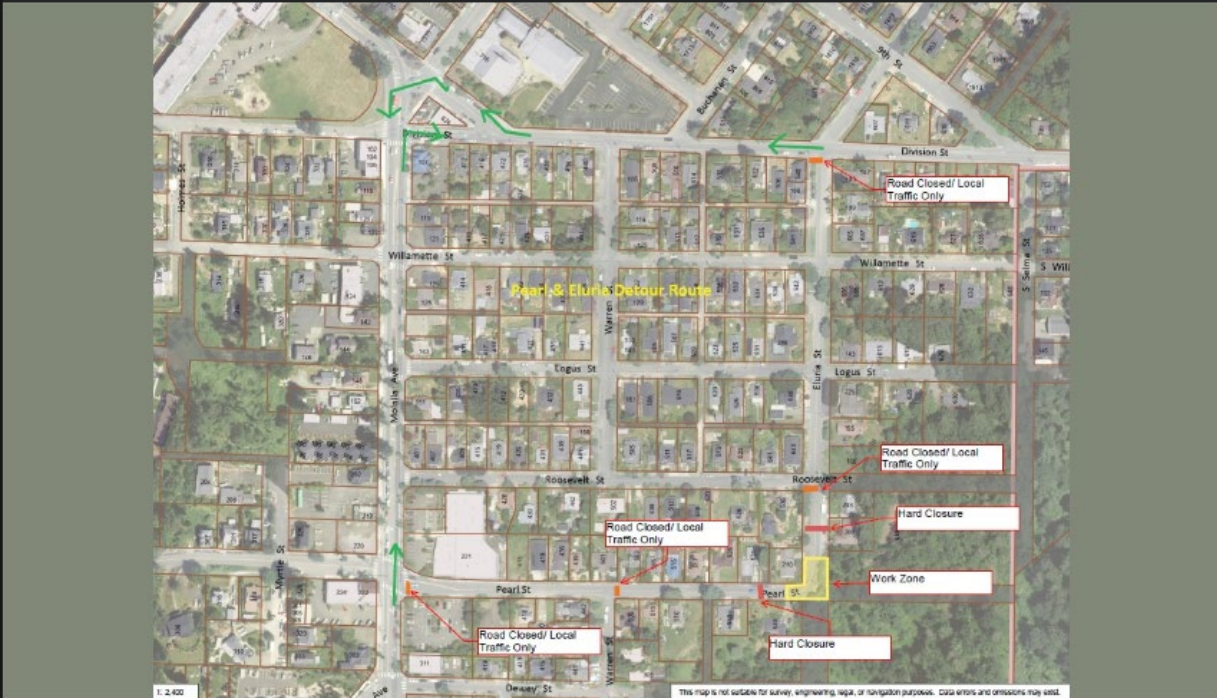
Oregon City's Stormwater and Street Departments will be closing Pearl St & Eluria St for some stormwater repairs and paving. The closure will be from Monday, Aug 28 through Friday, Sept 8 from 7:30 am – 4 pm. The map indicates the detour route.

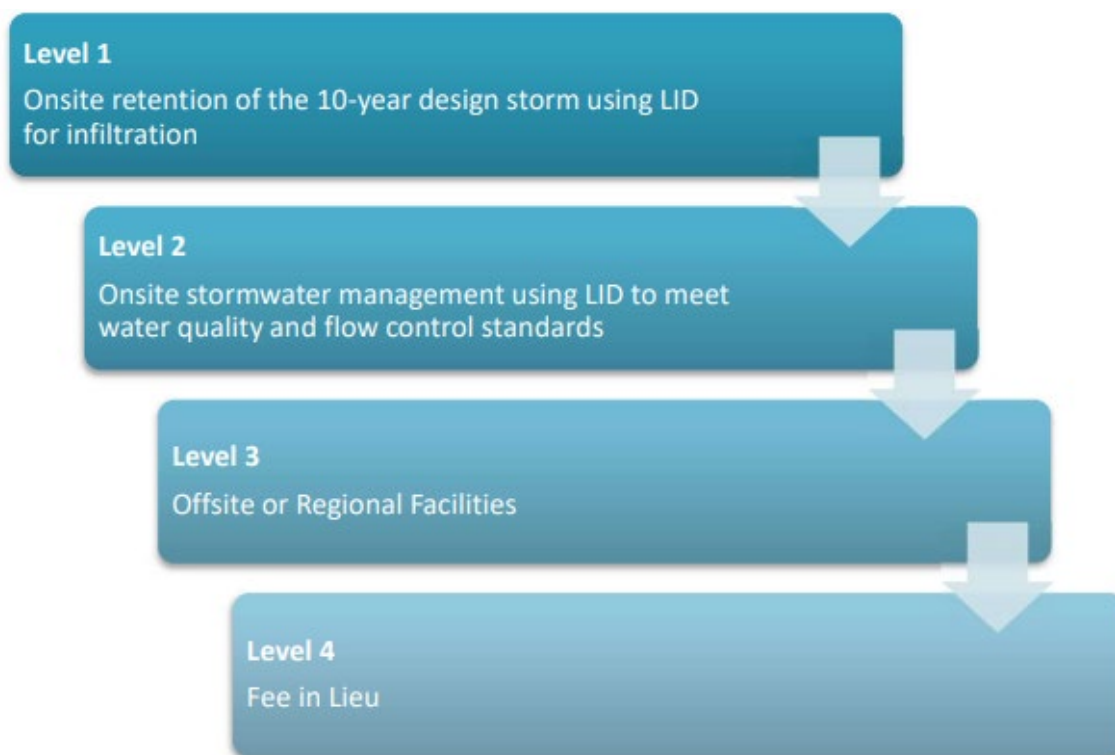
**Figure 1. Stormwater Management Strategy Hierarchy**

Following Site Assessment, the City requires the design of stormwater management to address the flow control and water quality treatment requirements for the remaining runoff (Manual Chapter 4). In meeting the flow control and water quality requirements, the City requires a Stormwater Management Hierarchy to be used in selecting the applicant's proposed stormwater management strategy. Applicants must demonstrate that the strategies higher on the hierarchy are not feasible before selecting a lower-level strategy for stormwater management. To move from one level to the next, the applicant must demonstrate that the proposed development site has one or more of the physical limitations listed in the Manual (Manual Section 2.2.4.1). The Stormwater management hierarchy is included in the Manual and reproduced for convenience in Figure 1 below.

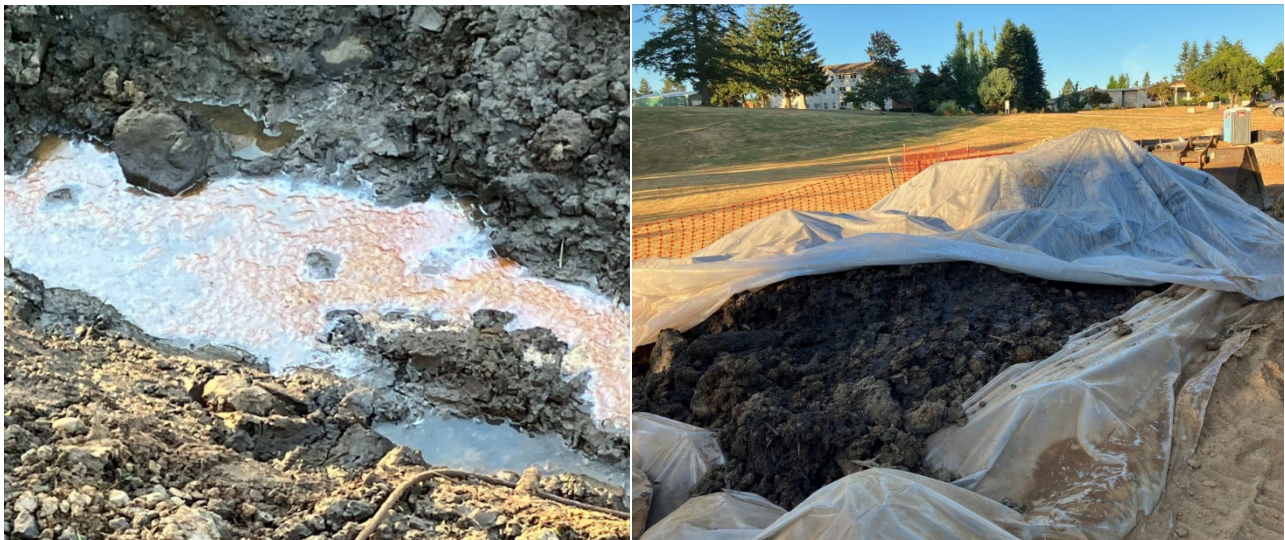
**Figure 2 images of initial contamination (top) and excavated soil (bottom) discovered in August of 2022. DEQ was satisfied with the mitigation plan and approved the completion of construction.**

A city employee discovered some concerning visual evidence that the newly constructed Stormwater quality facility was contaminated (Figure 2). Preliminary stream survey was conducted the same day with a Dissolved Oxygen (DO) Hatch - HQ30d - Flexi meter with an LDO probe, a Hatch - HQ40d - Multi meter with a Conductivity, and pH (IntelliCAL™ pH PHC101) probes (Figure 2). The second outfall and temperature were not measured at this point, but the contamination did not appear to be leaving the system (Table 1).
