# CITY OF OREGON CITY HISTORIC REVIEW BOARD AGENDA

1. GLUA-23-00041/ HR-23-00012 Proposal to replace windows on the Petzold Richard B. Building located at 714 Main Street.

GLUA-23-00041/ HR-23-00012 Proposal to replace windows on the Petzold Richard B. Building located at 714 Main Street.

### Staff Report and Recommendation

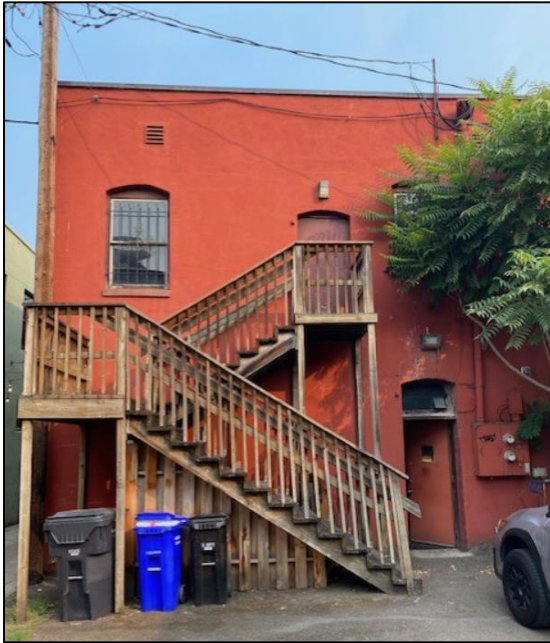
Figure 4- Rear yard view of southeast elevation

The rear of the building, which is the southeast elevation, (Photo 6) has two upper windows--40"x41" and 24"x46"--and one smaller window on the first level (28"x60"). There are two doorways, one on each floor, that retain their original paneled doors. The lower door (36"x110") has a transom and the remains of iron hinges. The second floor entry once gave access to a fire escape that was removed at an unknown date. The current owner intends to seal this door and construct an interior fire escape in the southeast corner of the building. There is also evidence of a lean-to addition across the lower story, probably erected when the fire escape was dismantled. It is not known when the addition was demolished.

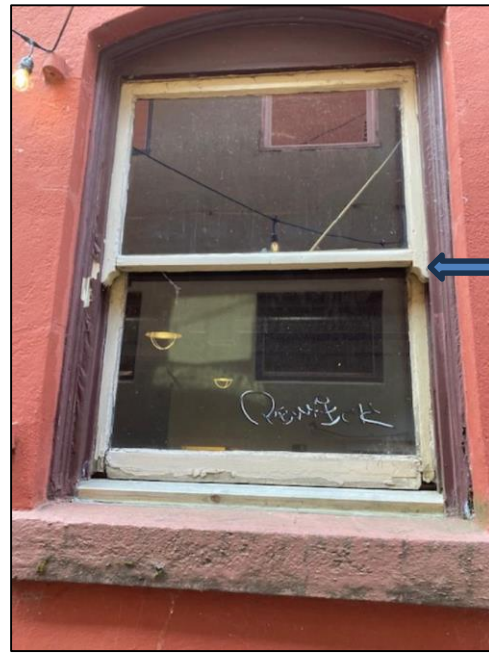
Figure 5 – Typical Double-Hung Window

Front Façade: *There are four, one-over-one, double-hung windows on the upper façade. Each sash is topped by flat arched brick rowlocks with keystones. The windows are original, though in a deteriorated condition. The [owner at the time of the National Register designation] intends to replace them in kind...*

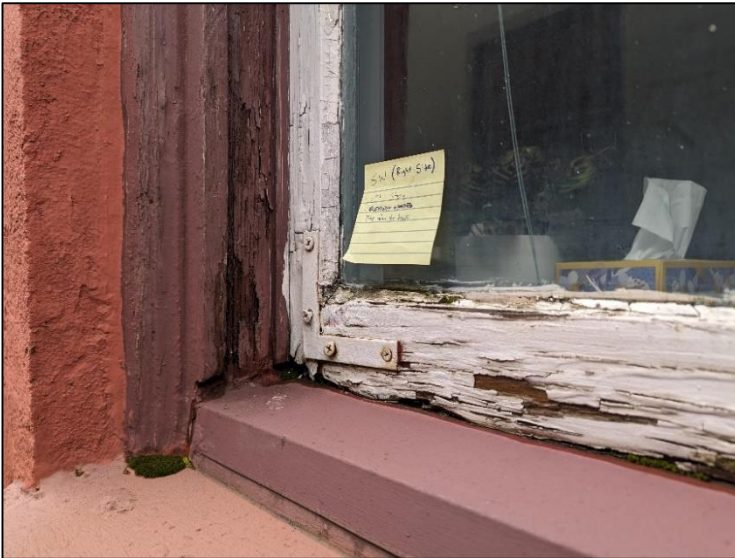
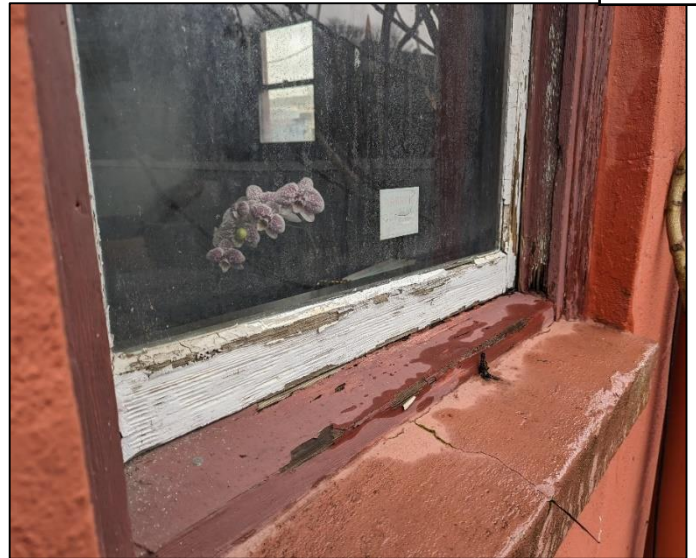
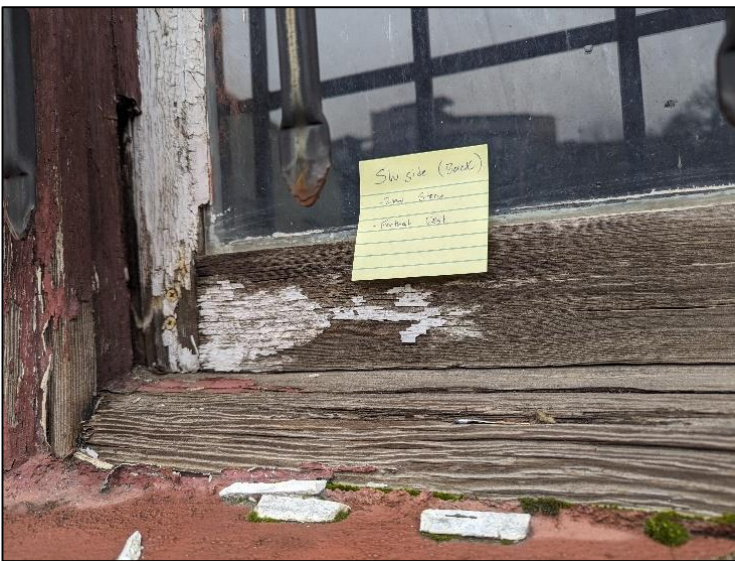
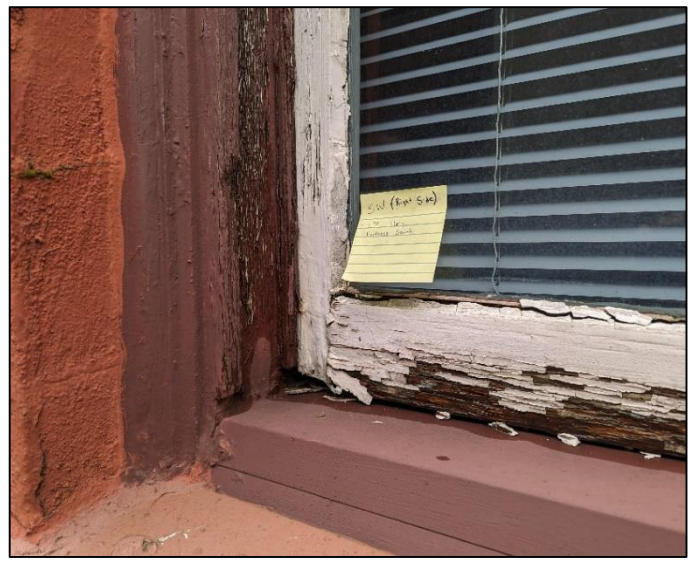
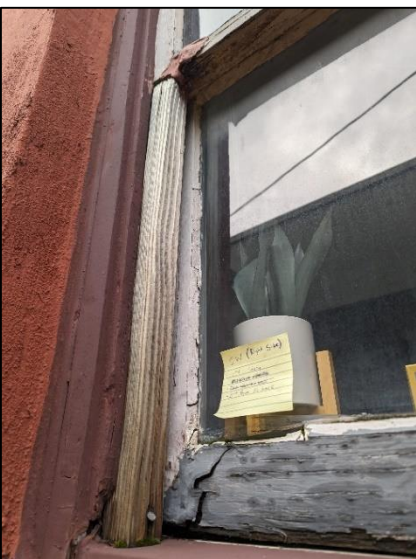
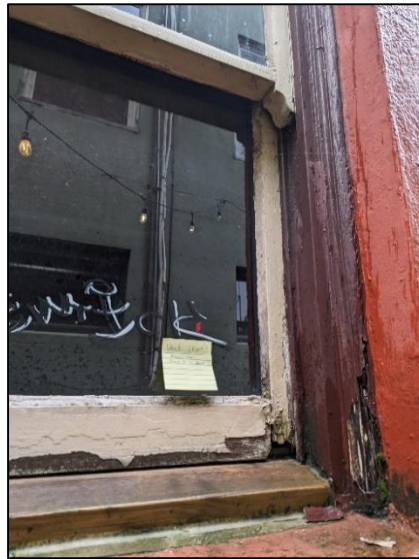
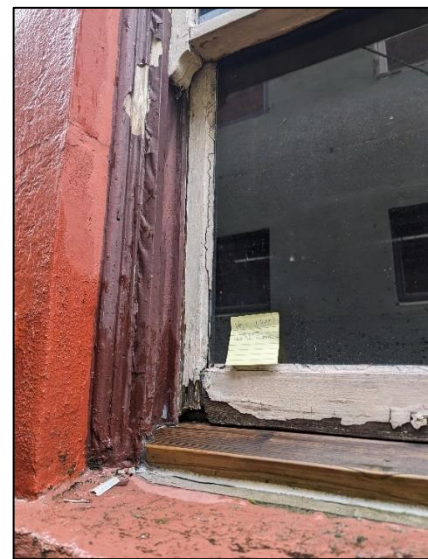
Figures 7 through 13- Details of existing windows condition and visible deterioration.

**Staff Finding: Complies as Proposed.** The applicant states that many of the subject windows have deteriorated beyond economically feasible repair. Images of the deterioration and rot of the sashes, frames and sills have been provided with this application. Furthermore, the Petzold Building’s registration form for the National Register of Historic Places mentions the original windows as “deteriorated” and were intended to be “replaced in kind” by the owner at the time. The proposed Marvin Ultimate windows are meant to closely resemble the existing windows in design, color, and material.

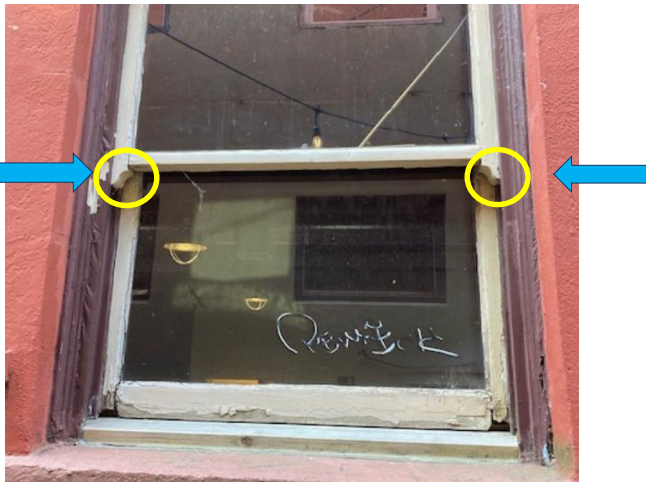
Ogee lugs are small, mainly decorative features on the exterior window sashes of approximately twenty-two of the windows. The other two windows—one on the rear elevation and the picture window on the left side elevation—do not have the ogee lugs. While these components of the windows are distinctive, staff seeks Historic Review Board direction on requiring ogee lugs on the new proposed windows.

**Staff Finding: Historic Review Board Direction Needed.** Staff finds that the applicant may meet this criterion with or without requiring ogee lug additions to the windows. If the Board finds the omission of ogee lugs would not adversely affect the distinctive character of the building, then this criterion is met as proposed. If the Board finds that the **omission of** ogee lugs would adversely affect the character of the building, then this criterion shall be met through compliance with conditions of approval to provide the ogee lugs on the some or all of the new windows. **See the recommended conditions of approval.**

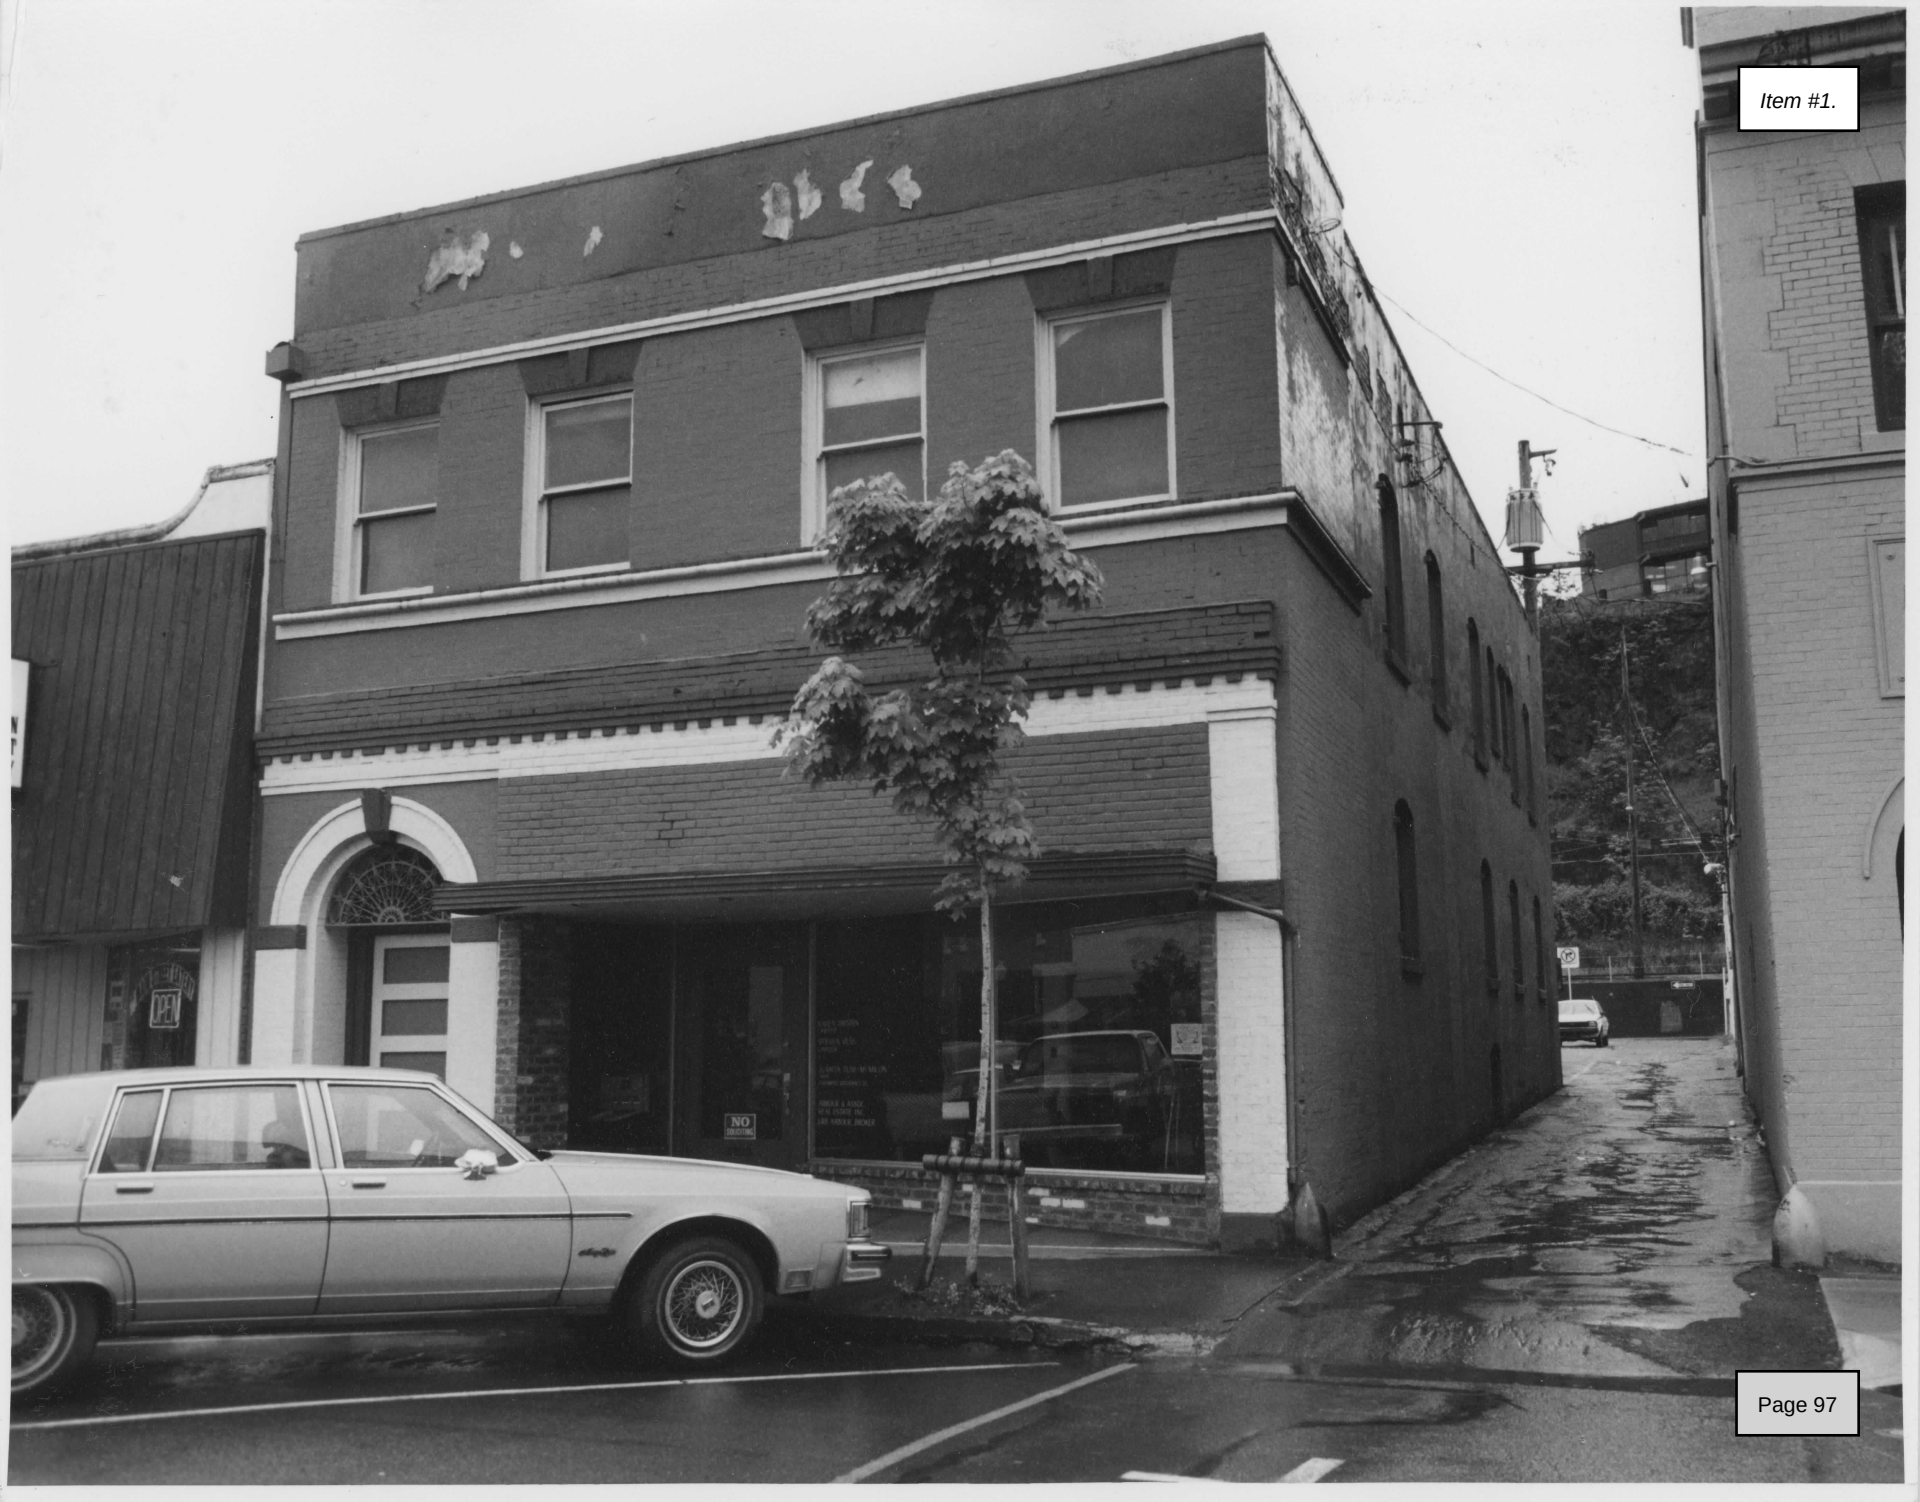
2 OF 11

TO THE SE, FACADE (NW ELE.)

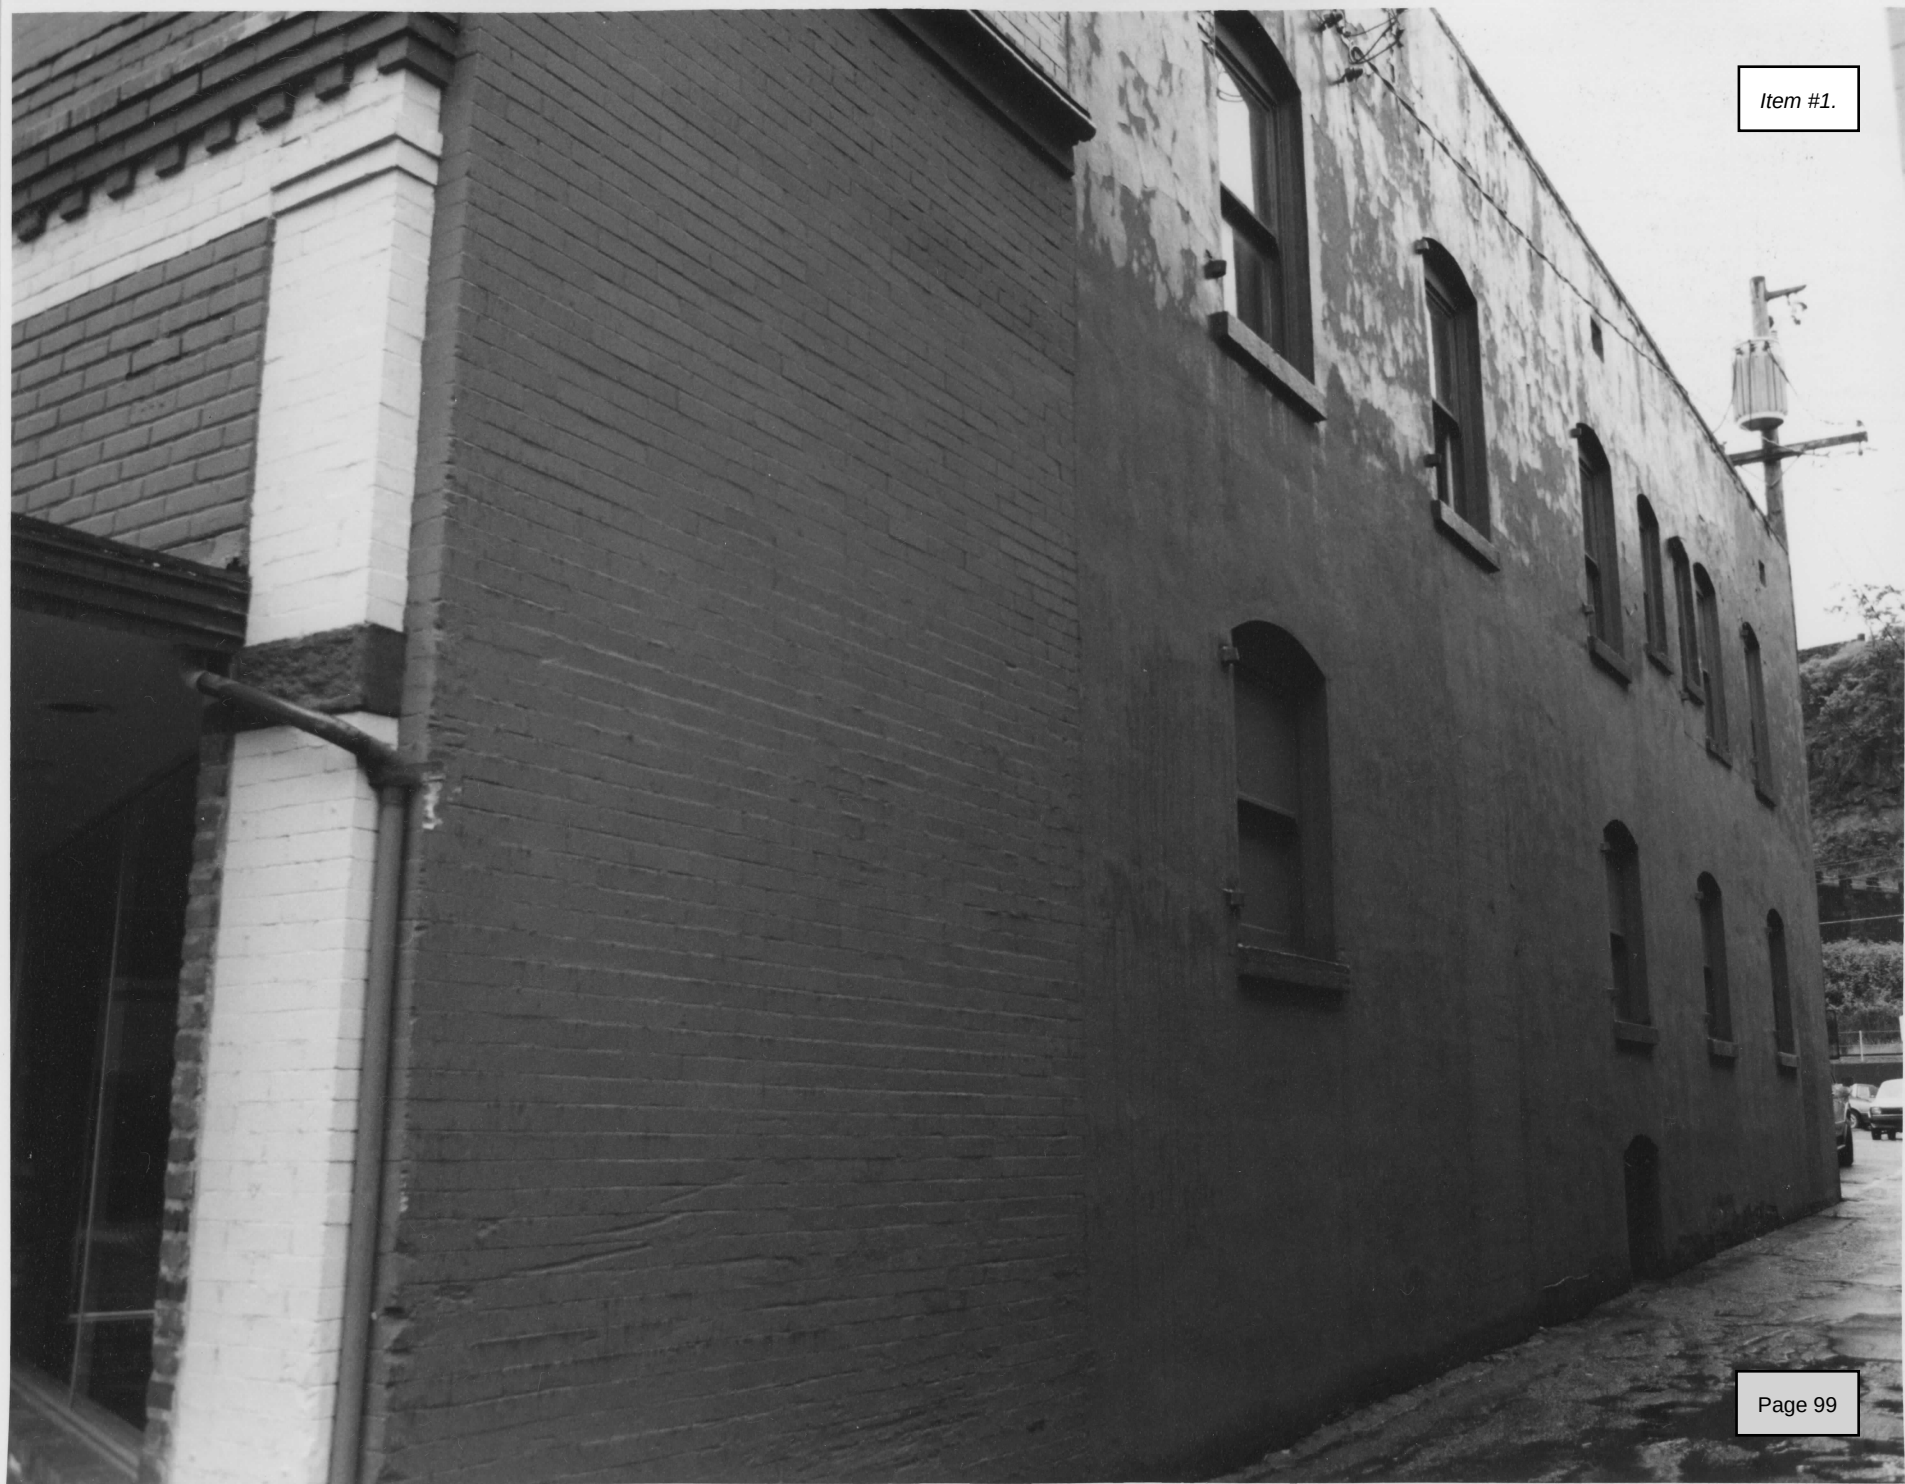
3 OF 11

TO THE NE, FACADE (NW) AND SIDE (SW) ELEVATIONS

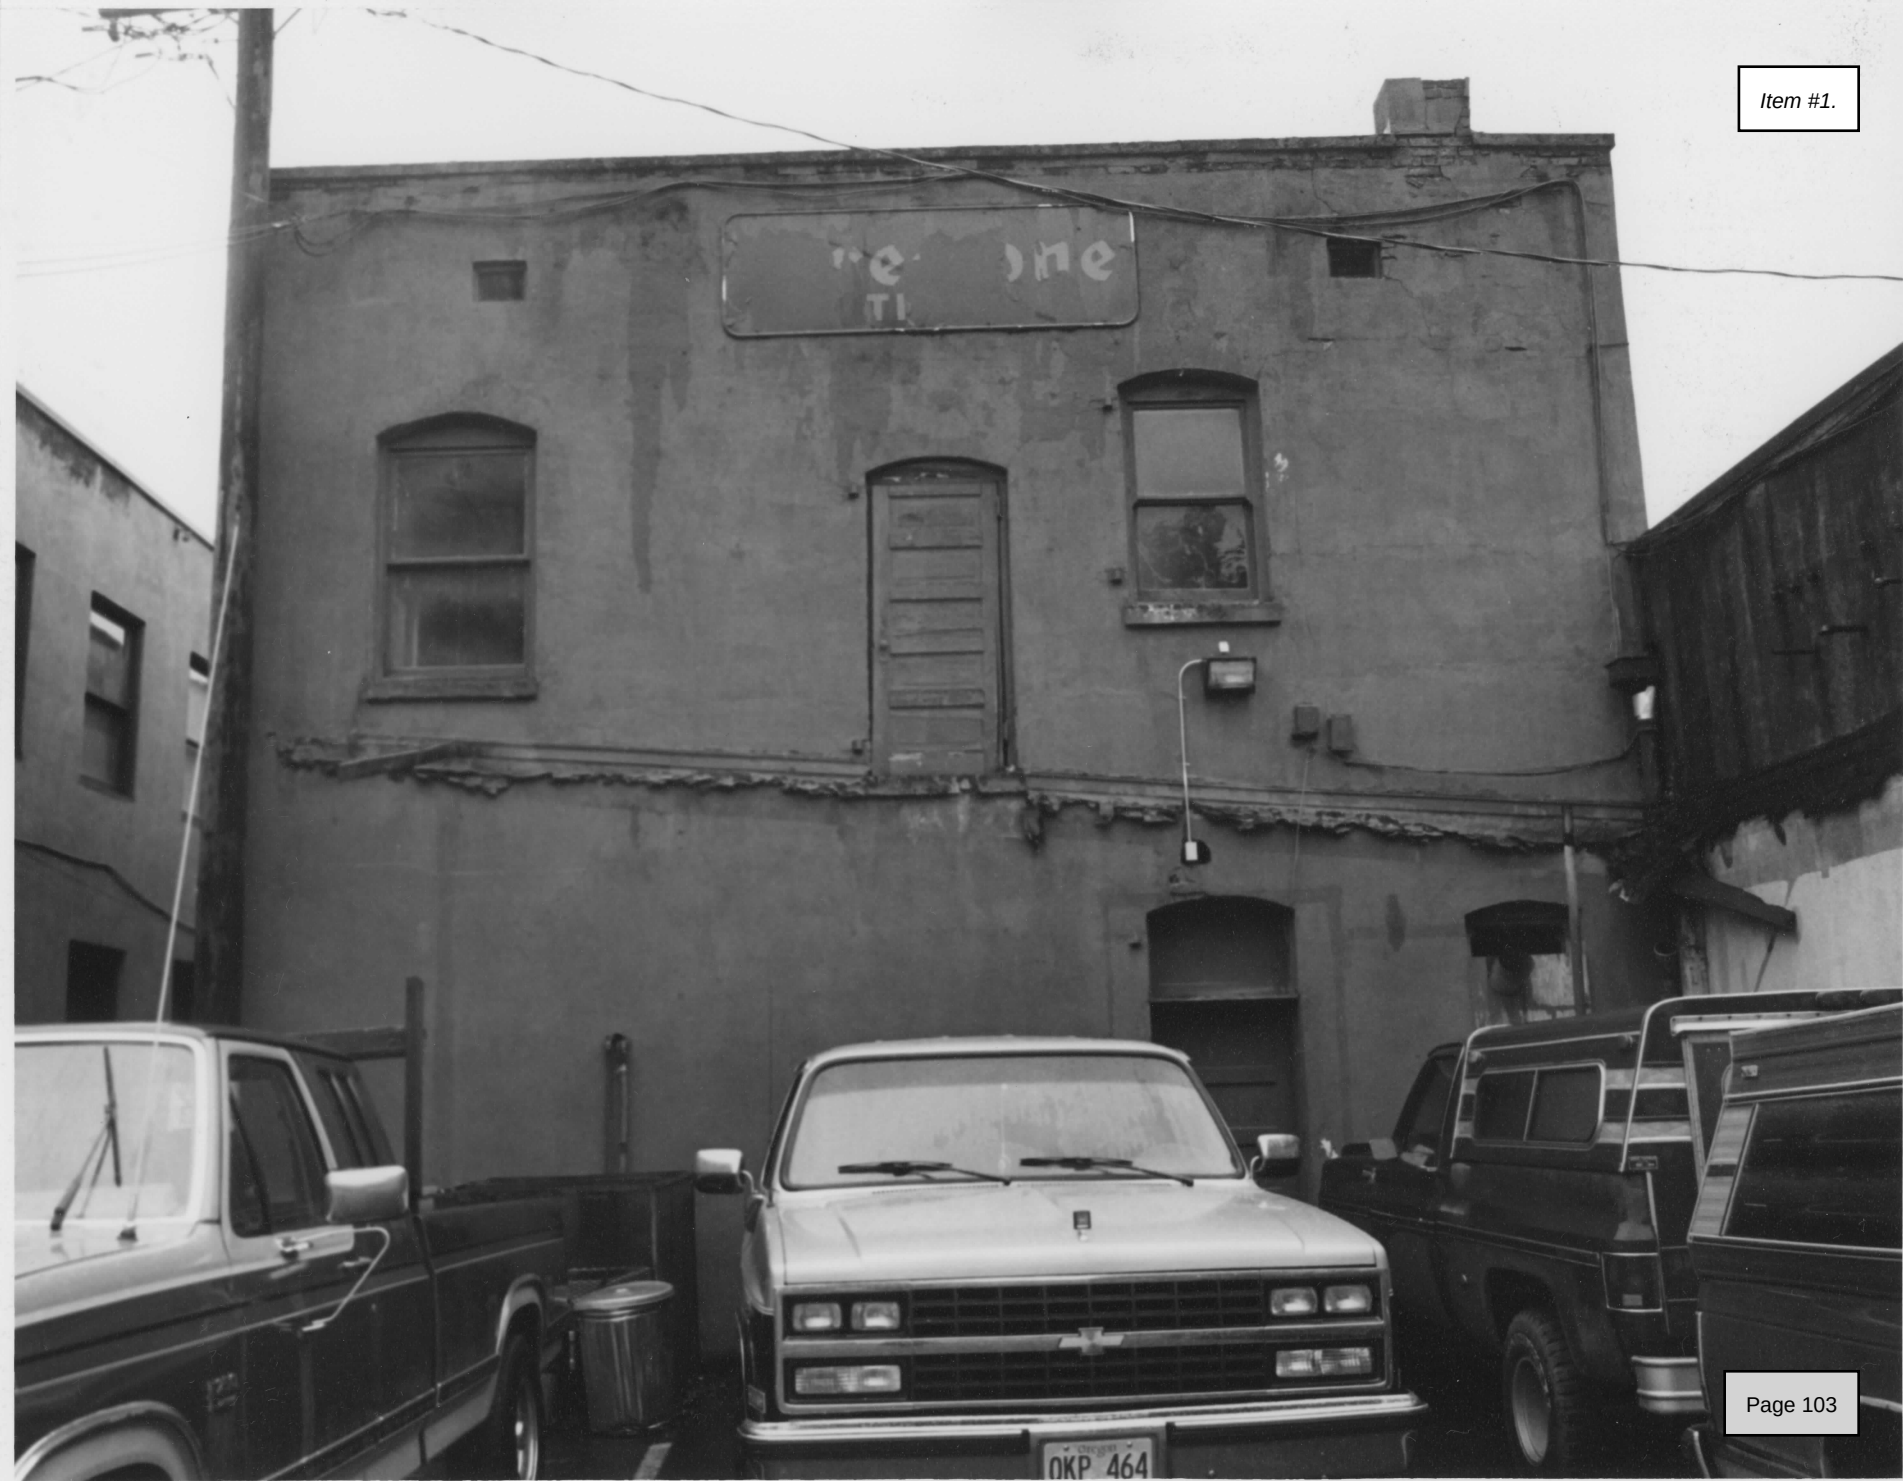
TO THE NW, SIDE (SW) AND REAR (SE) ELEVATIONS  
5 OF 11

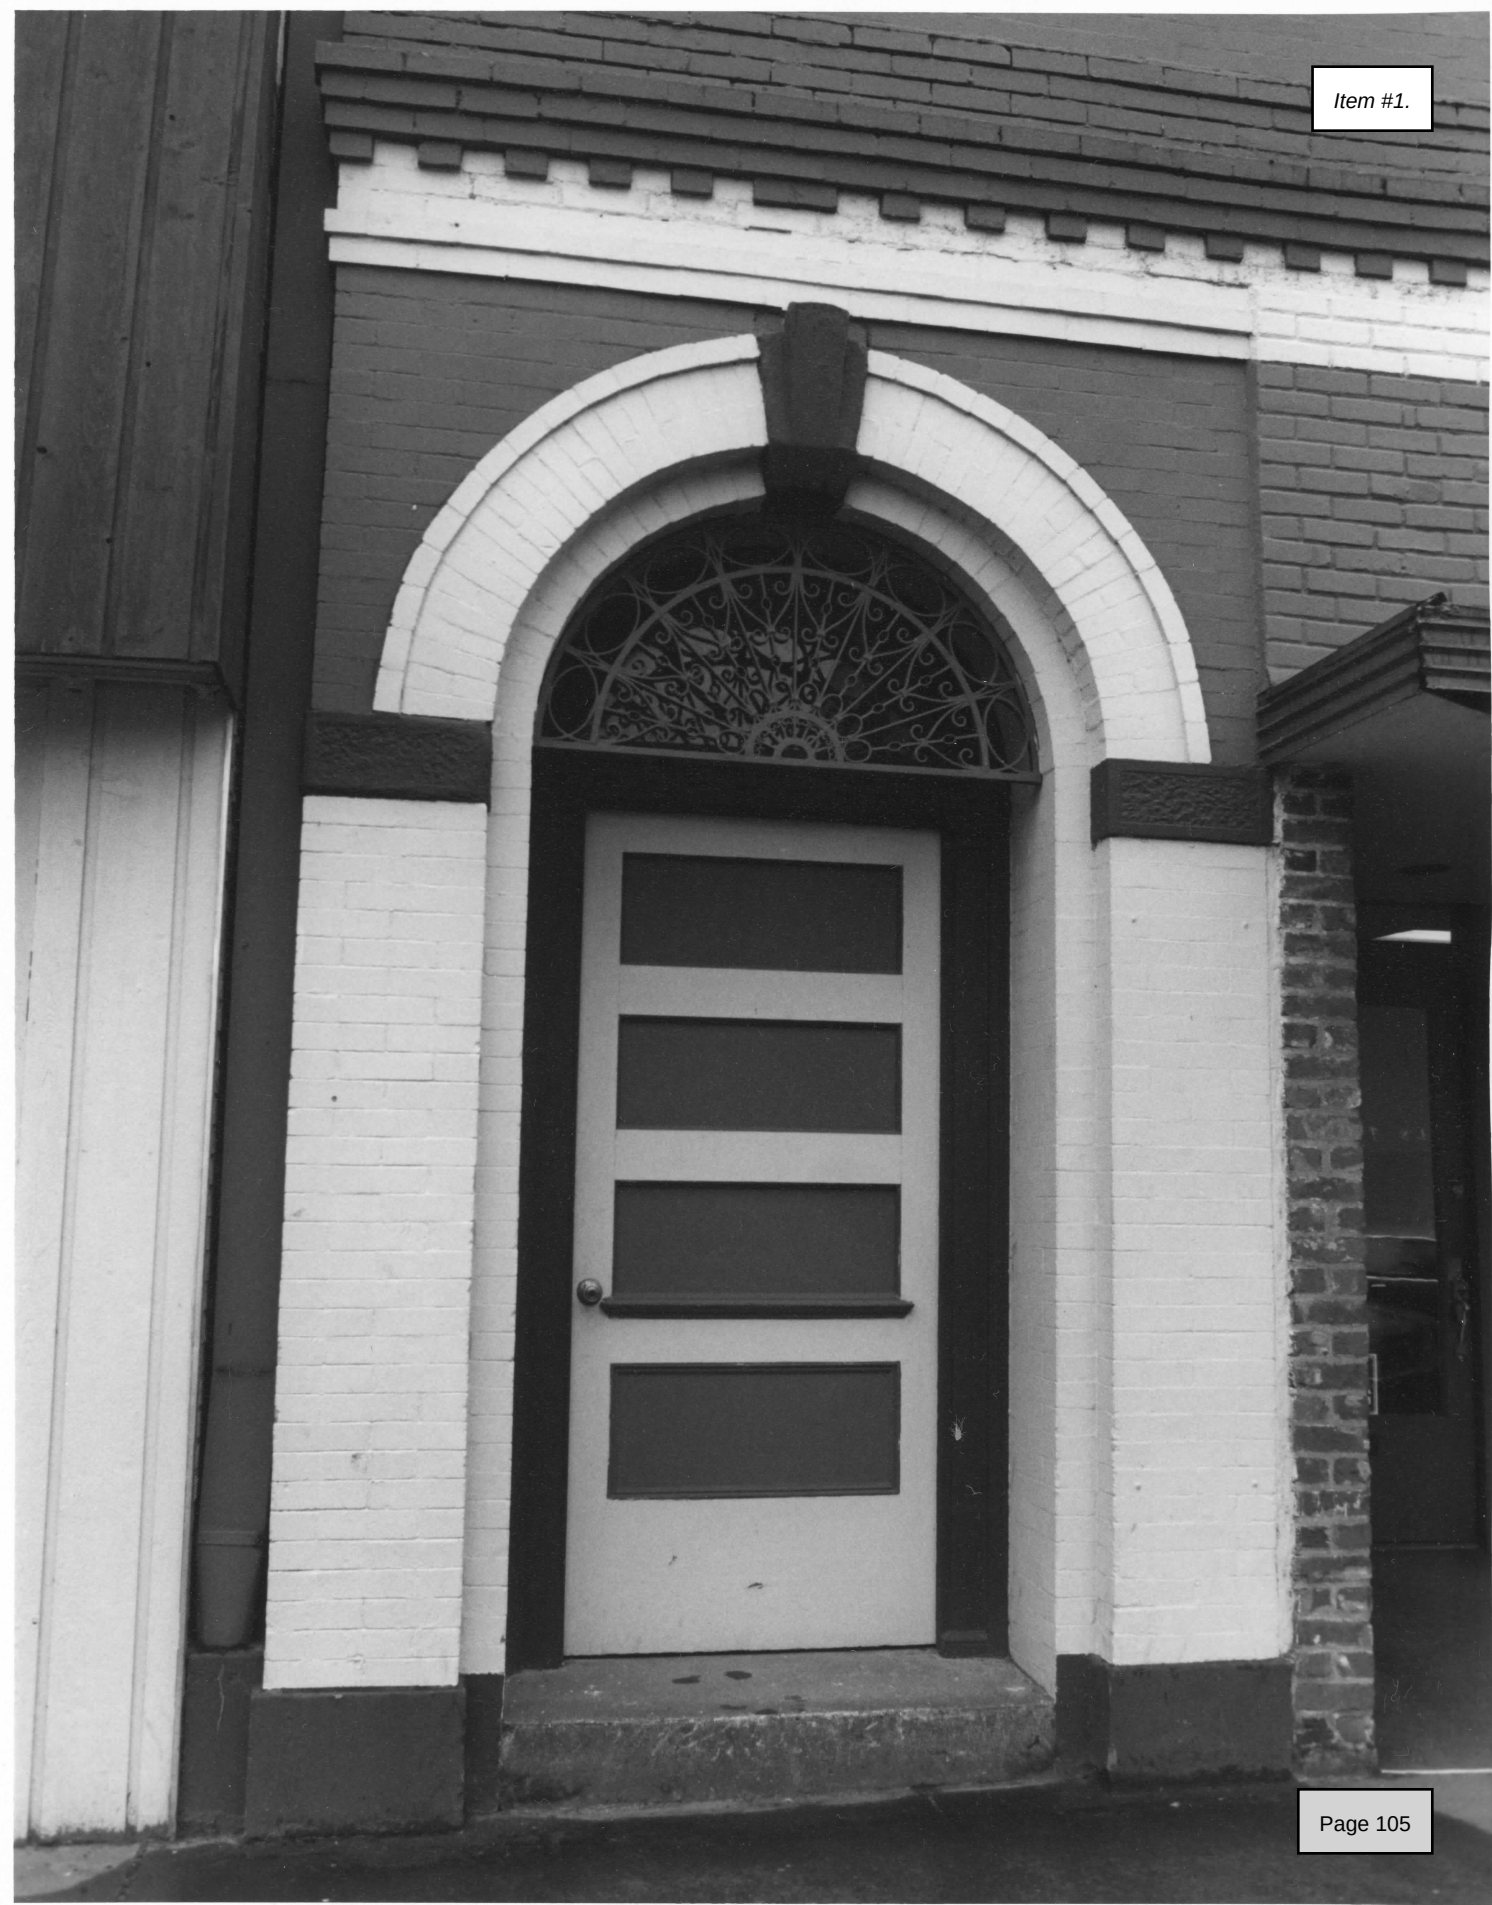
6 OF 11

TO THE NW, REAR (SE ELE.)

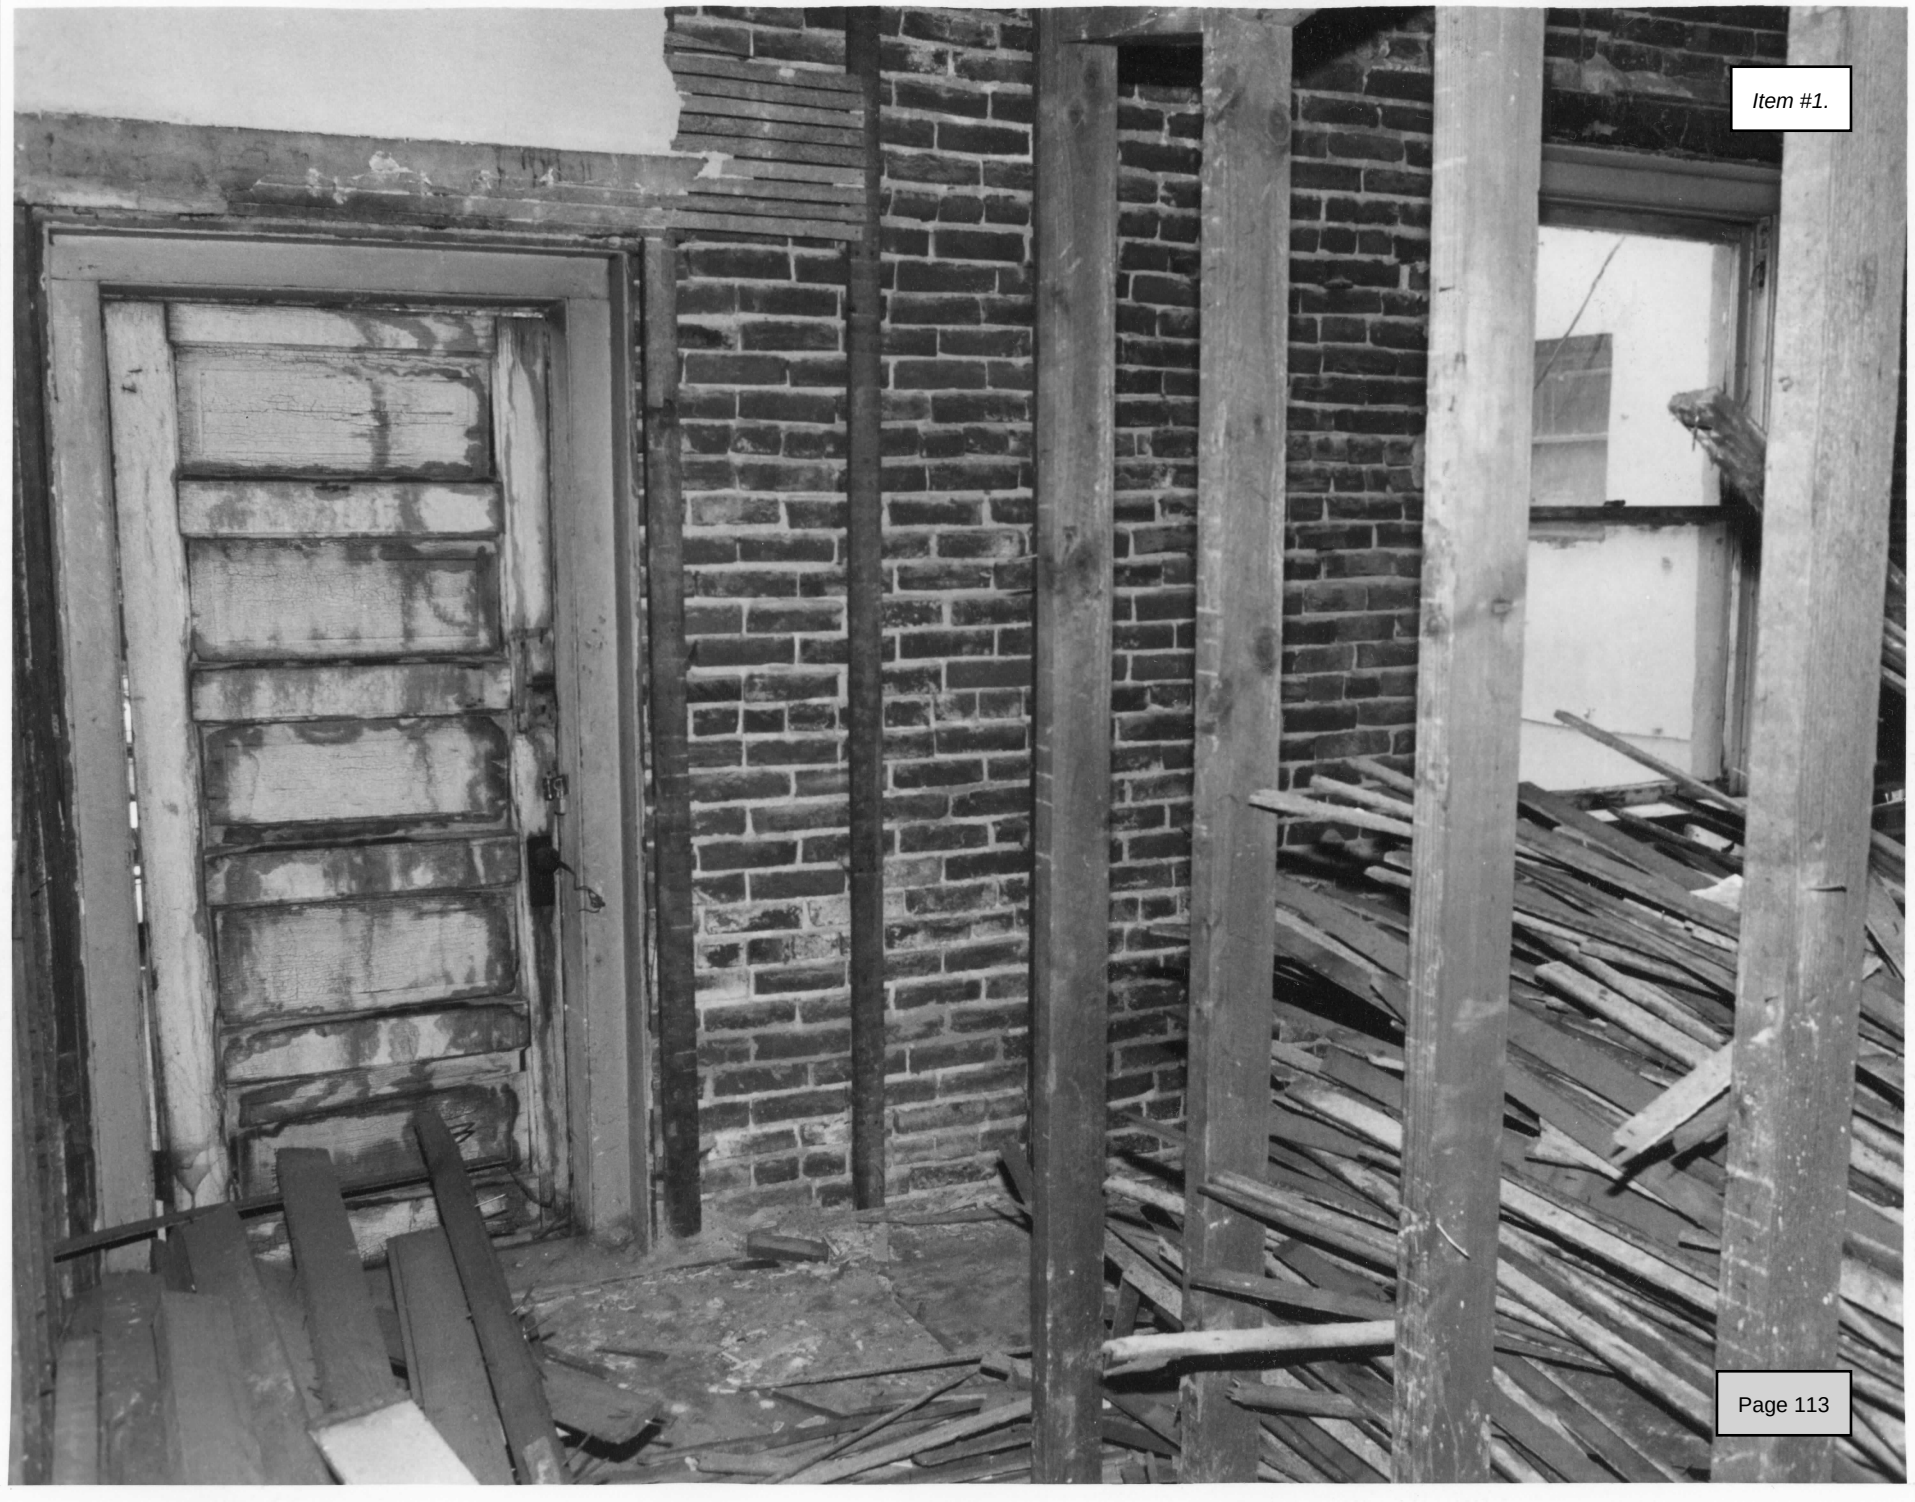
SECOND FLOOR INTERIOR, STAIRWAY  
10 OF 11

A black and white photograph showing the interior of a building under renovation or in a state of disrepair. On the left is a wooden door with horizontal staves, set in a frame. To its right is a brick wall. Several vertical wooden studs are visible, supporting the structure. The floor is covered with a large pile of wooden planks and debris. In the background, a window opening is visible, showing a glimpse of the exterior. The overall scene is one of decay and construction.

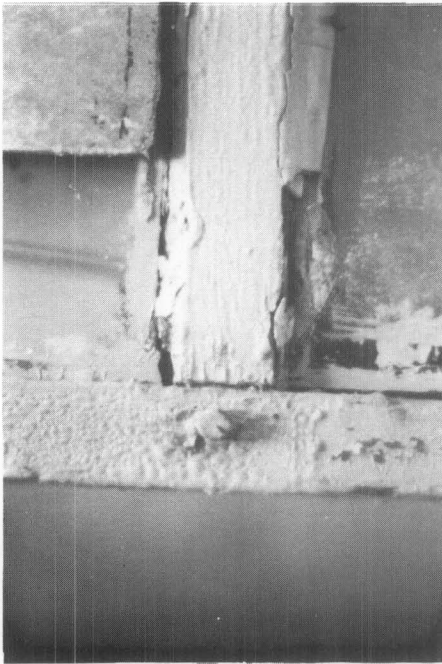
Figure 4a. The following series of photographs of the repair of a historic double-hung window use a unit which is structurally sound but has many layers of paint, some cracked and missing putty, slight separation at the joints, broken sash cords, and one cracked pane. Photo: John H. Myers

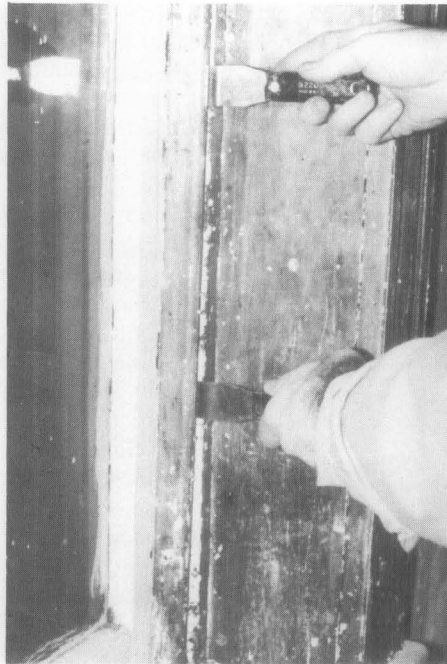
Figure 4b. After removing paint from the seam between the interior stop and the jamb, the stop can be pried out and gradually worked loose using a pair of putty knives as shown. To avoid visible scarring of the wood, the sash can be raised and the stop pried loose initially from the outer side. Photo: John H. Myers

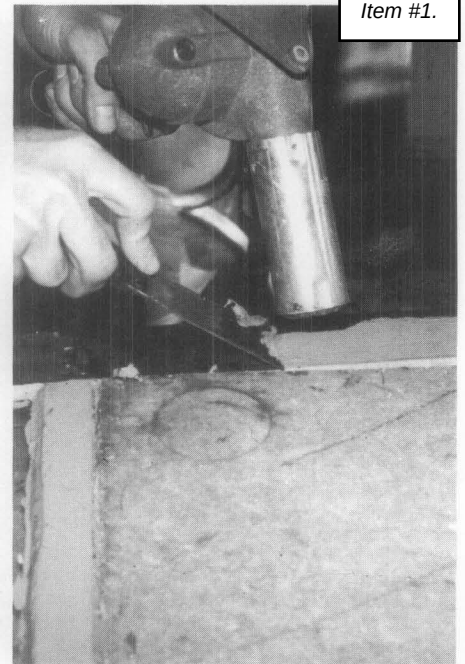
Figure 4c. Sash can be removed and repaired in a convenient work area. Paint is being removed from this sash with a hot air gun while an asbestos sheet protects the glass from sudden temperature change. Photo: John H. Myers

The sash can be stripped of paint using appropriate techniques, but if any heat treatment is used (see figure 4c), the glass should be removed or protected from the sudden temperature change which can cause breakage.

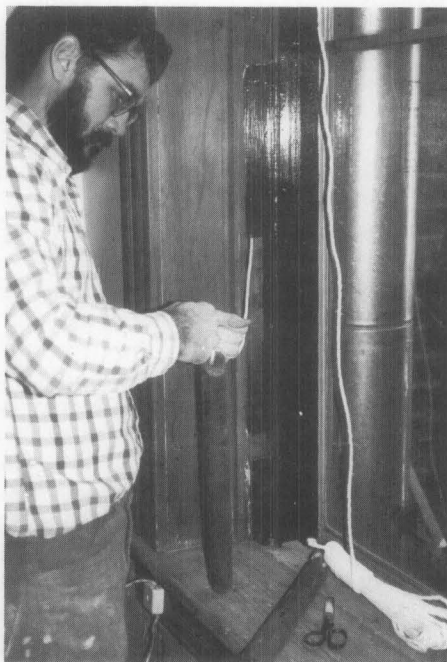
Figure 4e. A common repair is the replacement of broken sash cords with new cords (shown) or with chains. The weight pocket is often accessible through a removable plate in the jamb, or by removing the interior trim. Photo: John H. Myers

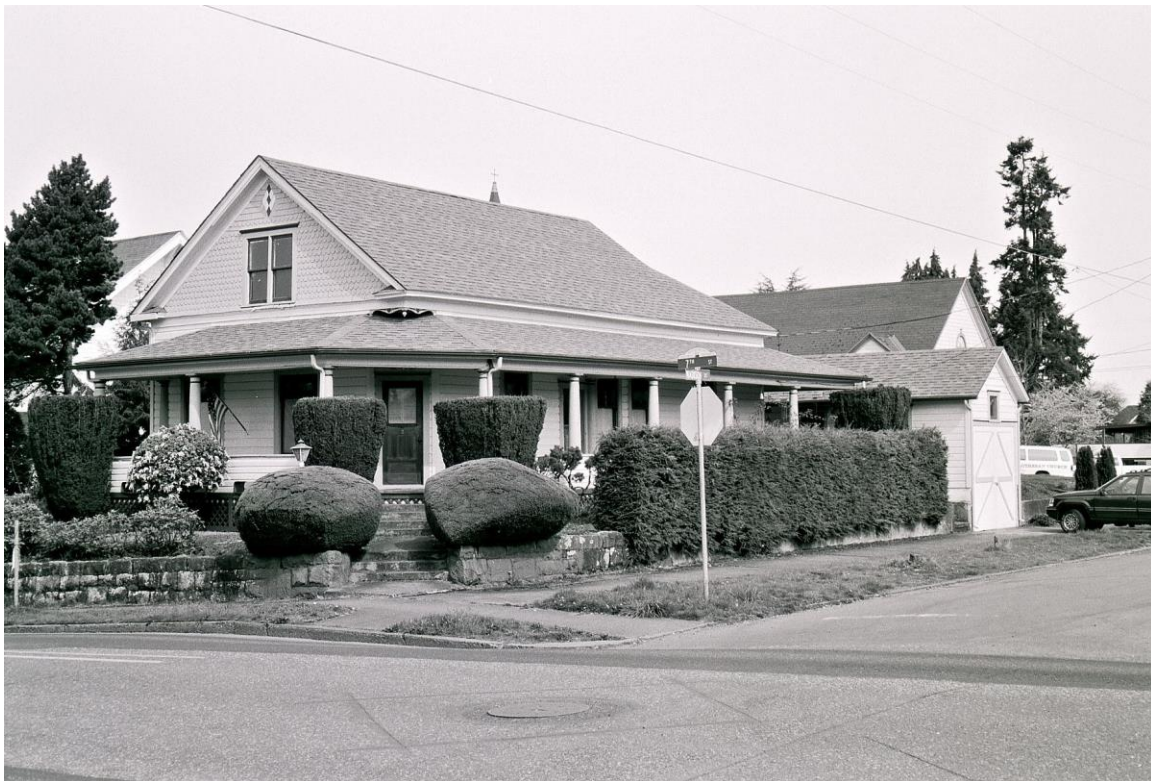
This 1-1/2 story house at 819 7th Street is a rectangular Queen Anne with Classical detailing, often referred to as "free classical". It has a front porch that extends across its front and down its entire side and halfway cross its back. The corner of the house is chamfered to mark the corner entry. The porch is marked by turned classical columns and a solid rail. The gable ends have eave returns and are imbricated with fishscale and square shingles. Windows are 1/1 wood double-hung with stained glass in the upper sash of the two front windows. A fine basalt retaining wall is located at the side. Two outbuildings have excellent integrity with original doors and siding. One is a carriage house contemporary with the house on Madison at the sidewalk. The second outbuilding is used for storage and is located off the north corner of the house.

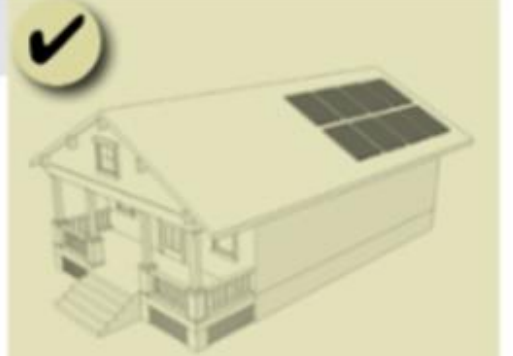
### Preferred Location

- » The building is highly significant.
- » The context has many intact historic buildings.
- » The roof is highly visible.

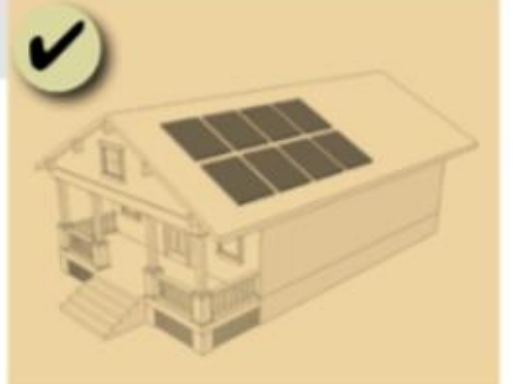
### Acceptable Location

- » Panels are set back from the eave, but closer to the front façade.
- » Panels are flush with the roof.

- » The building is a contributor to a district.
- » Site constraints restrict solar access.
- » The roof is not highly visible.

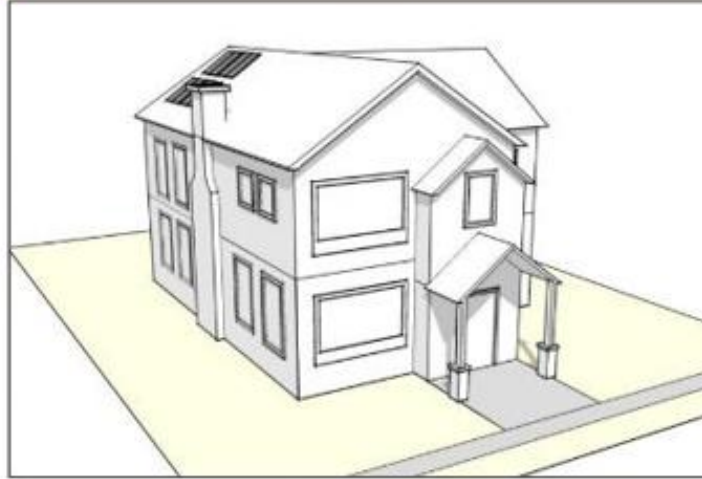
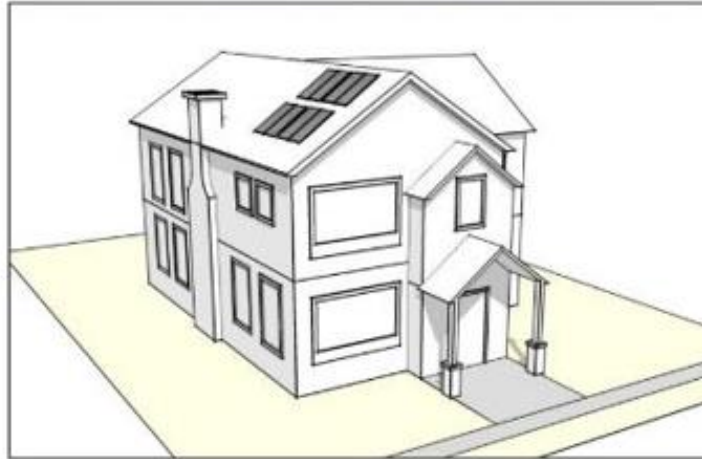
*Siting solar panels towards the rear of a visible roof surface or on a garage located at the rear of the property (top) is preferred to minimize the visual impact on the public right-of-way; however, where solar access is insufficient a more visible location (bottom) may be considered if panels are of a low profile and similar color as the roof surface.*
