# CITY OF OREGON CITY HISTORIC REVIEW BOARD AGENDA

1. GLUA-23-00041/ HR-23-00012 Proposal to replace windows on the Petzold Richard B. Building located at 714 Main Street.

GLUA-23-00041/ HR-23-00012 Proposal to replace windows on the Petzold Richard B. Building located at 714 Main Street.

### Staff Report and Recommendation

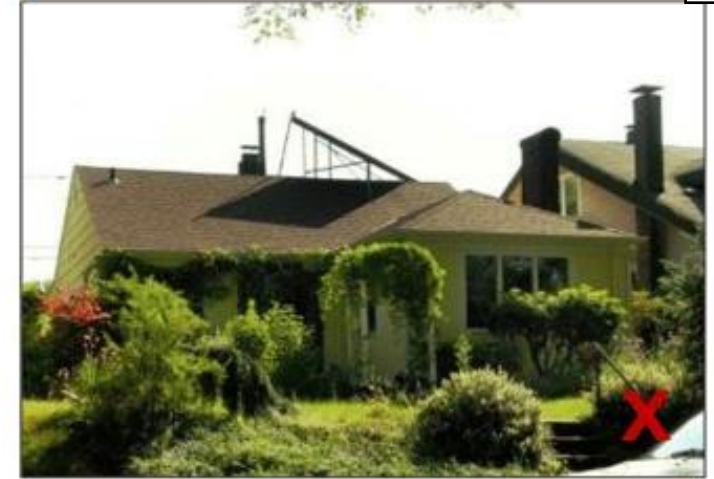
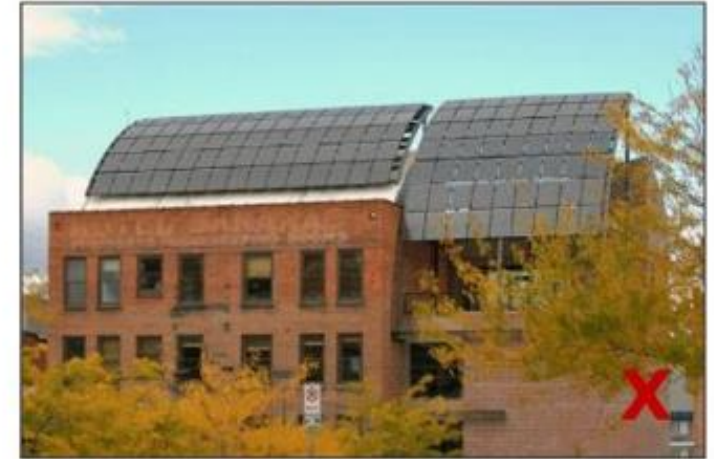
Not This

*Solar panels should be mounted flush with the surface of the roof to minimize their visibility from the public right-of-way, regardless of the building type they are attached to. The design and placement of solar panels should not create a visual distraction that detracts from the historic building they are mounted to.*

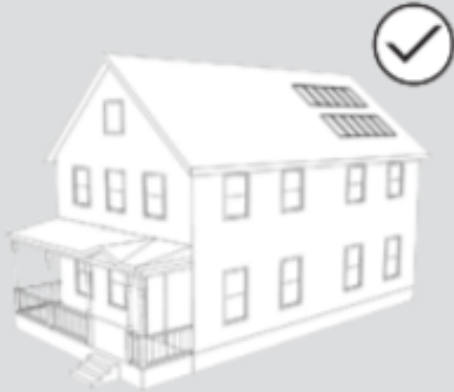
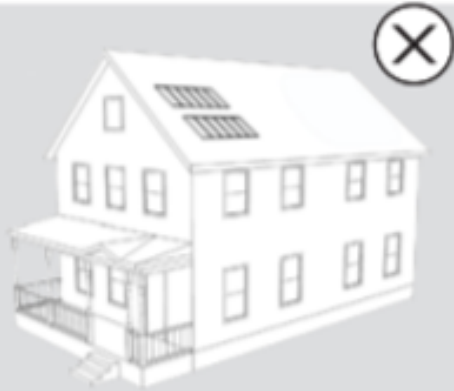
- b. Place collectors to avoid obscuring significant features or adversely affecting the perception of the overall character of the property.
- e. On a side-facing roof plane of a primary structure, minimize visual impacts by locating solar collectors on the rear 2/3 of the roof length.
- g. Ensure that exposed hardware, frames and piping have a matte finish, and are consistent with the color scheme of the primary structure.
- h. Use the least invasive method feasible to attach solar collectors to a historic roof.
- i. Install solar collectors so they may be readily removed and the original character easily restored.
- j. Minimize adverse impacts on a historic roof structure when installing solar collectors or similar technologies.

- 2.33 When installing solar collectors, minimize potential adverse effects on the character of a historic property.
- a. Place collectors in an unobtrusive location on the property, if possible. Such locations may include an addition, garage or secondary structure.
  - c. Mount collectors below the ridge line on a sloping roof.
  - d. Mount collectors flush, with a minimum rise above the roof plane. This will not cause a significant decrease in the device's solar gain capabilities.
  - f. Size solar collectors to be subordinate to the historic structure.

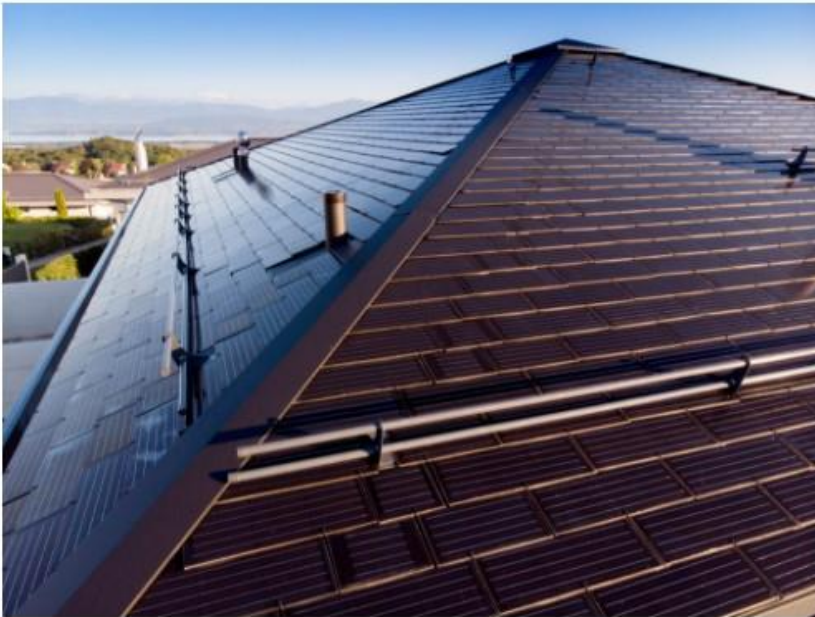
The product's developer says it can cover 100% of even complex roof layouts.

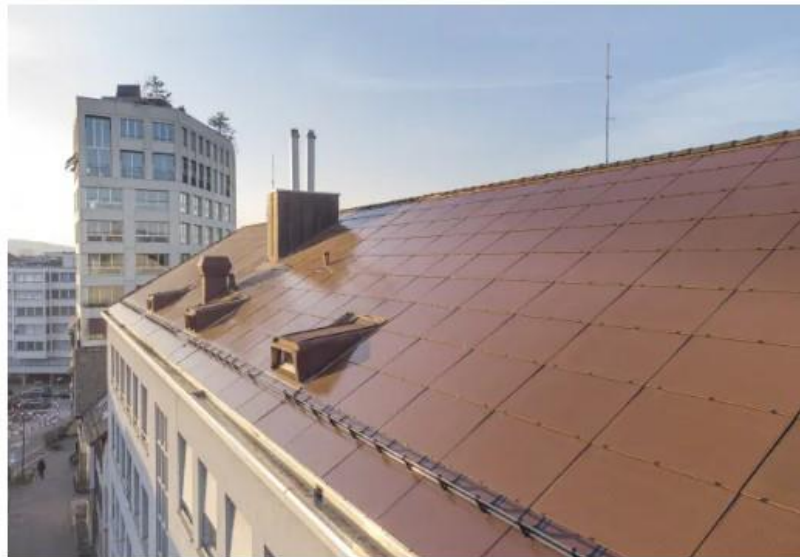
Standard grey and black solar panels do not comply with aesthetic regulations in some historical locations but this new technology provides an alternative although more expensive

New technology allows to produce solar panels that match the colour of the roof Pic: Solaxess

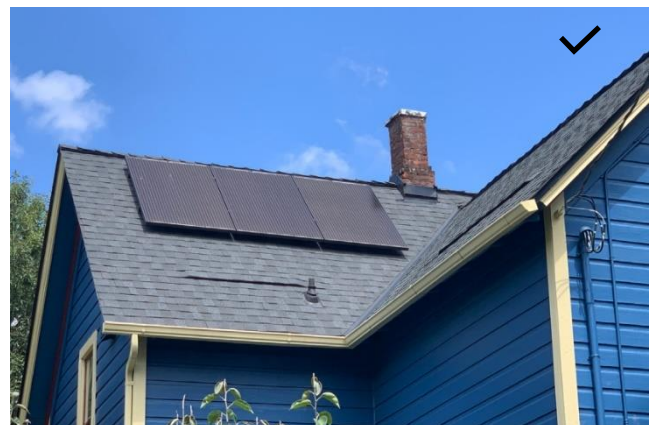
*Install solar panels on secondary facades.*

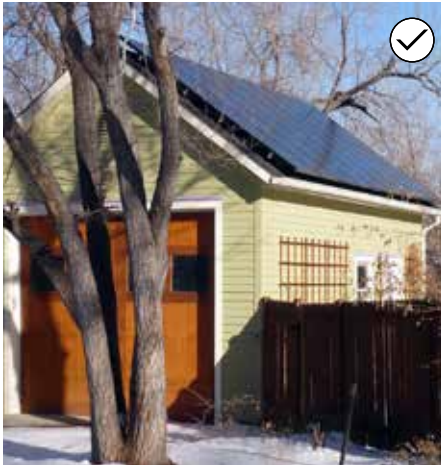
38. Place collectors in an unobtrusive location on the property.

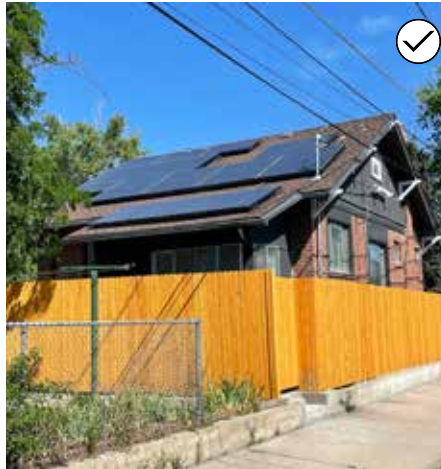
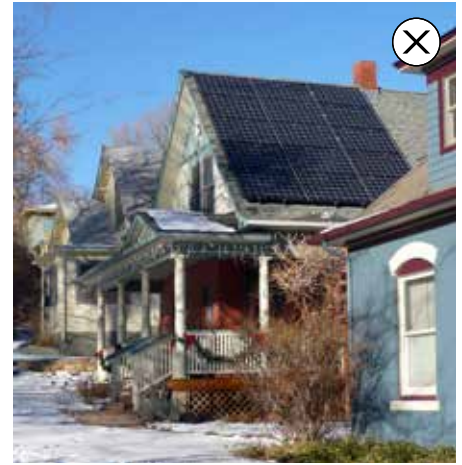
39. On a side-facing roof plane of a primary structure, minimize visual impacts by locating solar collectors at least 3 feet back from the front eave. The collectors illustrated above are not setback 3 feet.

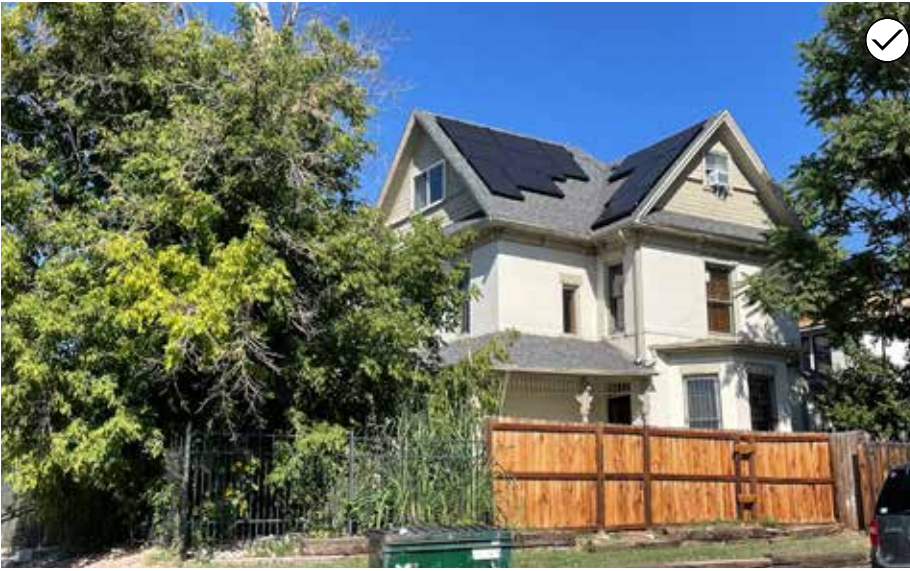
40. Solar panels are placed to avoid obscuring distinctive roof features.
