# CITY OF OREGON CITY URBAN RENEWAL COMMISSION AGENDA

- a. Residential Inspections of Urban Renewal Residential Properties
- b. Urban Renewal Property Discussion

# Residential Repair Review

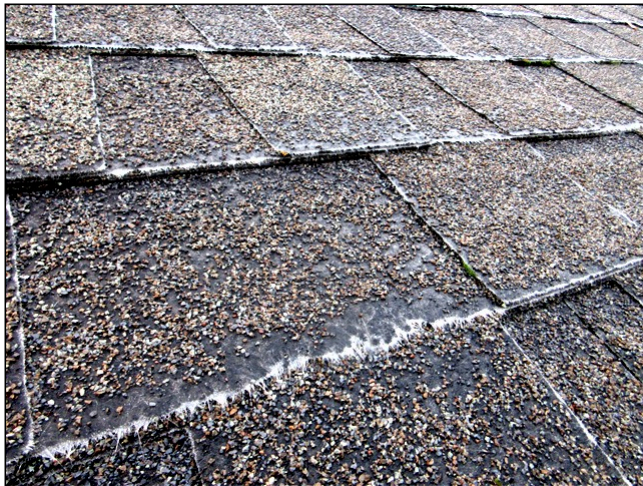
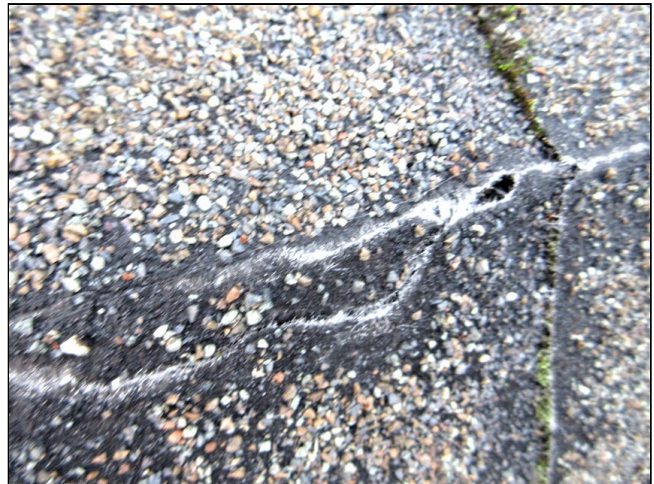
**Old, worn through roof on home & carport needs replacing by a roofing contractor including new vents & flashings.**

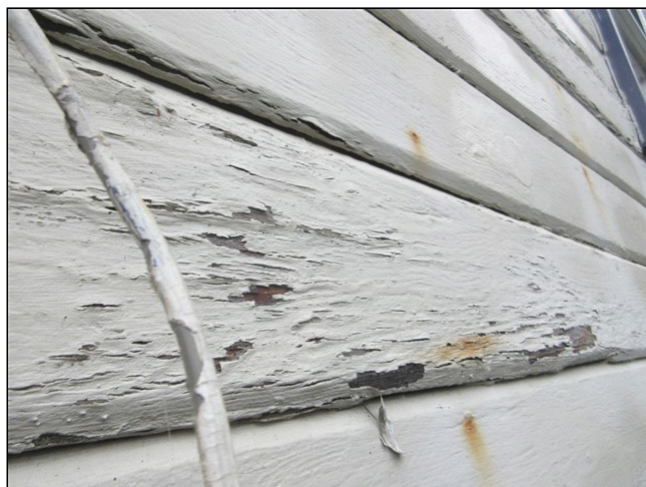
**Siding and trim has bubbling, peeling paint that all needs repainting. Rot needs repair at trim on corners, fascia & around windows where needed. Loose trim boards need securing.**

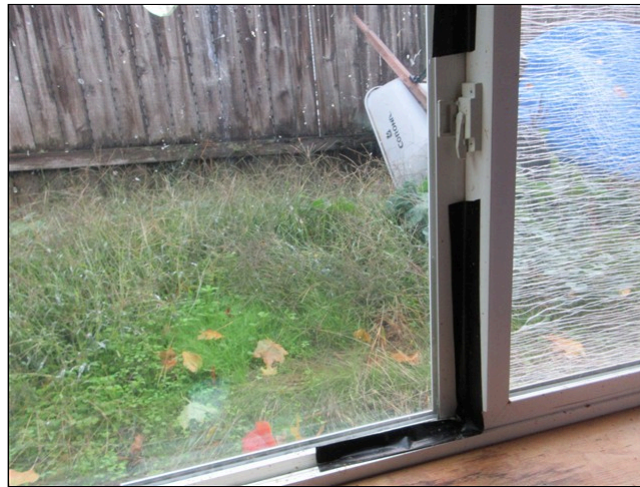
**Old metal sliding glass door needs repair to close & lock. Multiple windows need repairs to lock and be more easily operable.**

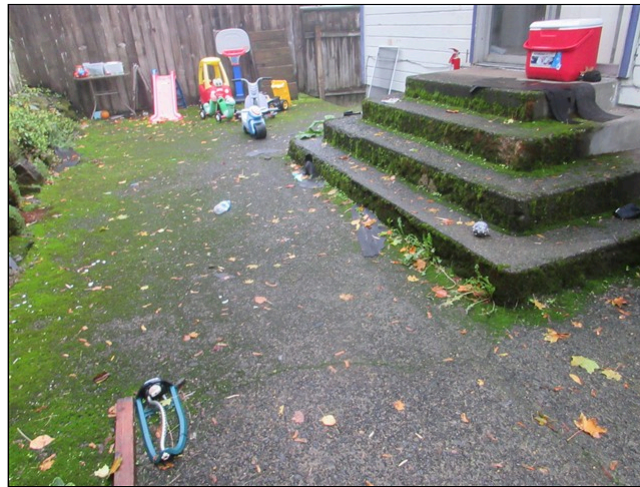
(2) **Broken up driveway needs replacing. Cracked rear patio needs repair. Steps need handrailing installed and flashing installed at connection to siding to keep rot from occurring. Side basement entry steps needs handrailing installed.**

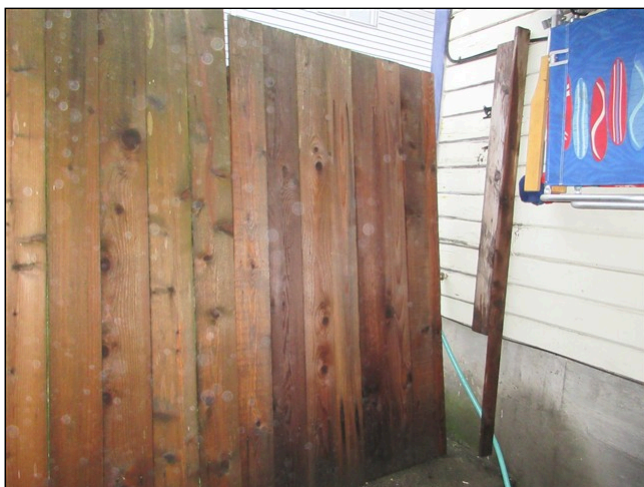
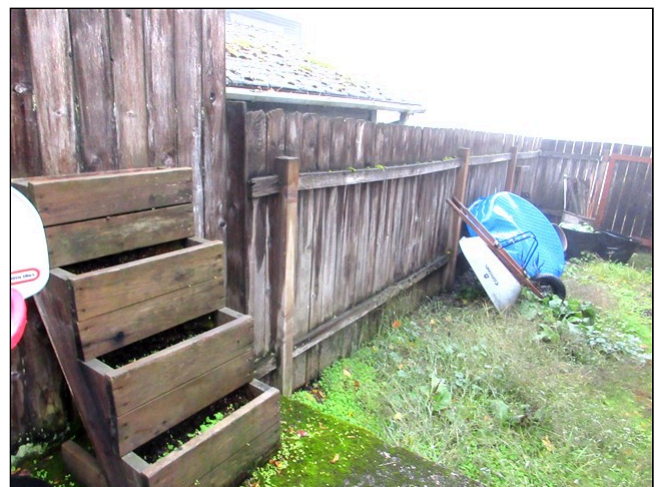
(3) **Rotted sections of fencing and gates need repair.**

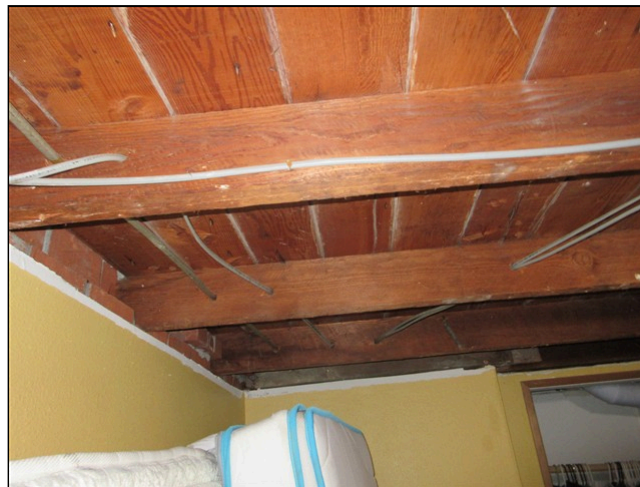
3.0 Item 1(Picture)

**Portions of ceiling drywall in basement have been removed and needs installation to patch.**

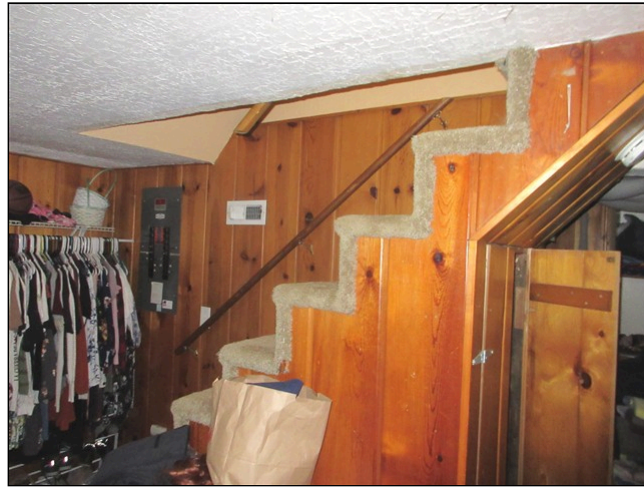
3.3 Item 1(Picture)

**Staircase in basement needs handrailing and balusters installed.**

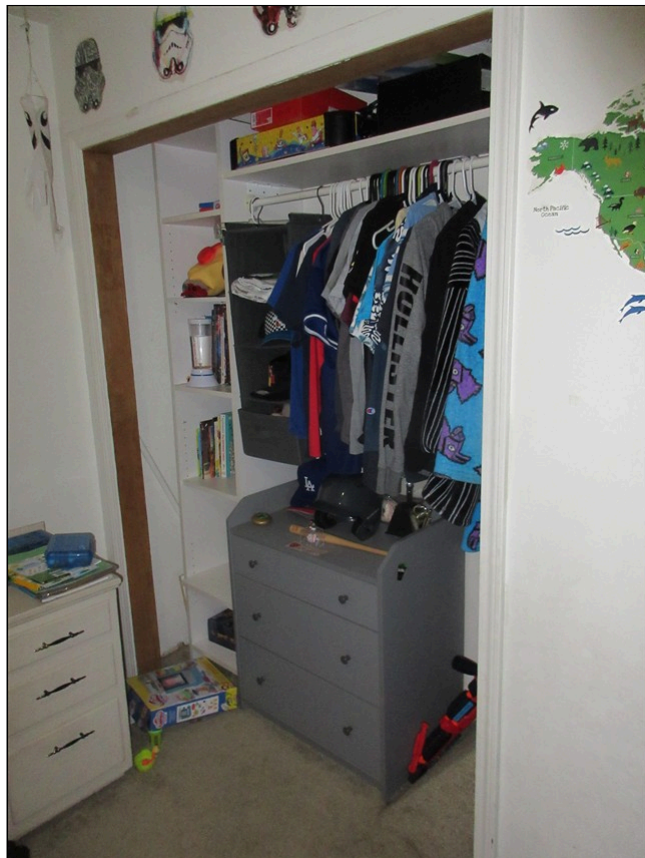
3.5 Item 1(Picture)

**Missing closet doors throughout home need installation.**

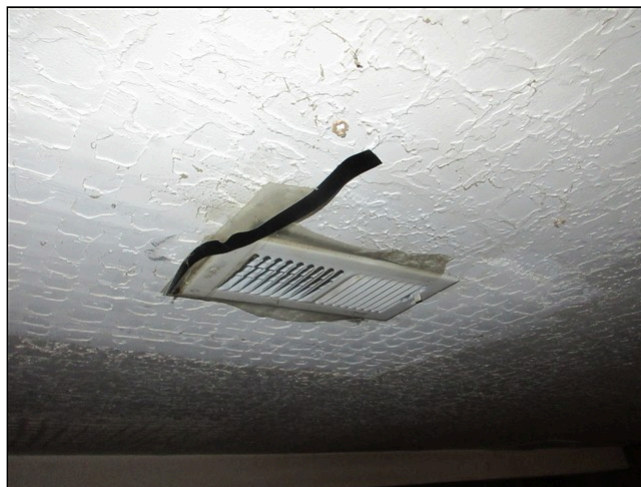
**Furnace & AC units need servicing and cleaning by a heating contractor to maintain including cleaning out ducting. Loose registers need securing.**

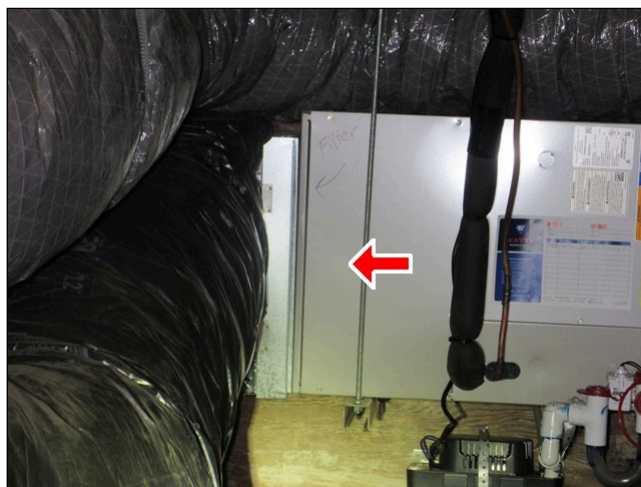
4.3 Item 1(Picture)

**Important: Furnace needs filter replaced regularly to maintain system.**

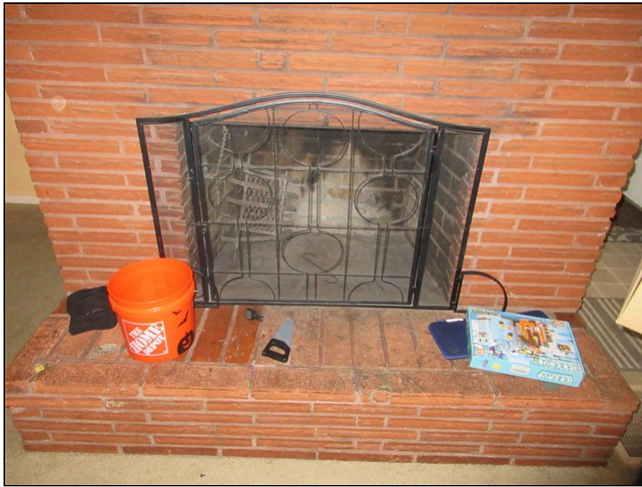
**Fireplaces need flues cleaned out and dampers repaired to function. Cracks in chimney need repair.**

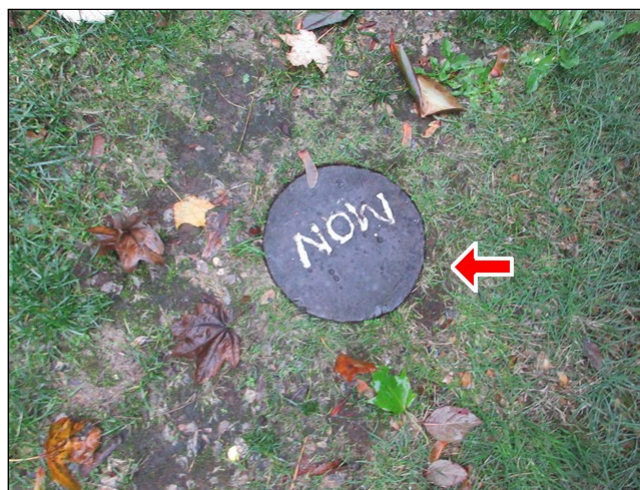
5.0 Item 1(Picture)

**(1) Due to age of home, I recommend a sewer scope, buried oil tank search & radon test be done by a contractor. Any buried oil tank found will need decommissioning by a deq contractor.**

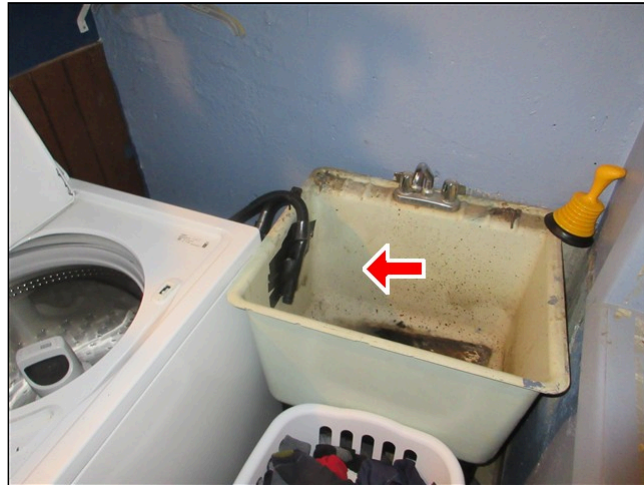
5.0 Item 2(Picture)

**(2) Washing machine drains into sink and needs dedicated 2" drain installed so cross contamination doesn't occur.**

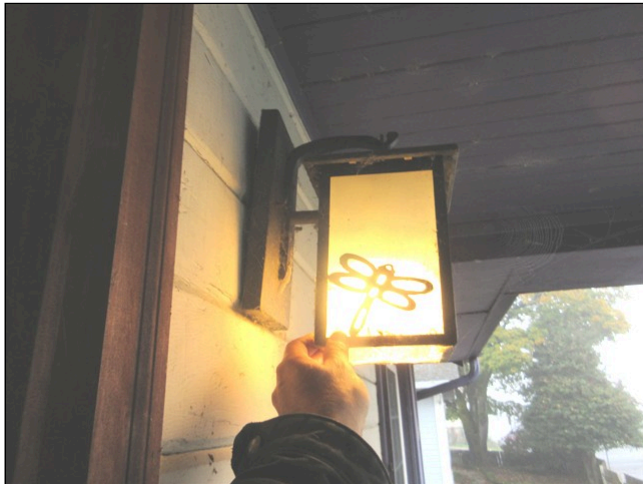
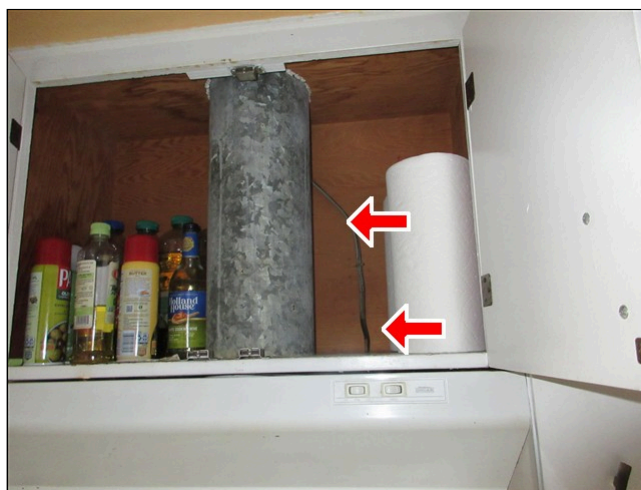
**Loose exterior lights need securing. Exposed wiring under kitchen sink, over kitchen hood & at floor needs enclosing in conduit. Non functioning gfci outlets in kitchen need repair.**

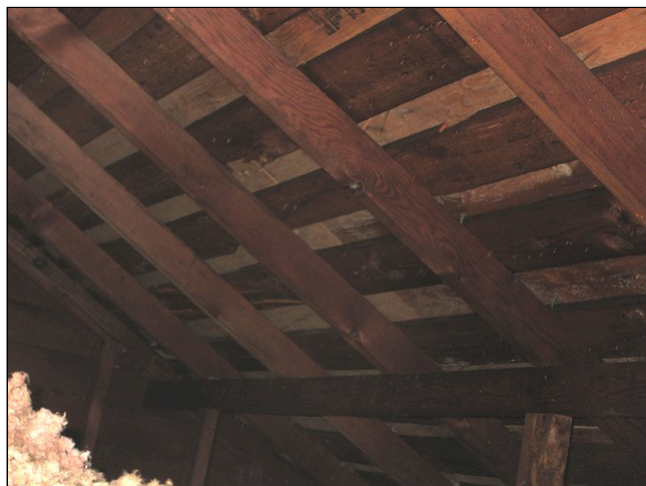
9.5 Item 1(Picture)

**Mold growth was noted throughout attic and needs removal by a mold remediation contractor. Cracked rafters need repair where needed.**

Mold growth throughout attic- Remove		Fireplace needs flues cleaned and dampers repaired to function. - <b>Repair</b>	
		No carbon monoxide detectors - <b>Install</b>	
		Expired smoke detectors - <b>Replace</b>

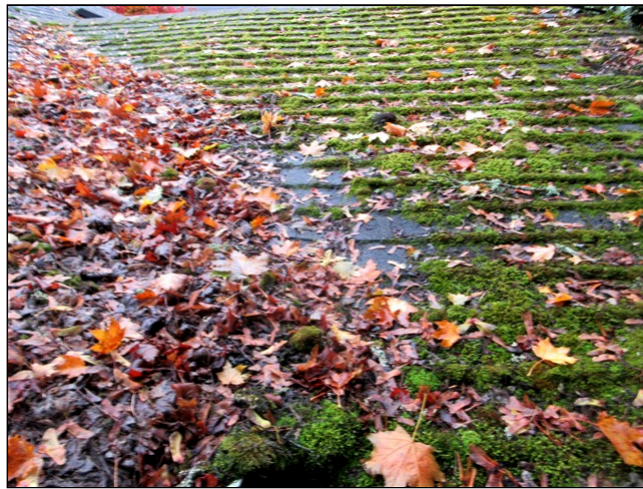
1.0 Item 1(Picture)

**Roof has heavy wear due to excessive moss growth and tree damage. Recommend roof be torn off and replaced by a roofing contractor including new flashings/vents.**

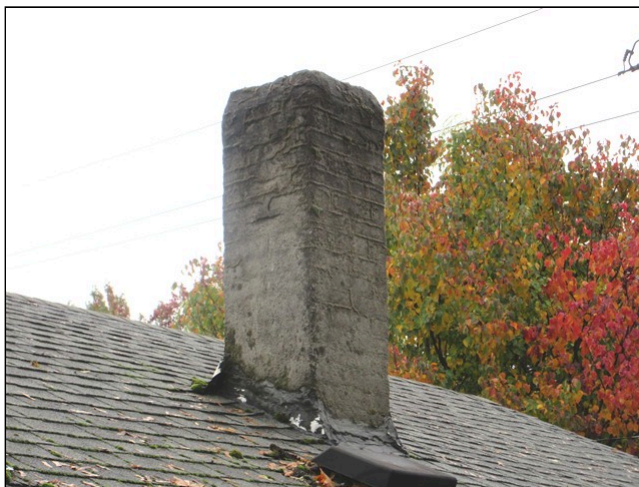
1.2 Item 1(Picture)

**Eroded, cracked chimney needs repair and new exhaust cap installed. Flashing at base needs replacing to keep from leaking.**

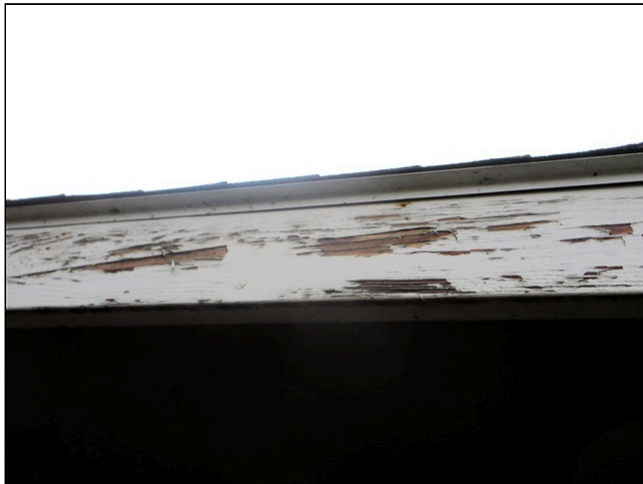
2.0 Item 1(Picture)

**Siding and trim has peeling, bubbling paint and needs house & garage to be repainted.  
Missing lower belly board trim needs installation.**

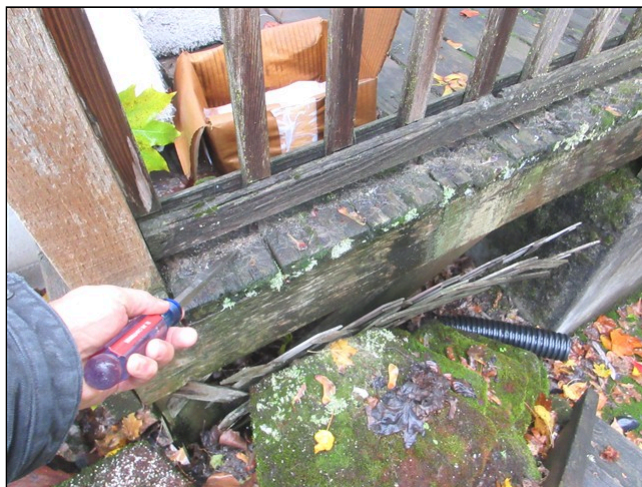
2.4 Item 2(Picture)

**Old, rotted rear entry deck needs replacing. Displaced, rotted landscape steps need replacing.**

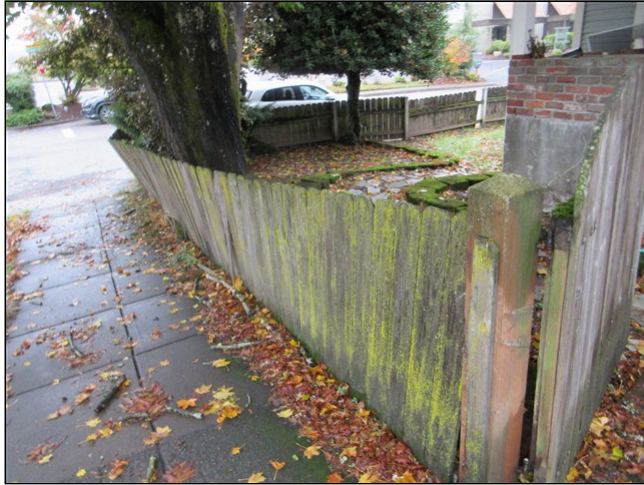
2.5 Item 1(Picture)

(1) **Rotted fencing needs replacing. Trees need pruning well away from home & garage.**

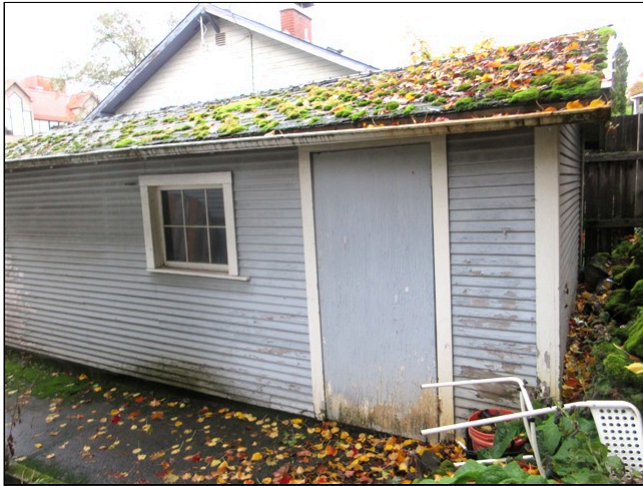
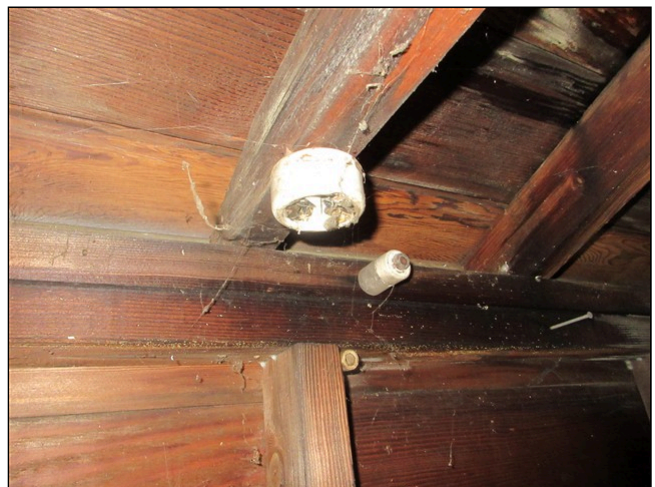
**Old garage structure needs repairs including tear off and replacement of worn through roof. Broken leaking gutters/downspouts need replacing. Entry door needs replacing to be operable. Siding and trim needs repair where rotted at base and building repainted. Siding to ground contact at base of building needs digging out to keep 3-4" spacing in place. Lower walls & sill plate at foundation is rotted and needs repair. Electrical has been decommissioned and no longer functions.**

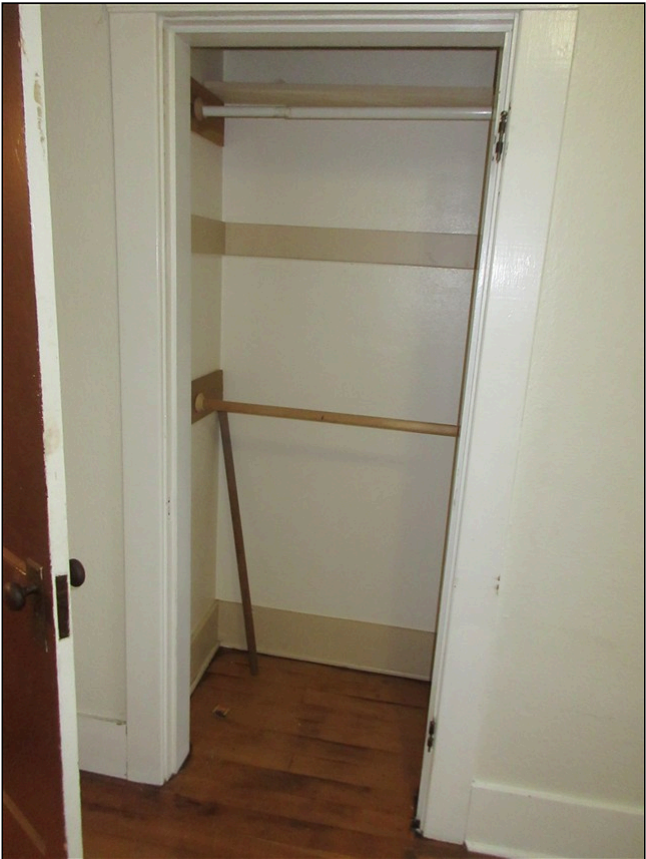
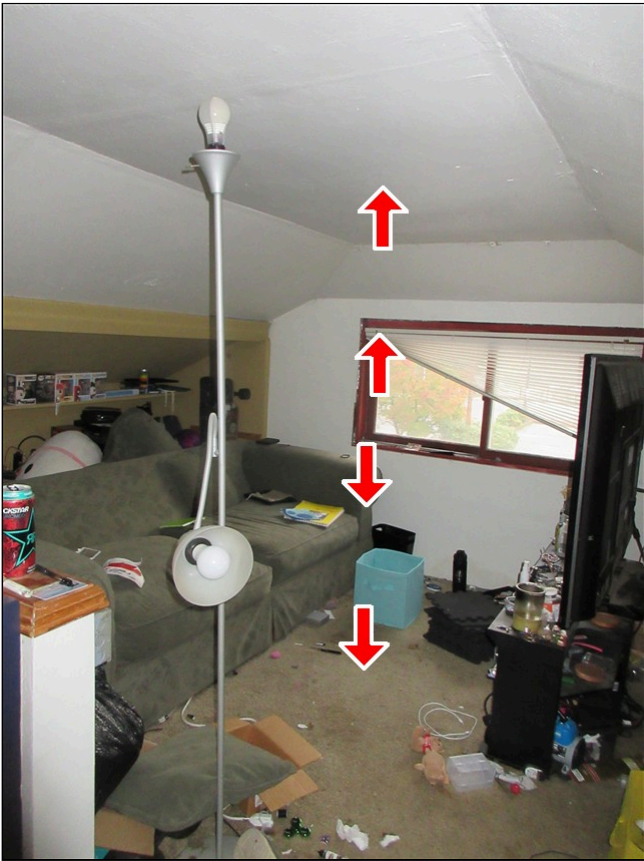
**Missing closet doors need installation where needed. Note: Top floor ceiling height is under**

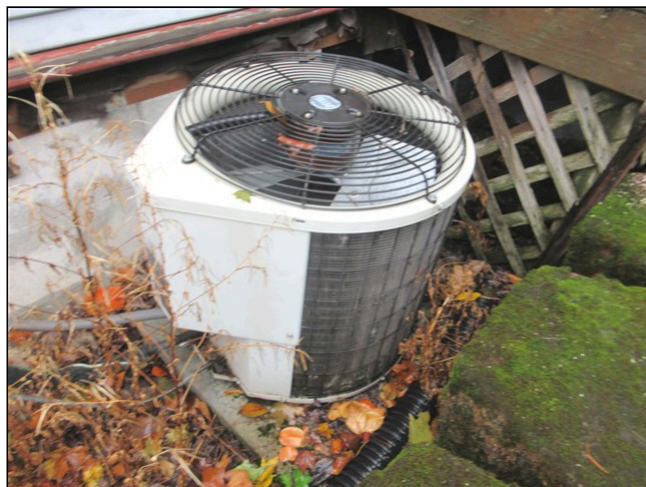
5.0 Item 1(Picture)

**Old oil furnace & AC units need servicing and cleaning by a heating contractor including cleaning out ducting. Units are over 20 yrs old and are nearing the end of there useful lifespans.**

Note: Furnace & a/c units should be serviced and cleaned annually by a heating contractor to maintain system. Heat exchanger inside furnace is not checked for failure and should be evaluated by a heating contractor.

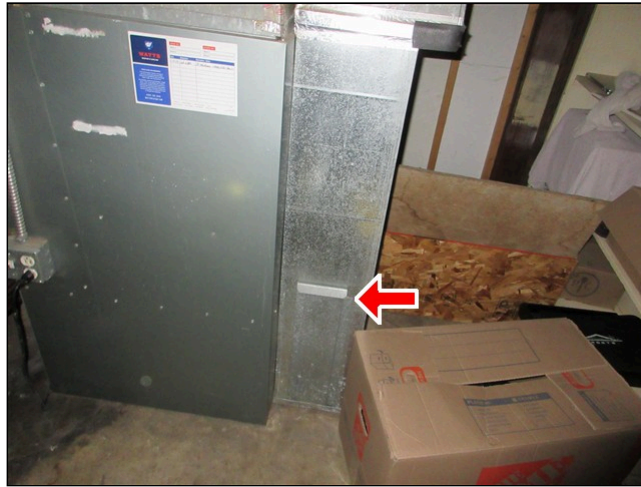
5.3 Item 1(Picture)

**Important: Furnace needs filter replaced regularly to maintain system.**

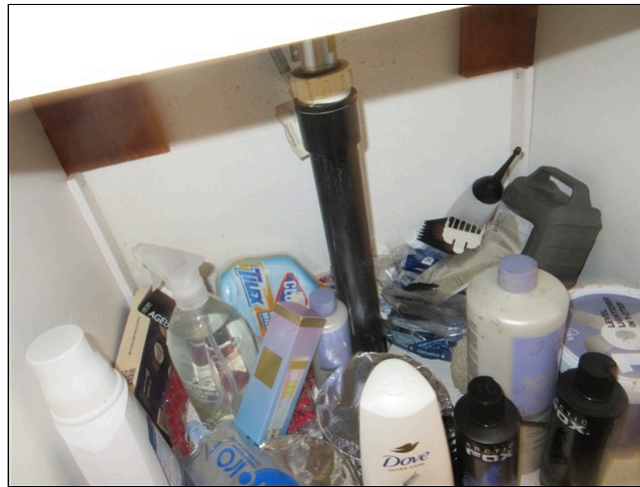
**(4) Main floor hallway bathroom needs leaking shower tile surround replaced and leaking valve handles repaired. Loose toilet needs reinstallation with new wax ring to keep from leaking. Sink needs drain p trap installed with AAV vent under sink instead of through floor.**

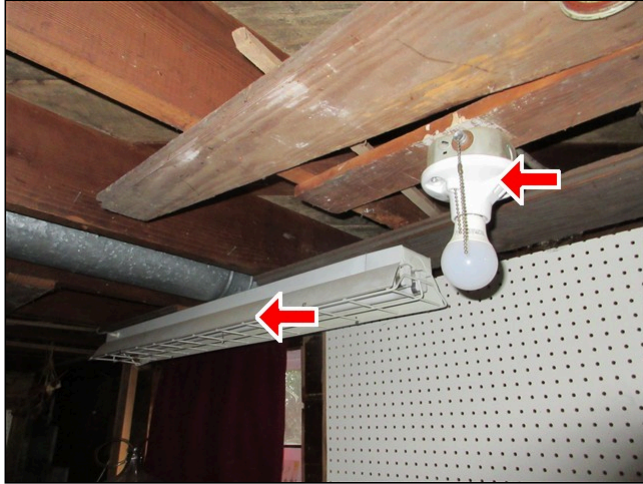
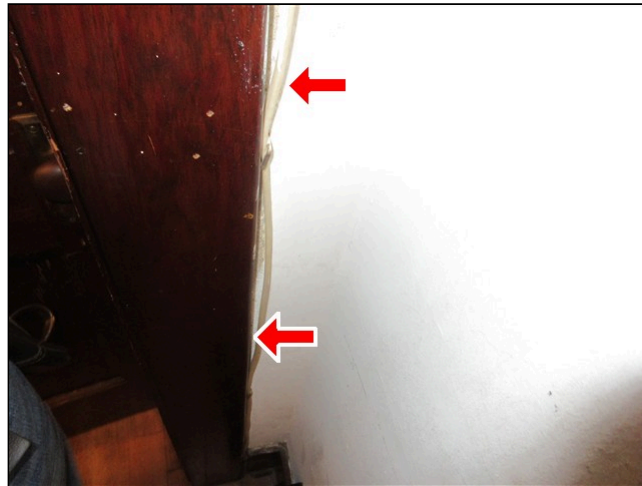
**Non functioning lights in basement need repair. Exposed wiring in stairwell of basement needs enclosing in conduit.**

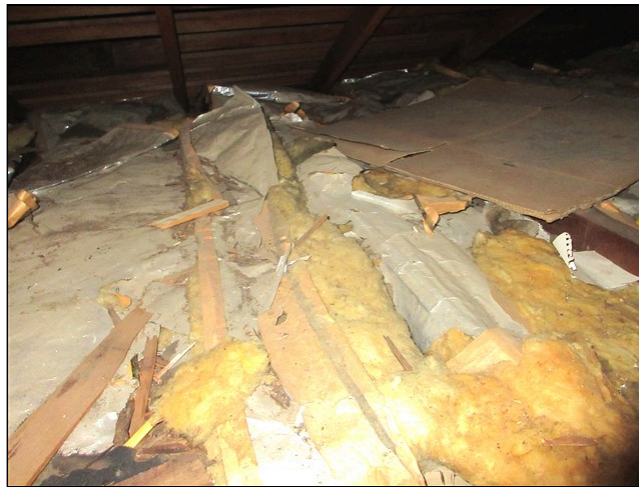
9.0 Item 1(Picture)

**Attic insulation is installed upside down and needs repair so foil backing faces heated portion of home.**

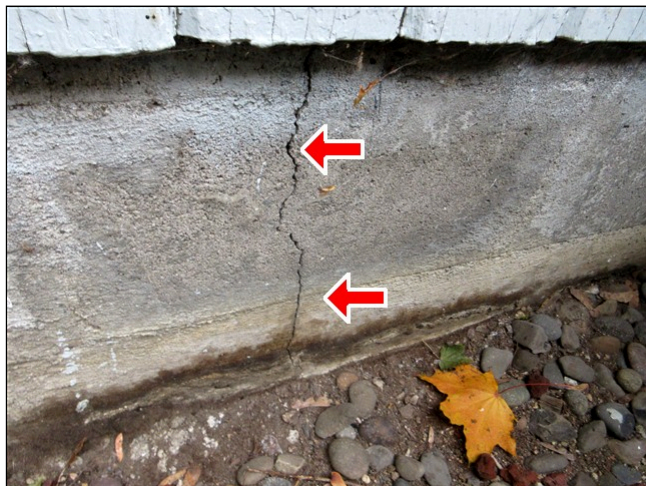
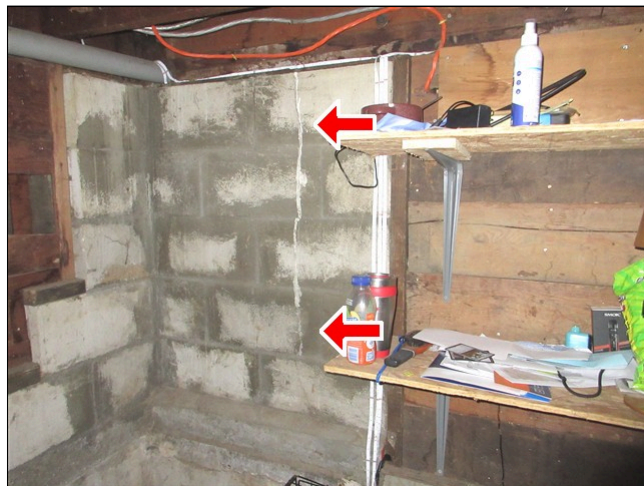
**Cracks in foundation need patching where needed.**
