CITY OF OREGON CITY ARTS COMMISSION AGENDA

City Hall Mt. Hood Room, 625 Center St., Oregon City, OR 97045
Thursday, January 15, 2026 at 6:30 PM

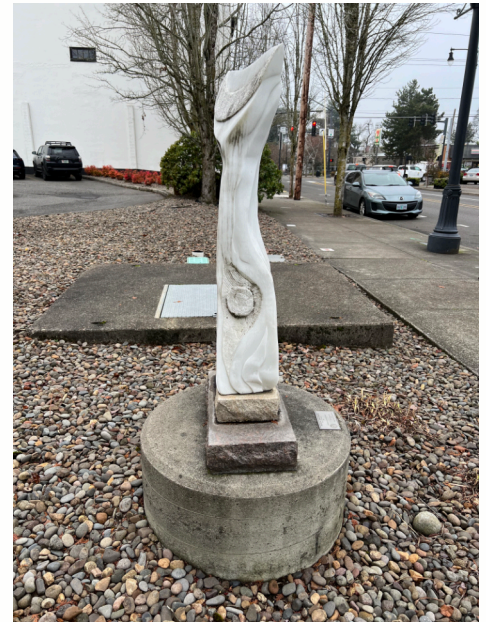
I am recommending a cleaning schedule be put in place for this statue if a professional can be found that is well trained in marble preservation and cleaning. There does not currently appear to be a cleaning schedule in place according to the public works record. This is likely due to a lack of professionally trained individuals that specialize in marble. Cleaning should occur every 2-3 years as needed by a professional that is familiar with cleaning marble statuary. Marble stone is very soft and can easily be degraded if cleaned with an abrasive, acidic, or alkali cleanser. The current dirt should not be allowed to stay for much longer as it could lead to permanent discoloration, damage, or biological growth. But, improper cleaning with the wrong materials could cause permanent damage.

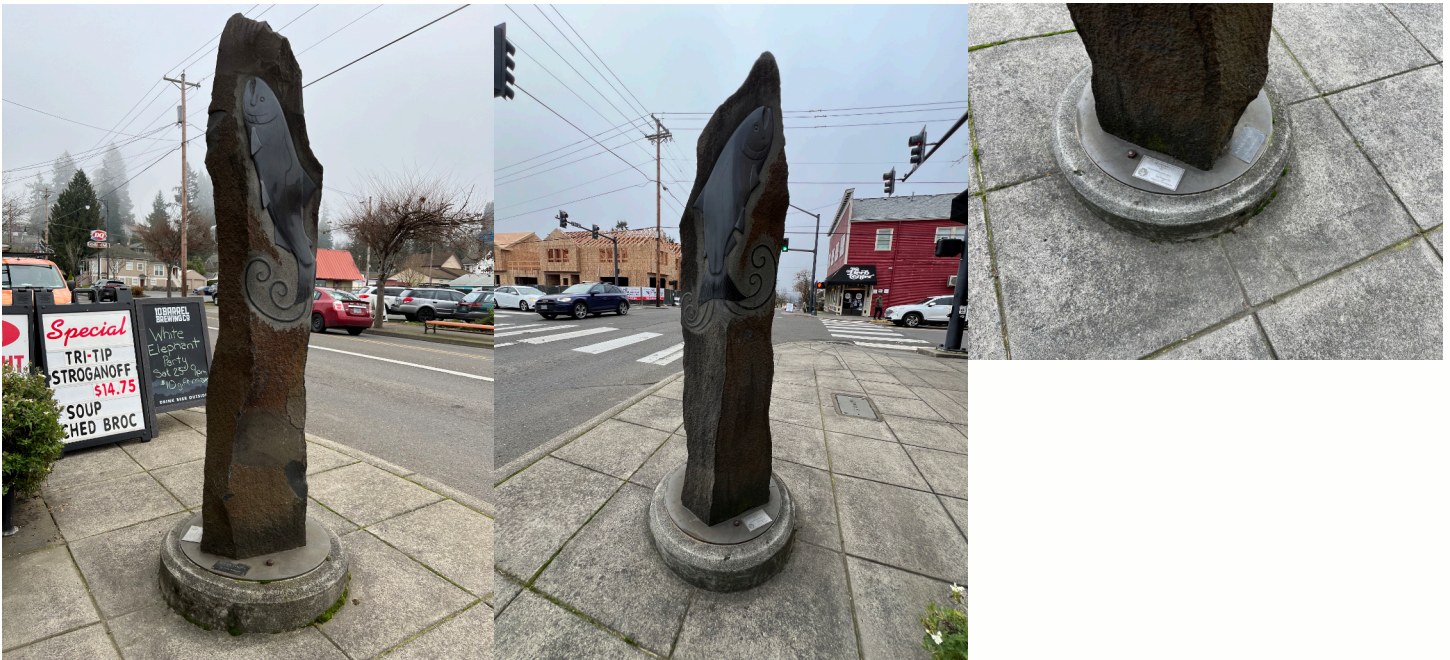
#2 “River Dance” Stone Statue
by Craig Breitbach
Located at 1001 7th Street at Monroe St.
2005

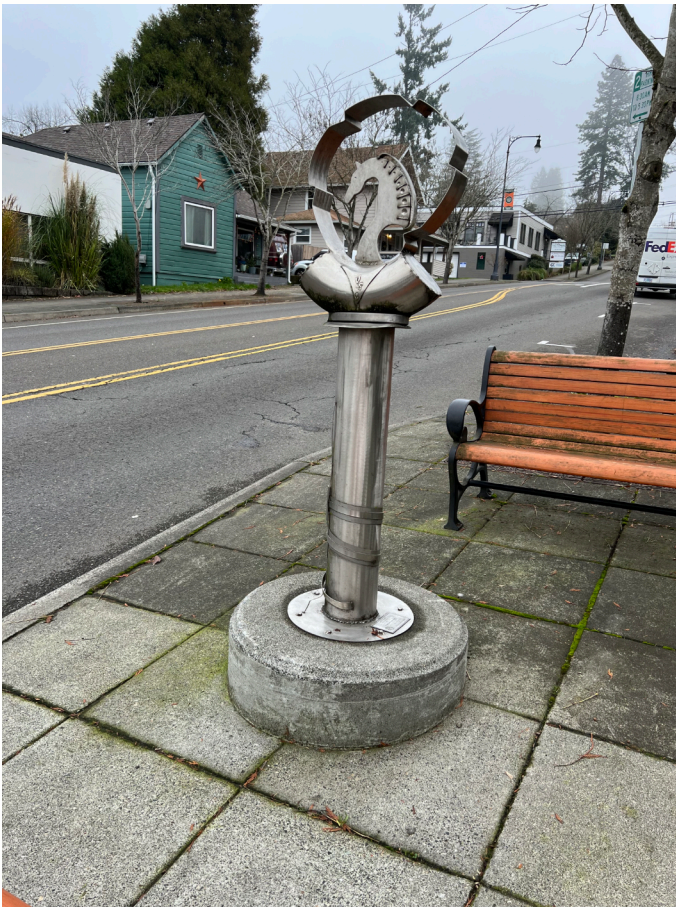
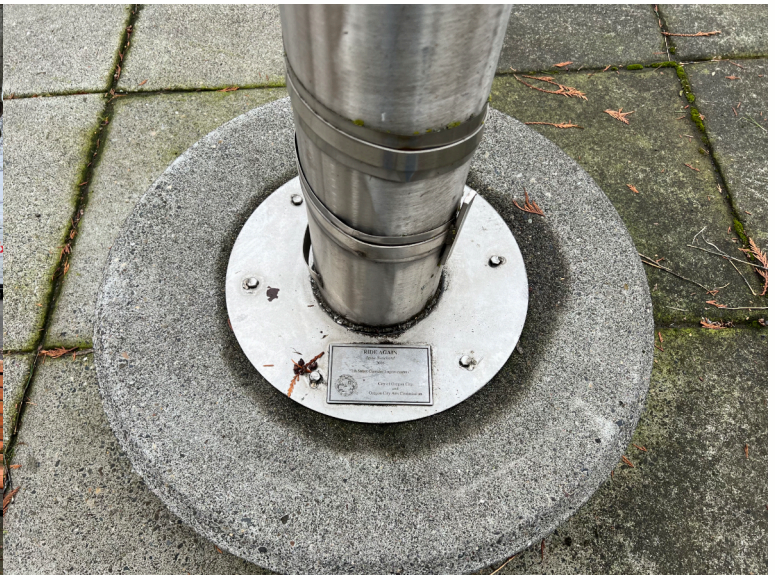
**#3 “Ride Again” Stainless Steel Statue
by Jesse Swickard
Located at 1108 7th Street between
J.Q. Adams and Jackson
2005**

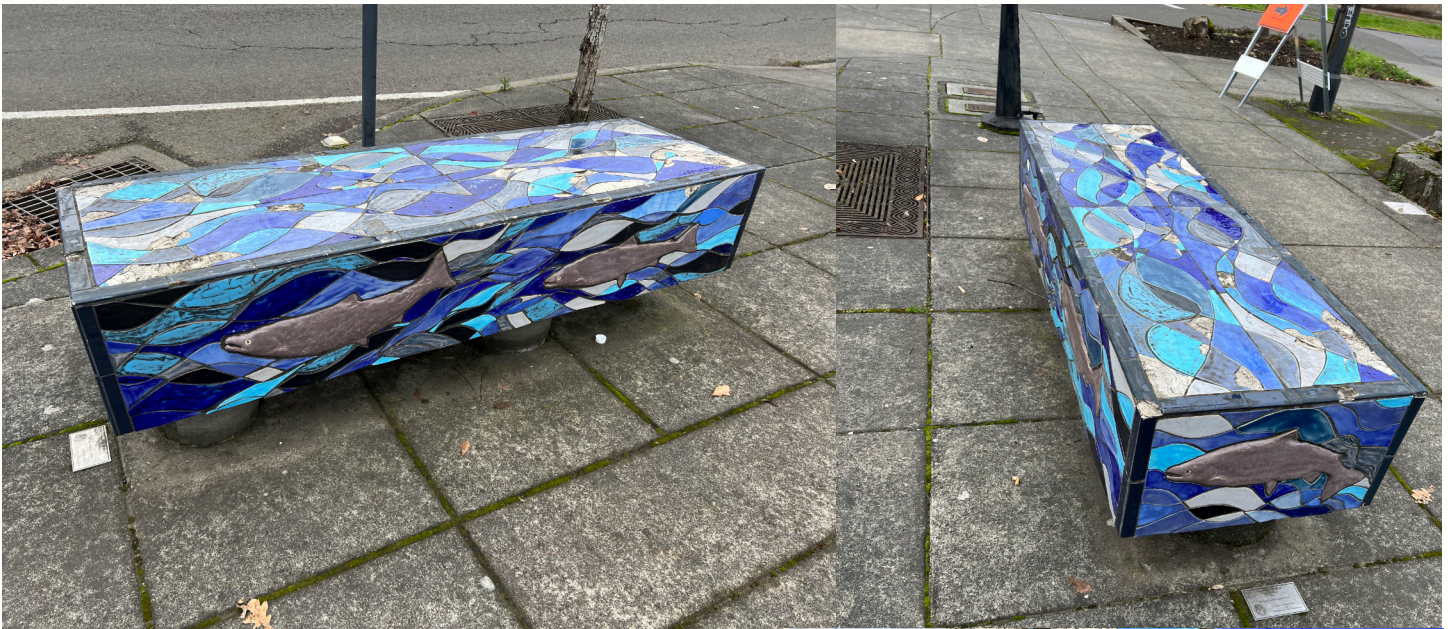
#5 “Salmon Bench” mosaic bench
by Nora Brodnicki
Located at 905 7th St.
2005

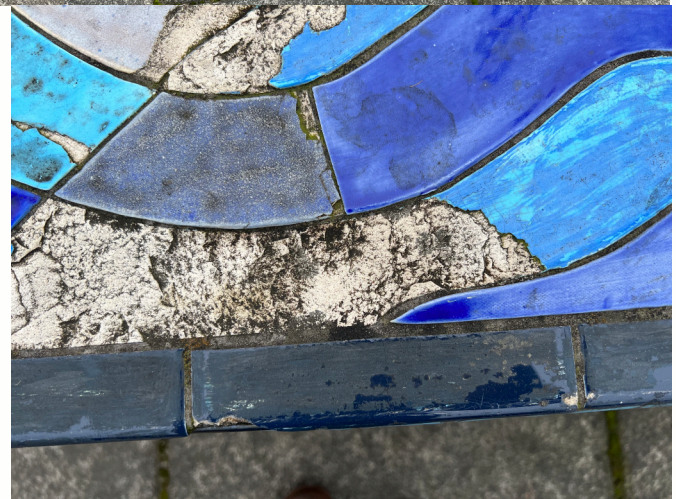
Cost \$10,000 in 2005. Funded by Urban Renewal. Insured. Current value adjusted for inflation: \$16,100. In May of 2025 a restoration project was funded by the Oregon City Art Commission to replace the top portion. Restoration was completed by Becky Dawson for \$10,000. The project was funded through an Arts Commission Grant.

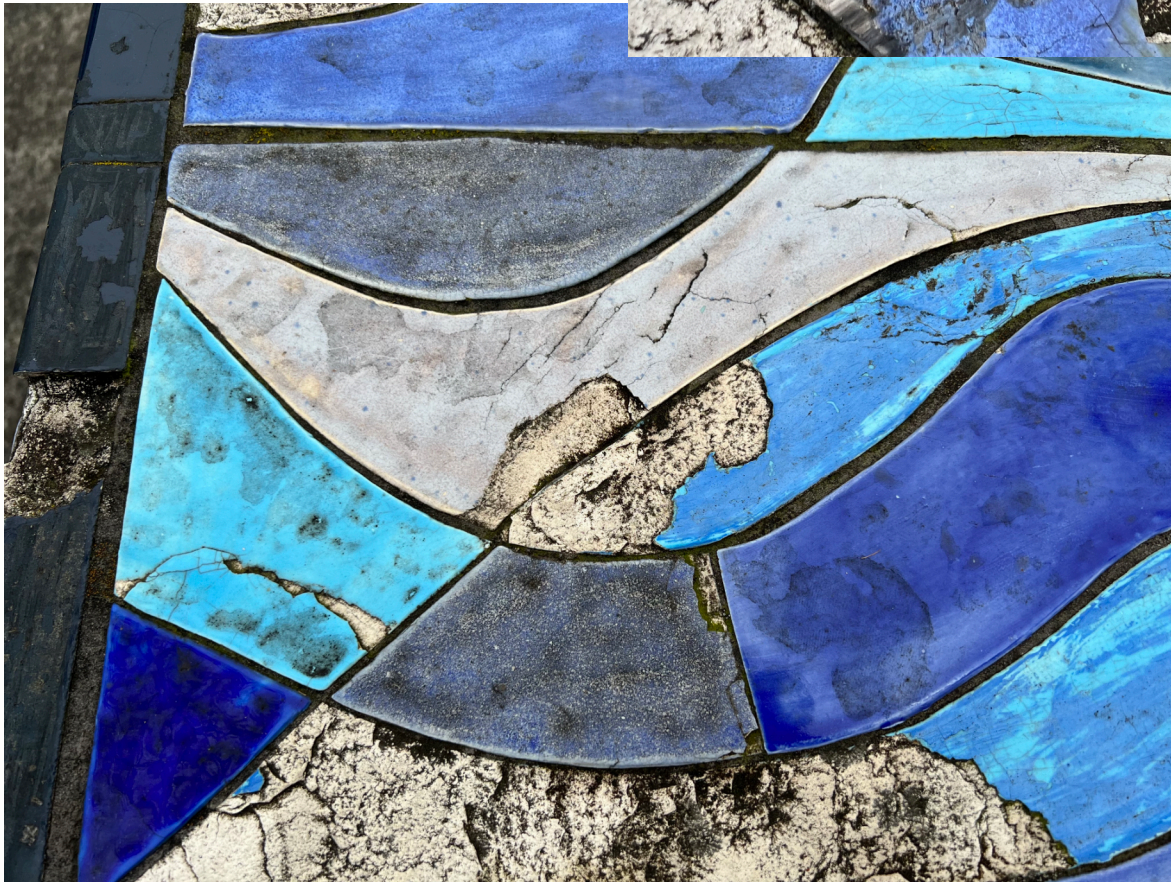
The image that includes my finger (on this page) shows some dark scuffing that is evidence of skateboarding misuse. This misuse from skateboards has not been completely mitigated in the recent restoration, but steps were taken to give the platform more structural strength at the edges.

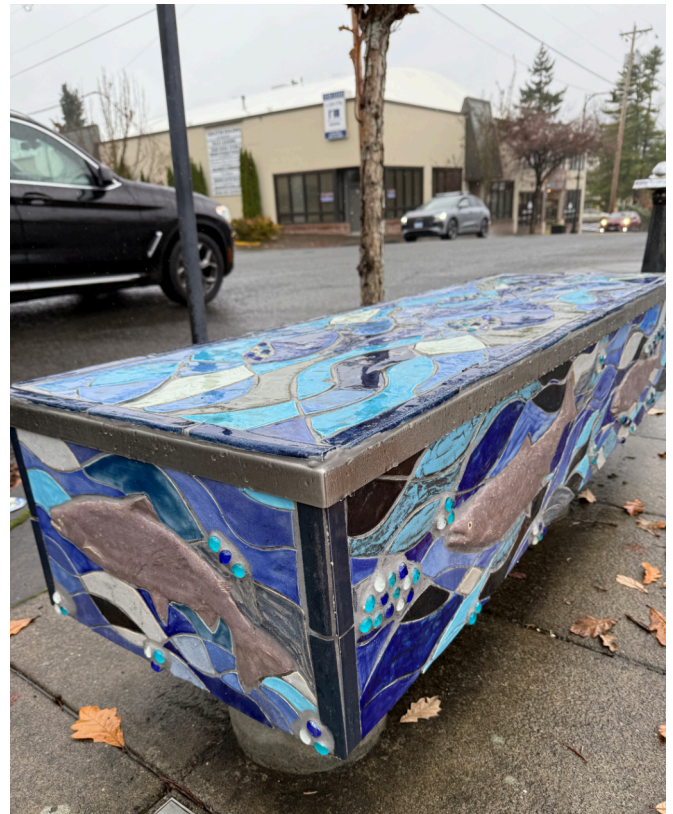
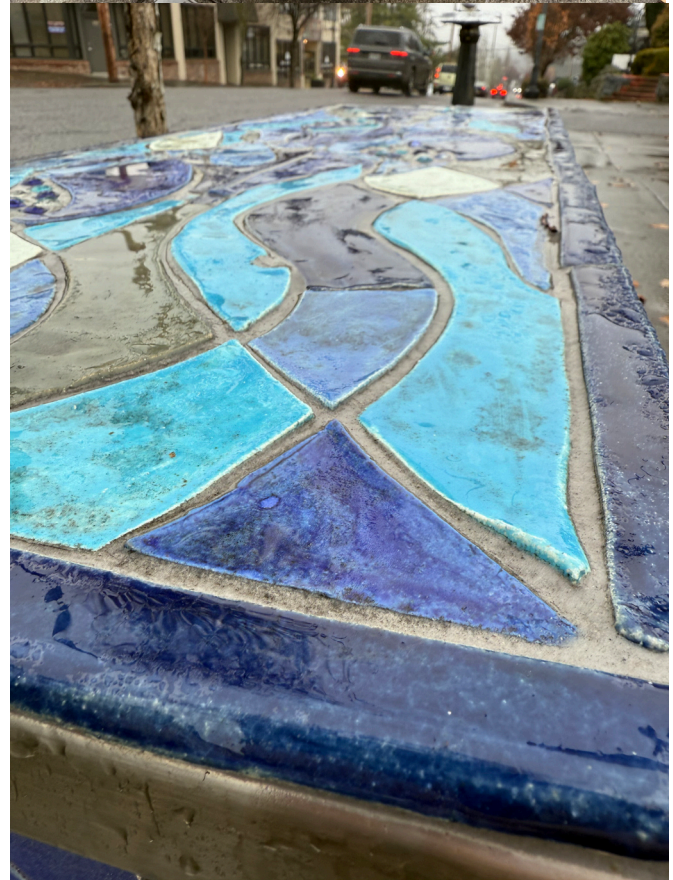
Images on this page show newly restored bench top as of Nov., 2025.

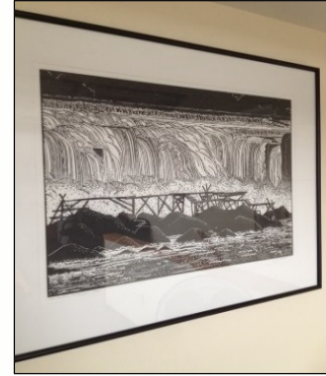
#7 “Amtrak Dedication Plaque” with artwork by Darla
 Cole-Bowen, The Graphics Doctor and constructed
 by Calcagno Studio & Foundry
 Located at the Amtrak Station
 2007

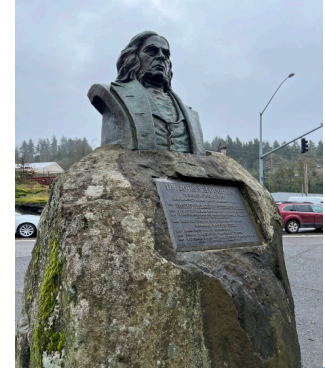
Public Works noted: “Plaque is in really good shape, can be buffed to show gold finish on top. Rock is in terrible condition, needs to be cleaned immediately, considerable pollution and biological accumulation. Light abrasive blasting should be done, sealant should be placed in rock to prevent cracking, bust needs to be cleaned and waxed”. Bust is discolored from pollution and weather. The statue’s “view” of the falls is blocked by a tree, diminishing the overall message of the bust and its placement. The current state and surrounding of the bust feels slightly disrespectful.

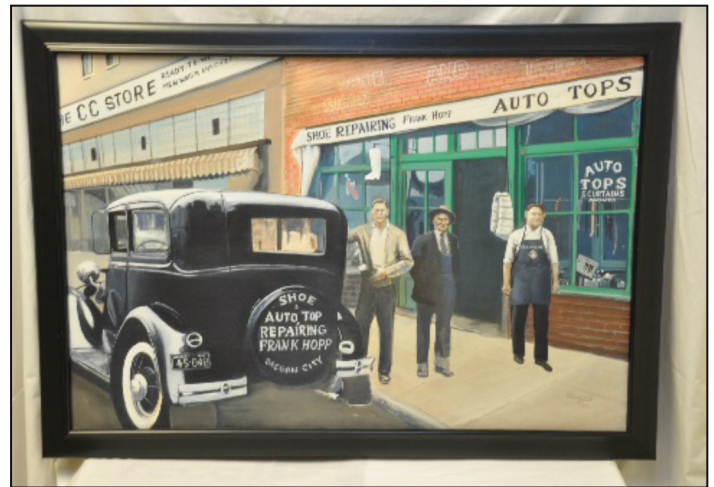
Shoe & Auto Top Repairing - Frank Hopp,
 Oregon City. Appears to be a small scale
 painting study for the large scale mural of
 the same design at 916 Main St.

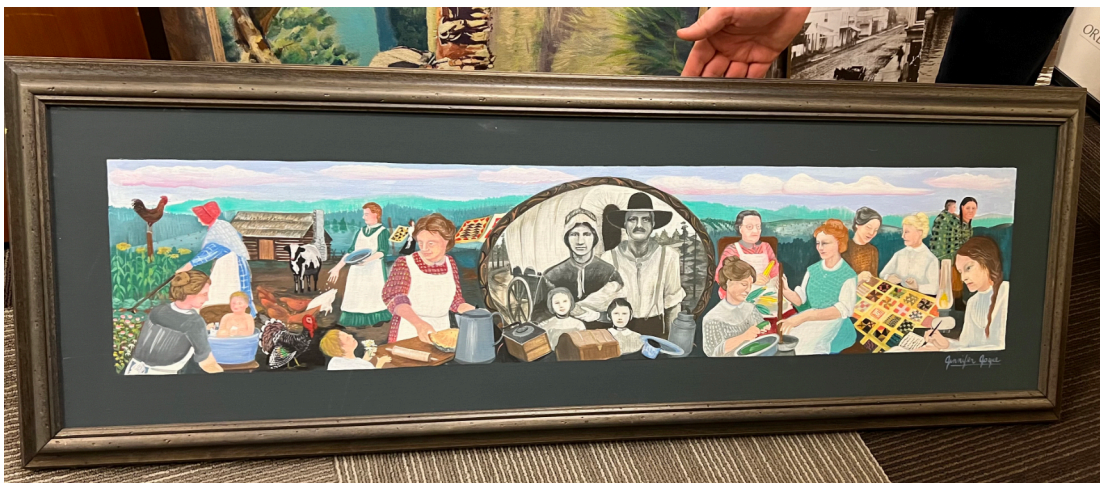
#13 “Pioneer Household and farming scene” Artwork, study for Mural, by
 Jennifer Joyce
 Located in Storage at City Records
 Date unknown

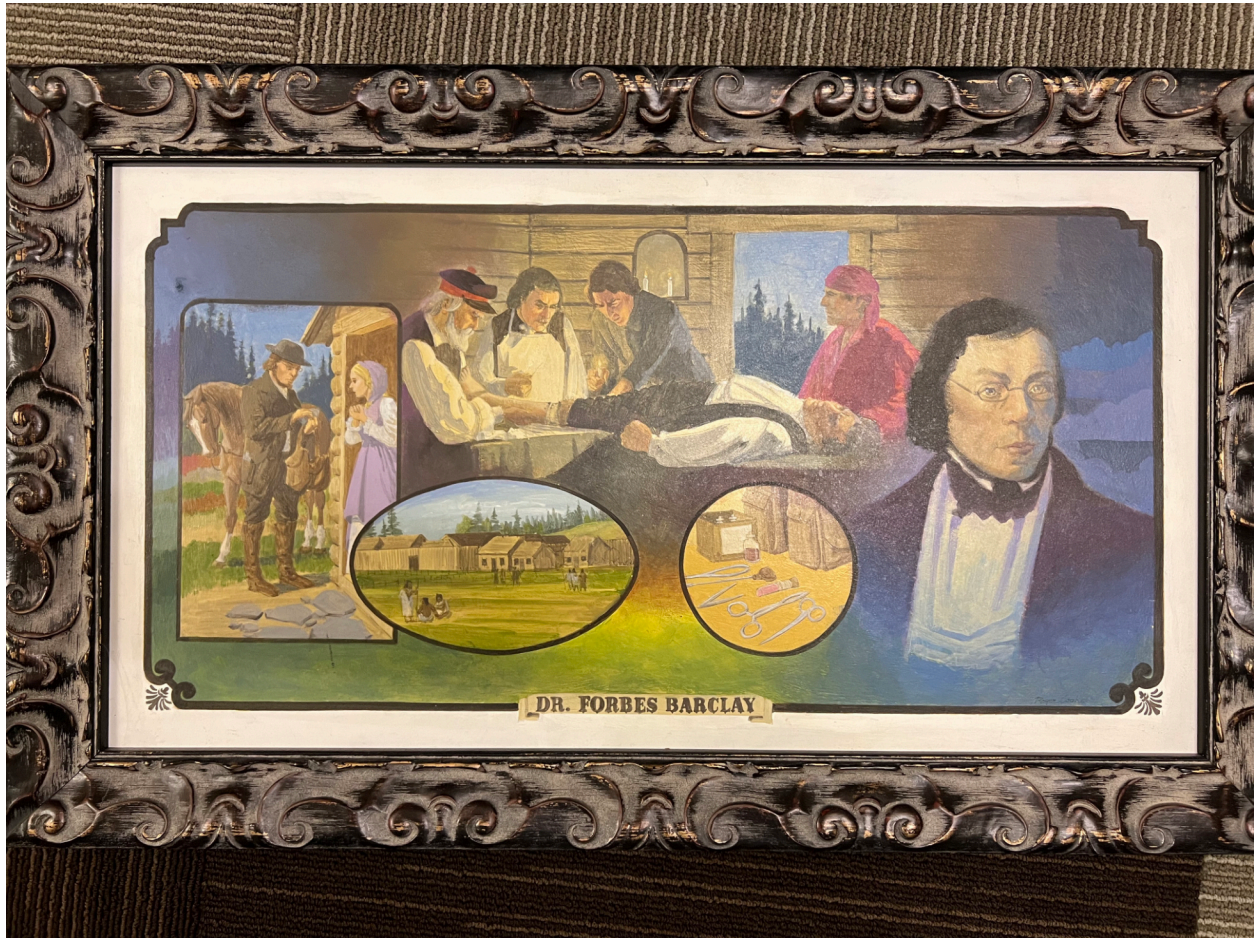
#14 "Dr. Forbes Barclay" Artwork, study for Mural, possibly by Roger Cooke
(artist of the mural)
Located in Storage at City Records
Possible date 1992

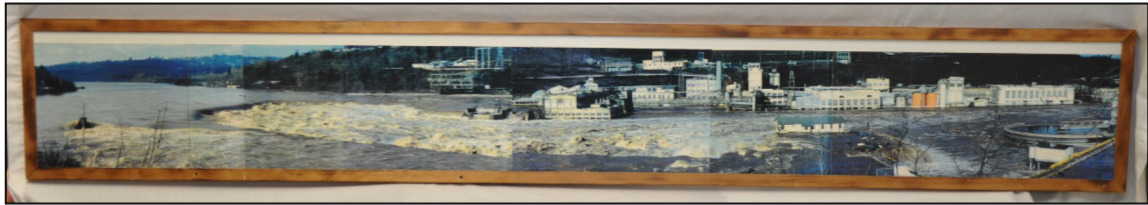
#15 "1996 Flood Photo" Photograph by an unknown photographer
Located in Storage at City Records (City Hall Basement)
1996

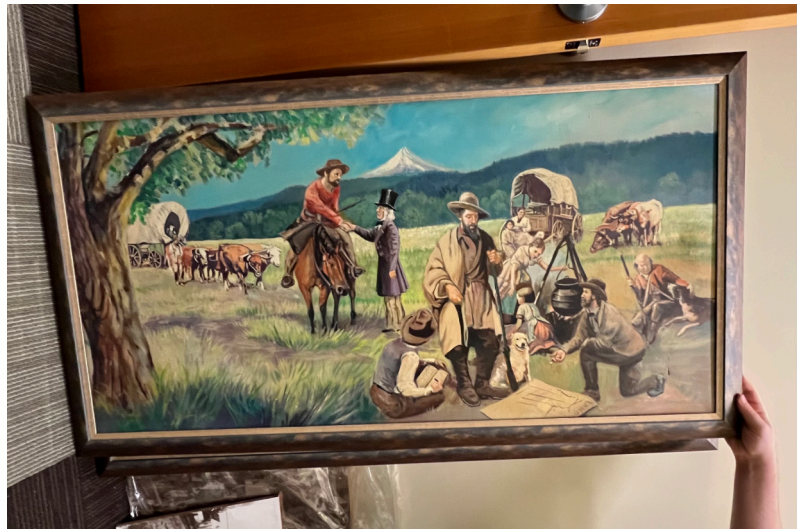
Prairie Scene - horses,
wagon, pioneer family.
Appears to be a small scale
(about 18" x 36") oil painting
study for a large scale mural
of the same design. This

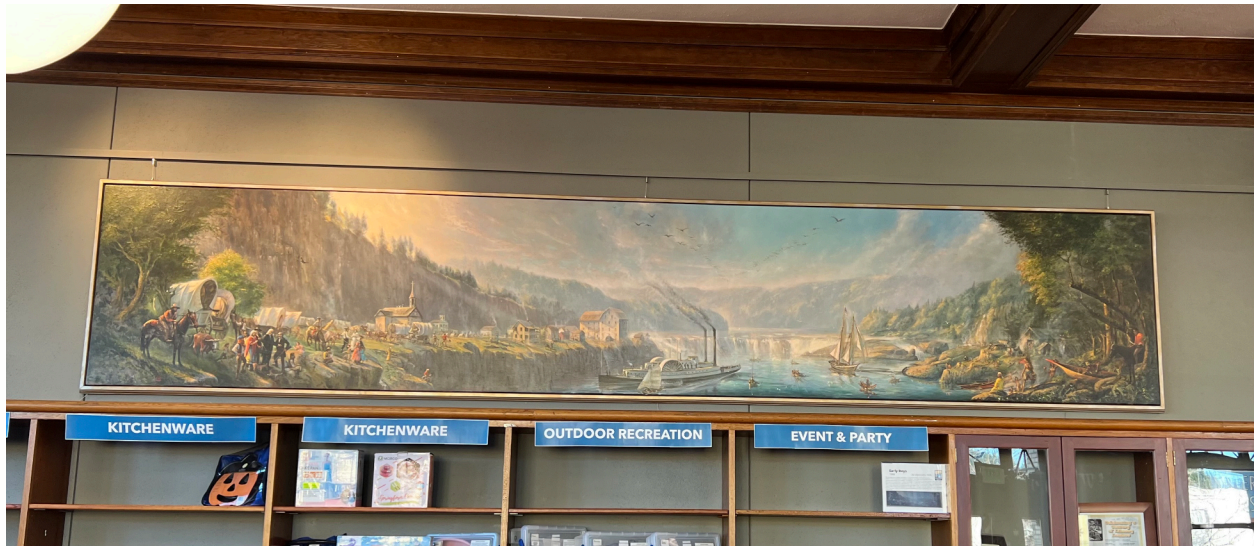
#17 “Early Days” Mural (large painting) of Oregon City
by Leland John
Located in the Carnegie Library
1988

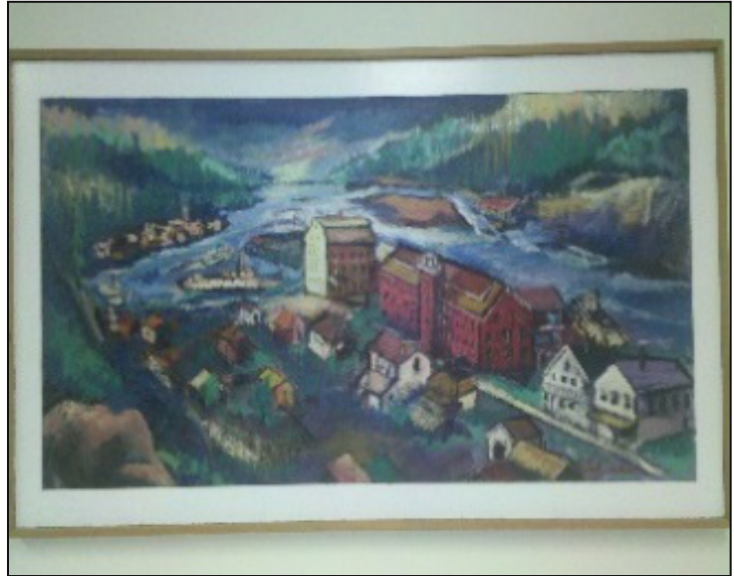
Cost \$1,000 in 1994. Funding
Unknown. Insured. Current Value adjusted for inflation: \$2,100.

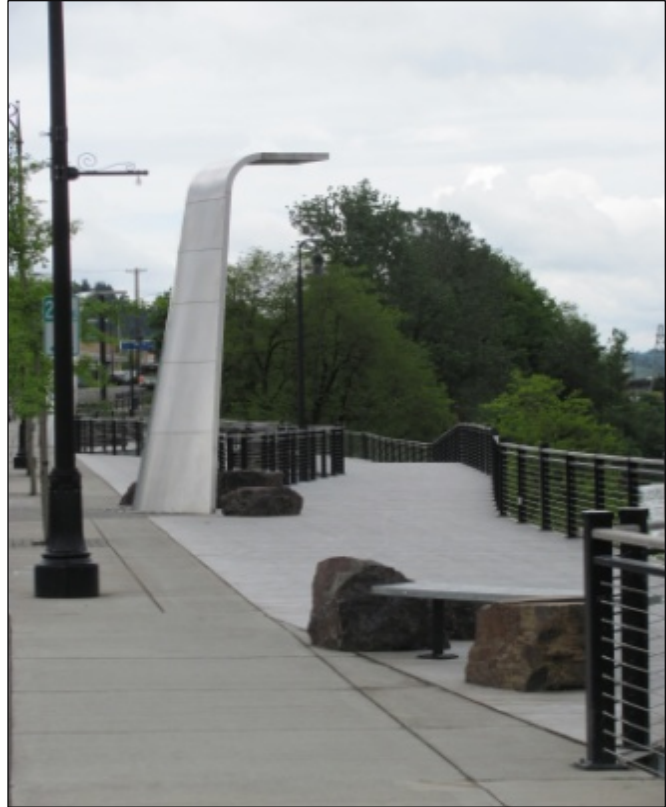
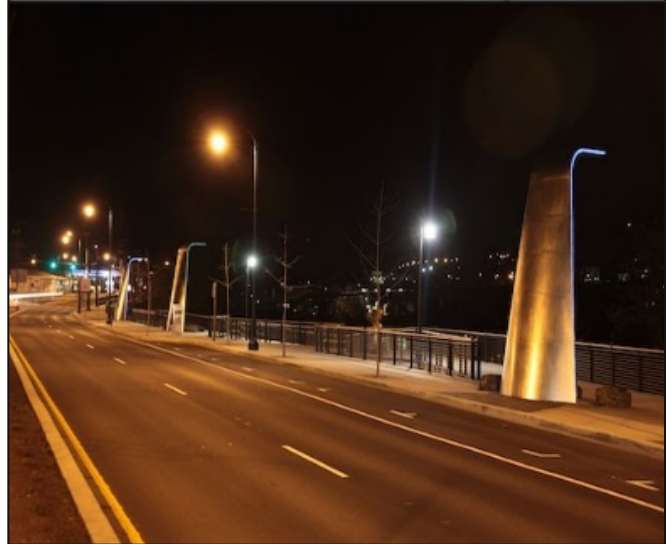
#20 “Moontrap” stainless steel wall sculpture
by Lee Kelly
Located at 299 8th St. at the bottom of
Singer Falls
2011

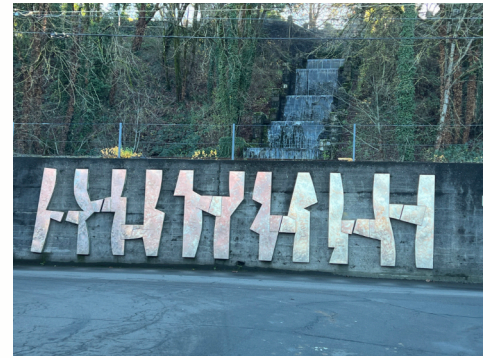
Public Work notes: “A gateway and link between uptown and downtown Oregon City, Moontrap is a legacy gift from the Rotary Club of Oregon City to embody and reflect the Club's mission and motto: Service Above Self.” Piece includes several stainless steel forms attached to the wall just below the Singer Falls. Lee Kelly is a modern artist of note with several pieces prominently located in public and private collections in the Pacific Northwest. Lee Kelly passed in 2022.

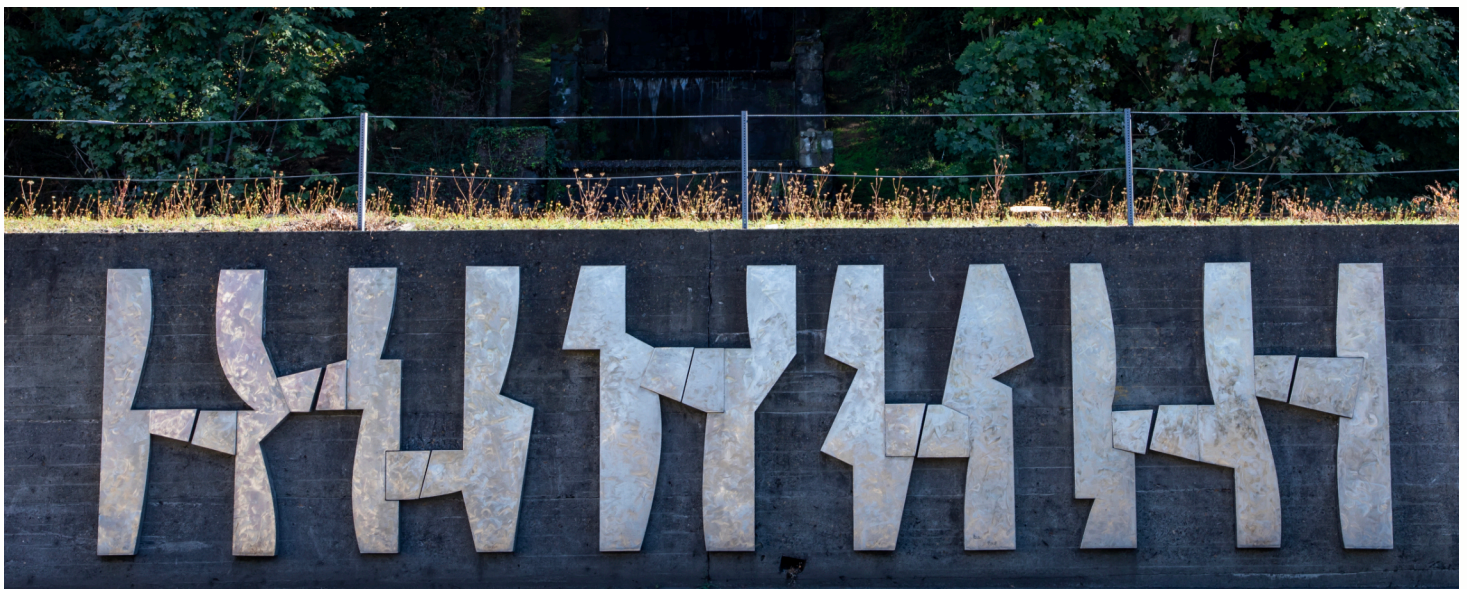
On a personal note, I am sometimes asked what this piece “says” as if the forms are letters and words. I find it interesting that people look to this piece and see letter forms where they were likely not intended. Some people may find this frustrating to have a public piece that is so easily misread as a jumble of letters (especially when viewed quickly by car) or some encoded or foreign language. A piece such as this could benefit from a bit of community outreach that clarifies what it is supposed to be and its connection with the community and the artist.

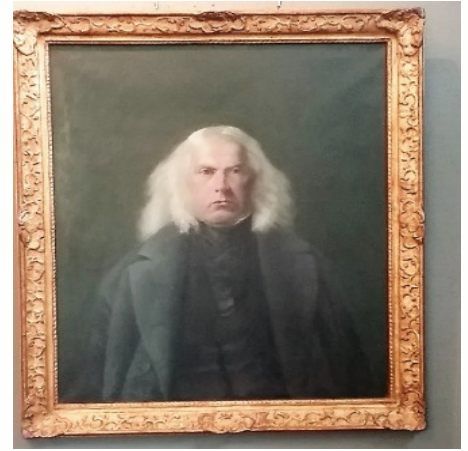
An original oil painting of John McLoughlin.

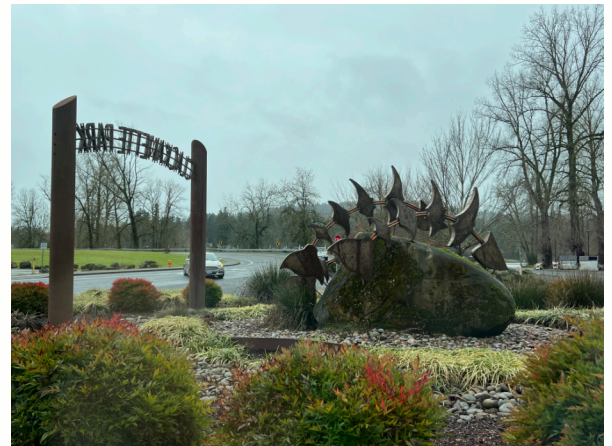
Primarily recycled metal river debris in a boulder base. A "RiPPLe Legacy Sculpture" to promote the intersection of river restoration, recreation, stewardship, and art.

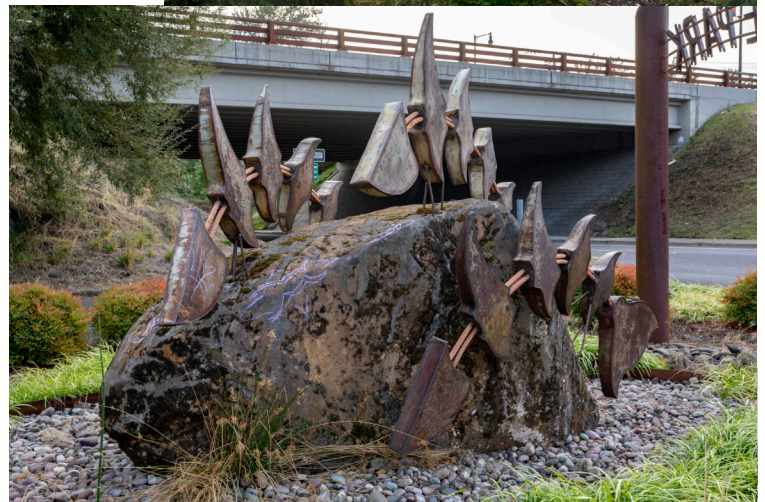
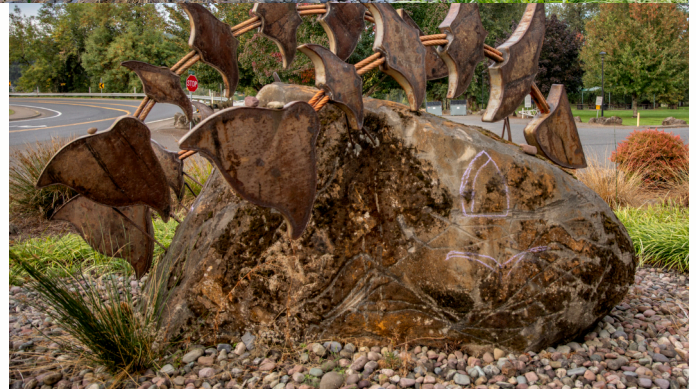
#24 “Singer Falls Lighting” lighting art
by Fountain People
Located at Singer Falls
2012

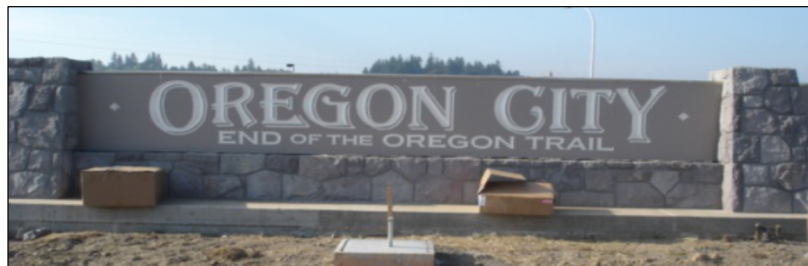
#25 “Gateway Sign” welcome to Oregon City sign
located at Hwy. 213 and Washington
2012

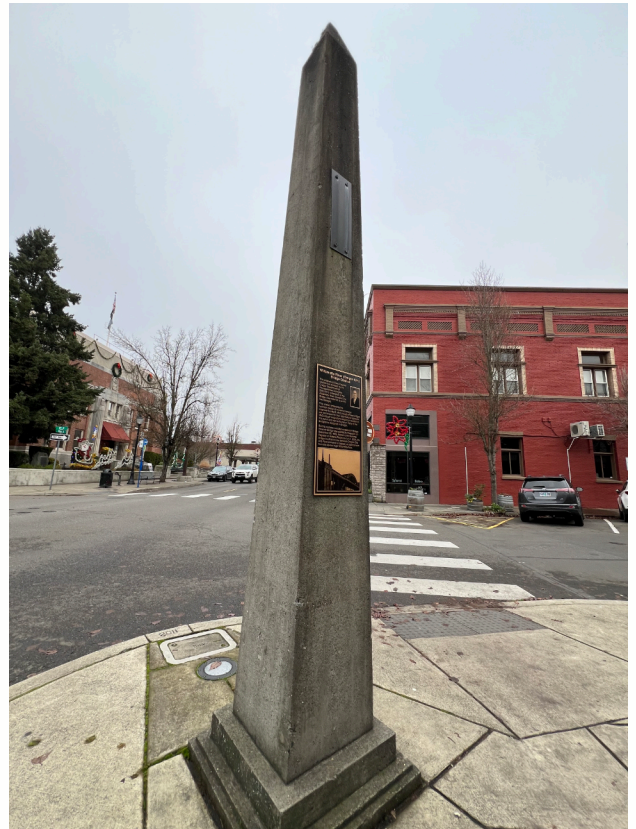
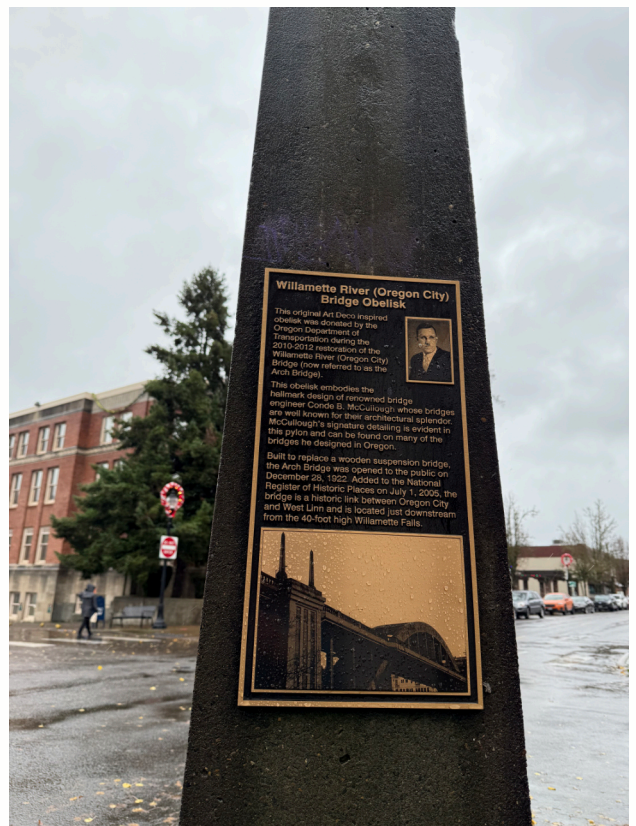
#27 “Willamette Compass” steel sculpture
by Brandon Zebold
Located at NW Corner of 8th and Main st
directly in front of the Courthouse
2012

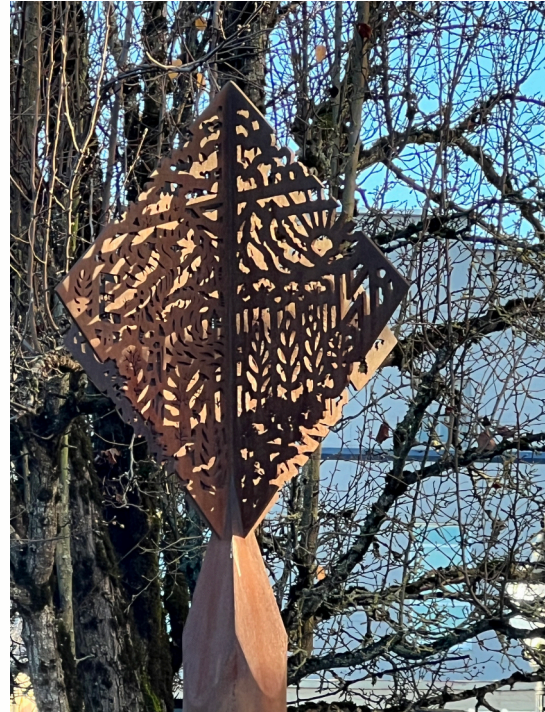
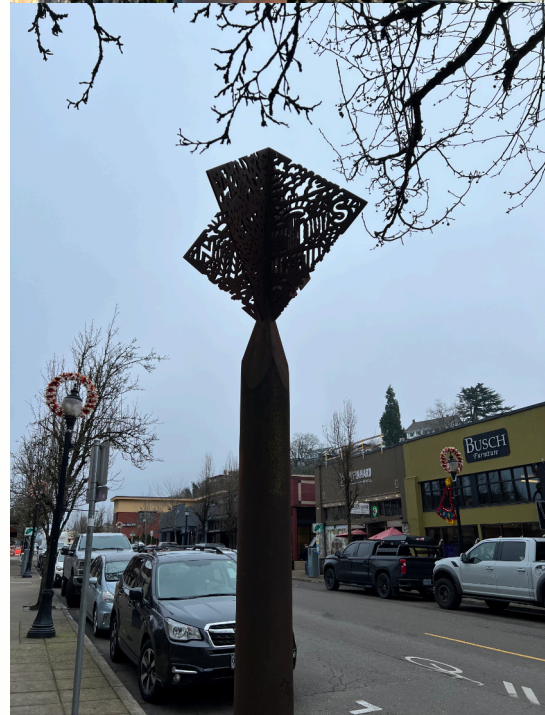
#28 “Oregon Trail Interpretive Signs”
by Security Sign
Located on Holcomb Blvd.
2013

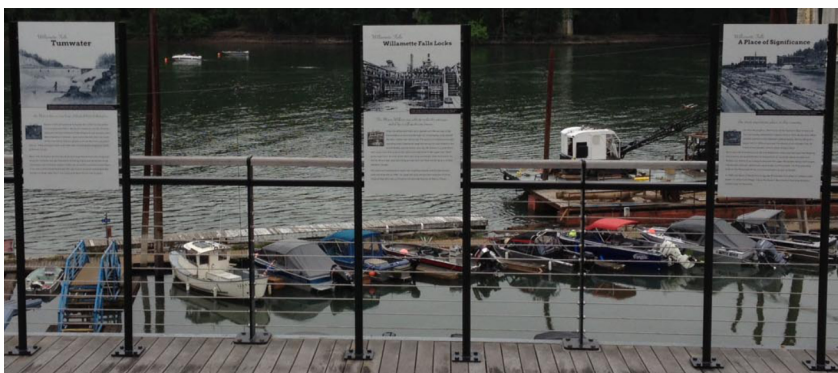
#29 “Willamette Terrace & Greenway Signs”
with artwork by BergerABAM Inc., fabricated by
Security Signs, and Installed by Todd Hess
Building Co.
Located along the Willamette Terrace
2012

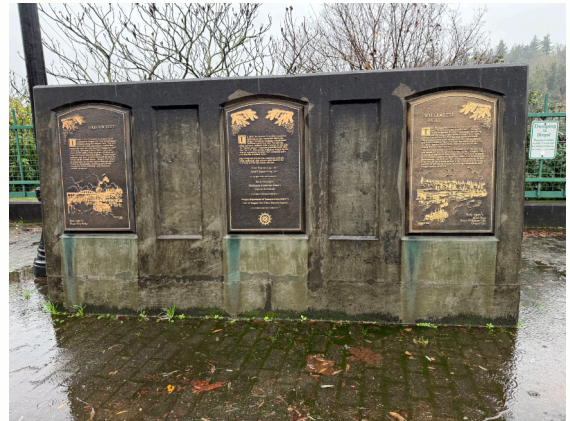
Cost \$4,356 in 2001. Funded by Urban Renewal. Not insured. Current value adjusted for inflation: \$7,639.

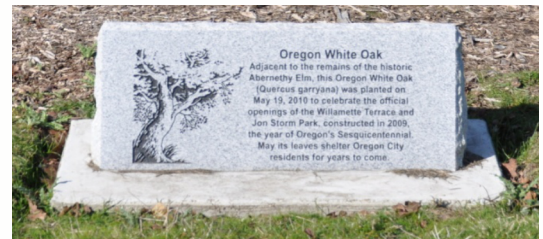
Cost \$779 in 2010. Funded by Parks SDC. Not insured. Current value adjusted for inflation: \$1,104.

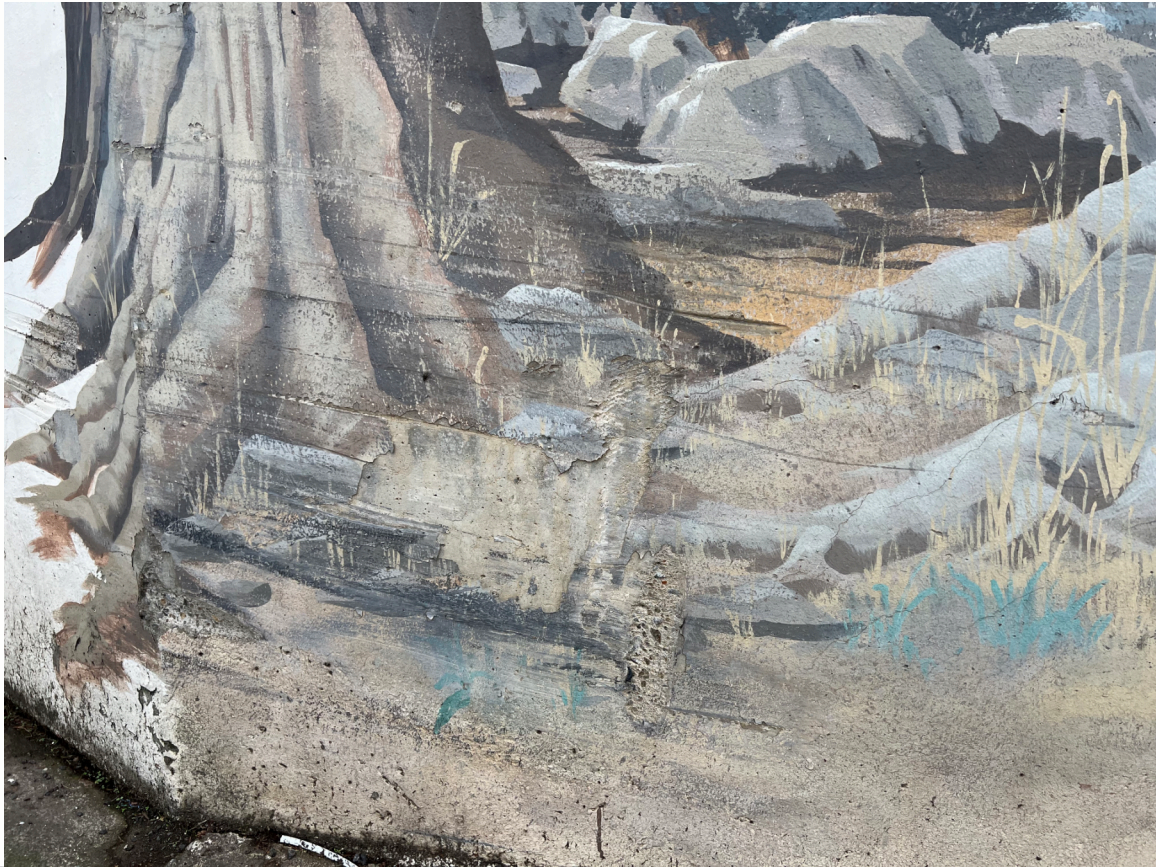
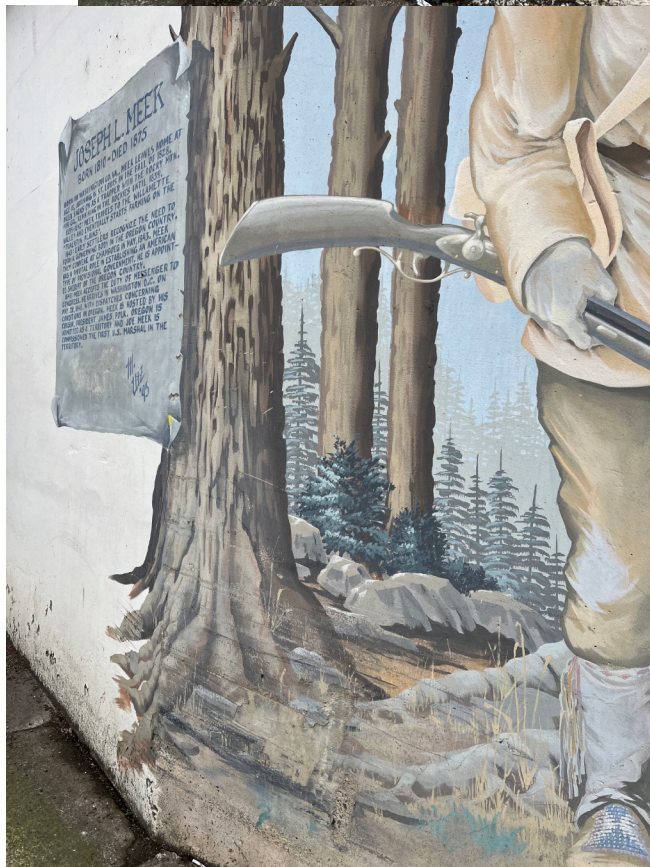
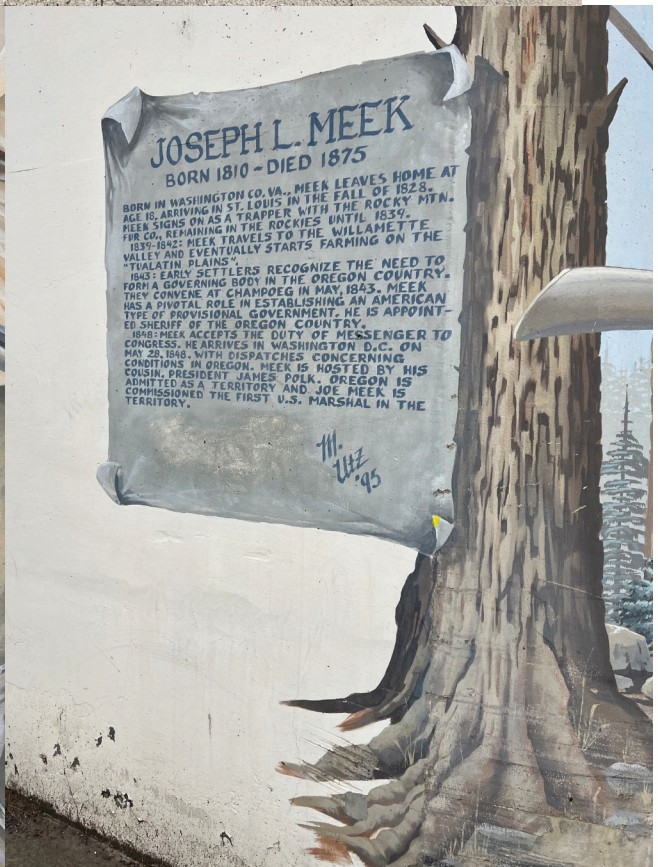
This mural is very faded but is in fairly good condition for an unprotected 30+ year old mural at street level. The fading has occurred in a uniform and even way. All words and lettering are clear and legible. There is an area on the “plaque” that appears to have some damage from previously removed graffiti. When this piece is compared to the image of the mural study (piece #11 in storage) one can easily see the degradation of colors over time. The wall itself appears to be in moderate condition with no substantial

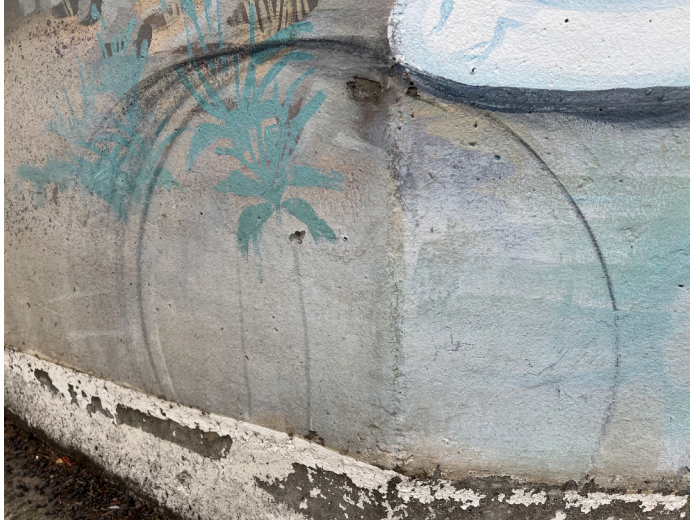
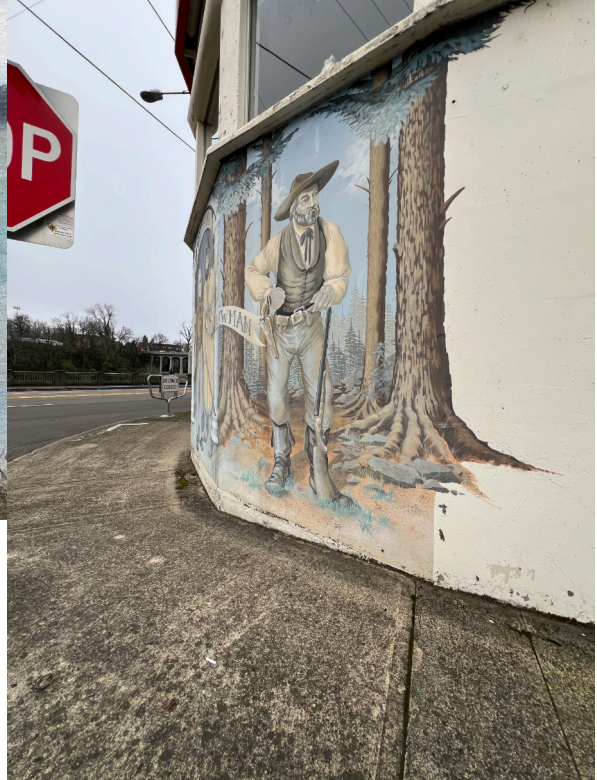
structural chips or cracks. There is a significant amount of wear and chipping on the wall just below the mural. There are a fair number of small chips (the size of a quarter or smaller) and pits (most smaller than a pea), but these are mostly superficial surface damage. The biggest area of damage is a spot on the lower left portion with significant scraping and scratches (likely from a vehicle). There is also an area with dark circles (likely from where a tire rubbed along the wall).

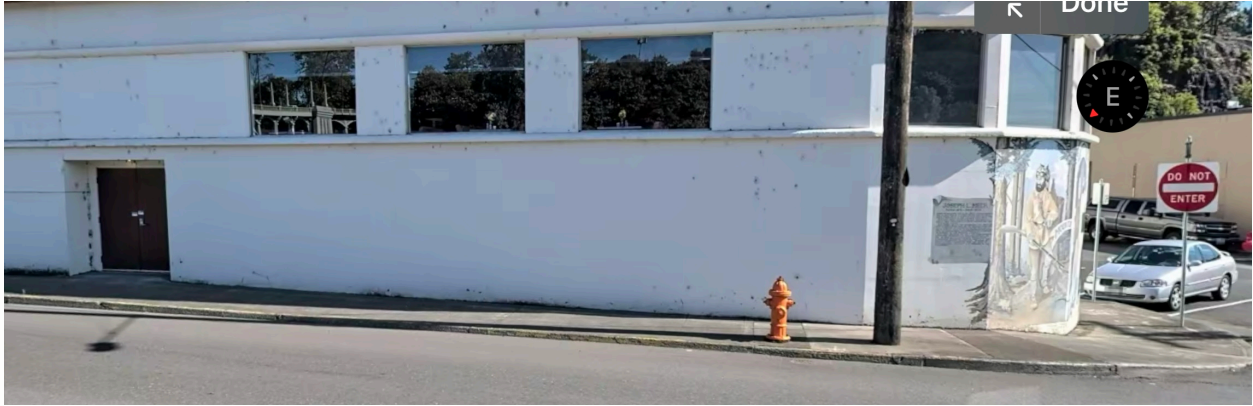
to the community? Does this mural accurately express their values? Would a different piece of art serve their purposes better?

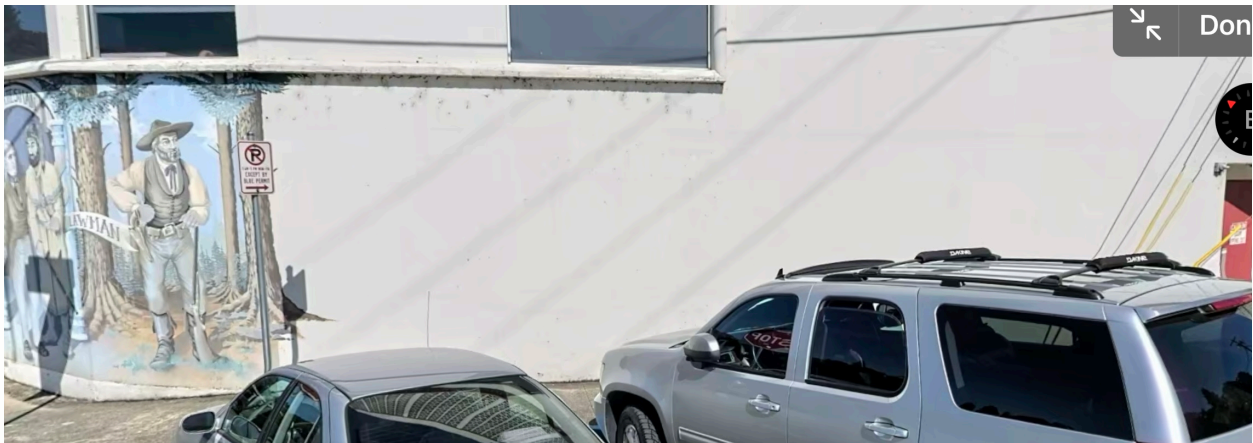
Estimate for Restoration of Joseph Meek Mural

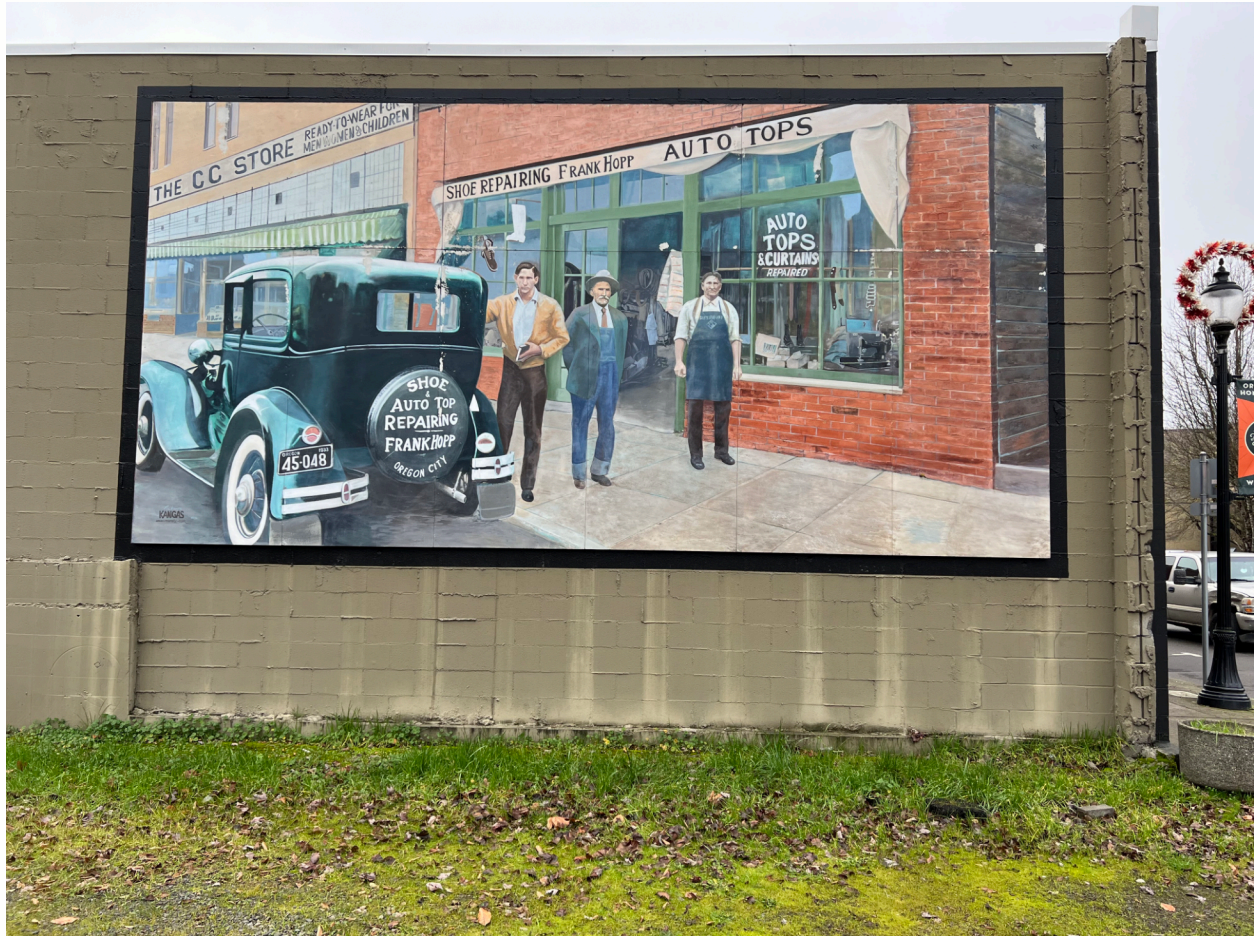
#34 “Hopp Family Photo” mural
by Larry Kangas, Roger Coke, and Leo Lauc
Located at 916 Main St.
1994
