CITY OF OREGON CITY ARTS COMMISSION AGENDA

City Hall Mt. Hood Room, 625 Center St., Oregon City, OR 97045
Thursday, January 15, 2026 at 6:30 PM

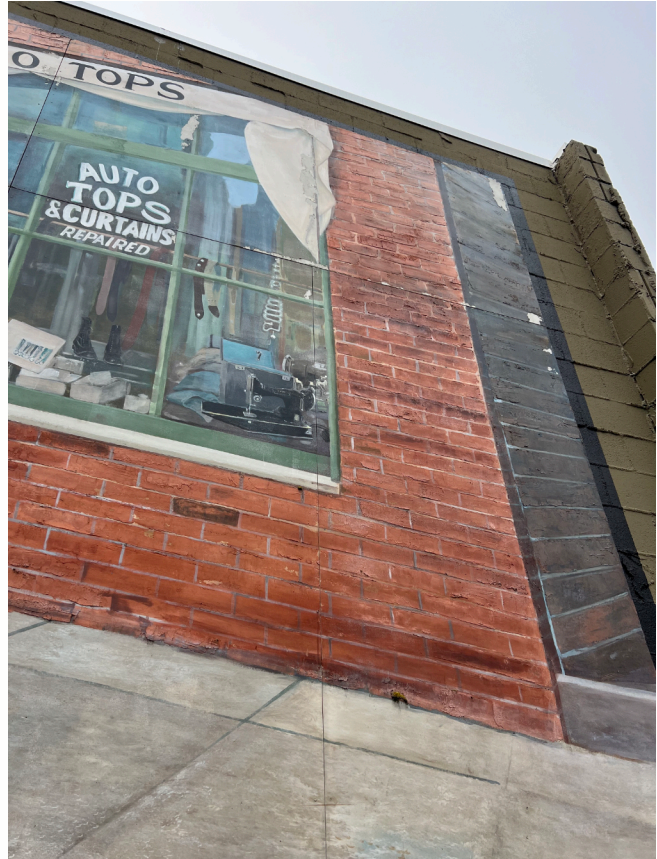
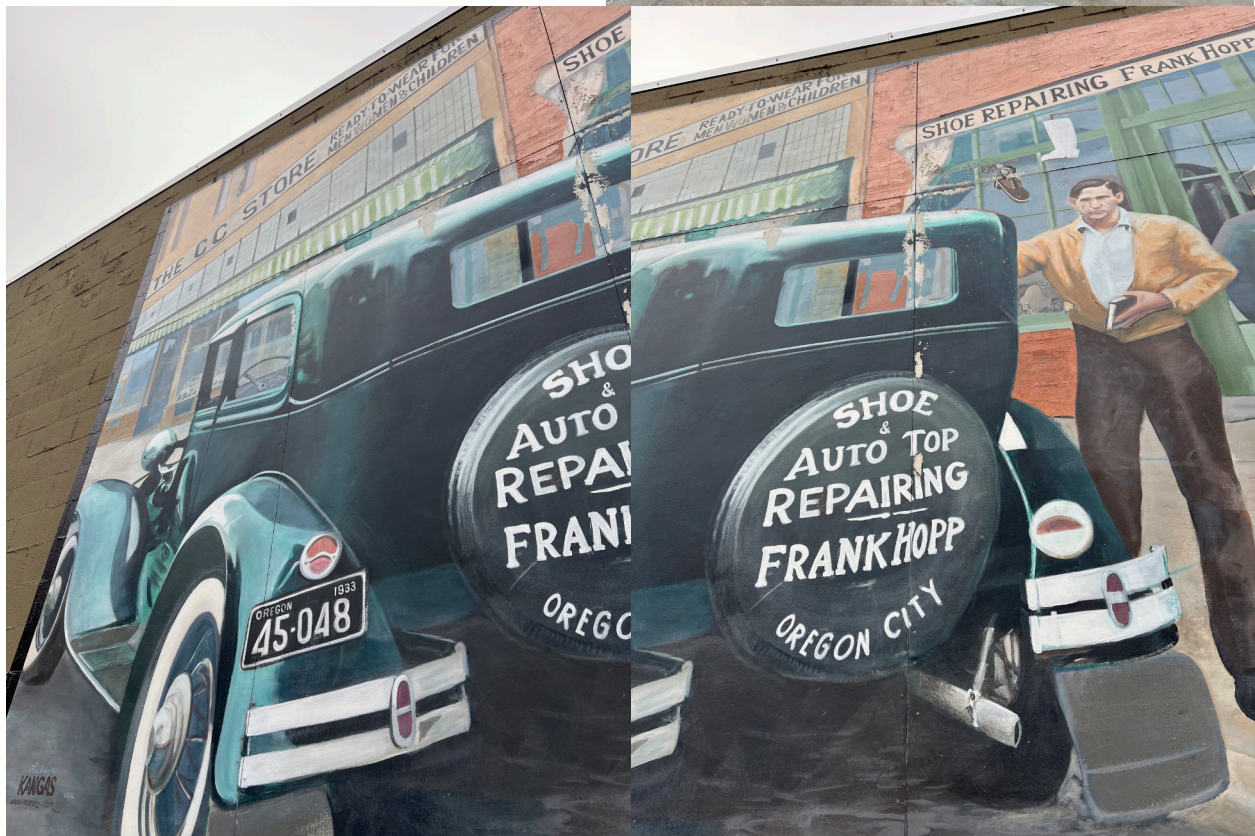
to be delicately cleaned so as not to damage the high texture paint (could be prone to cracking or chipping if cleaned aggressively). A study painting is listed as existing in storage (piece #12) which could be an excellent resource for any restoration endeavor. The chipping damage should be repaired soon to prevent further damage. The worst of the chipping is along the edges and mounting hardware, especially towards the top left. Once the restoration is completed a UV/anti-graffiti coating should be applied to slow and prevent future damage. Overall this mural is an excellent example of how well exterior grade paneling can work as a mural substrate for 30+ years of wear and weather. I recommend that this restoration occur within the next 2-5 years.

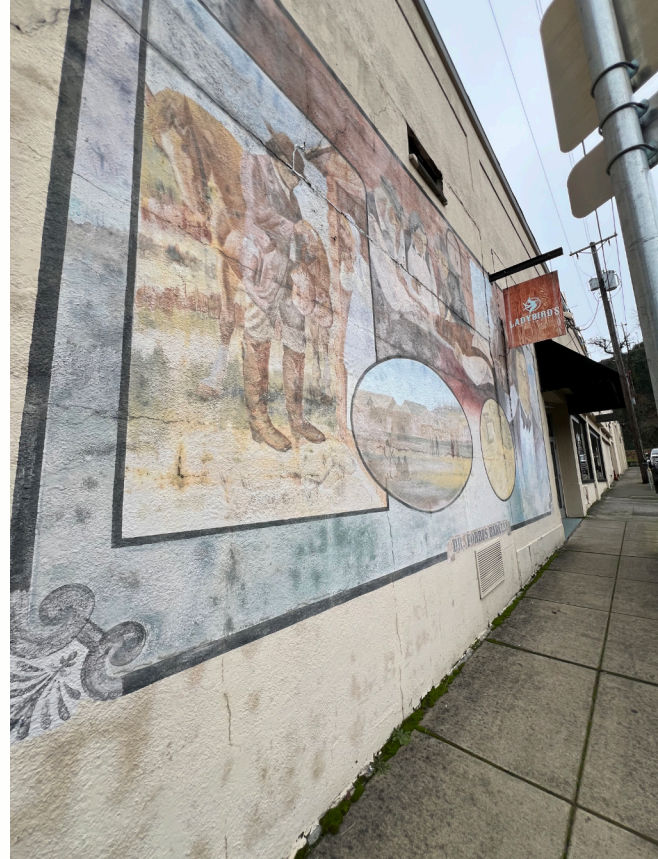
This mural is severely degraded on a

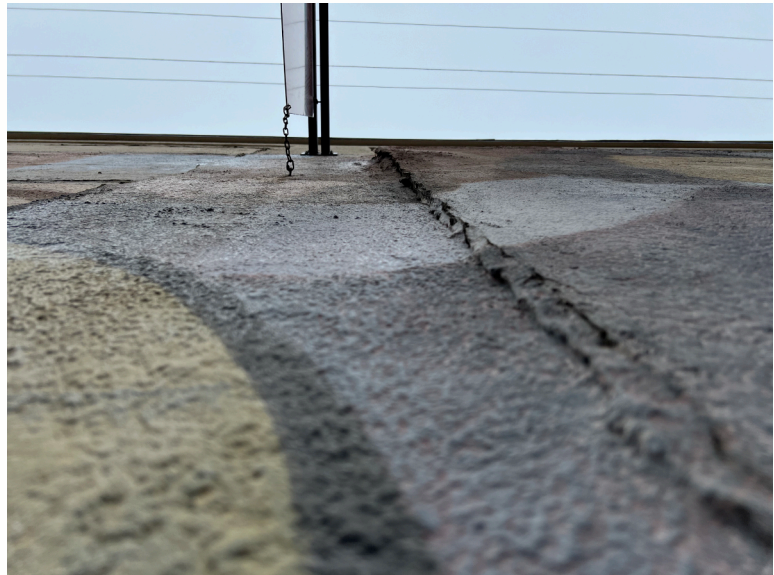
When observed in late 2025, this mural wall appeared to be in the process of being repaired. There were significant areas of patching, crack filling, and what appeared to be a structural brace. The wall is in a state that is structurally much better than it was in 2023. The state of the repair would still make this wall unfit for a mural restoration at this time.

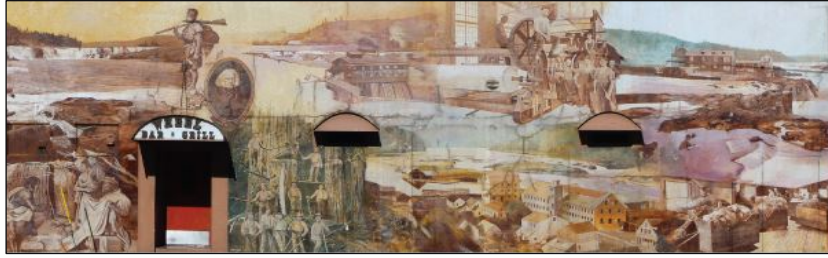
#37 “College Of History” mural
by Larry Kangas
Was located at 503 Main St.
1992

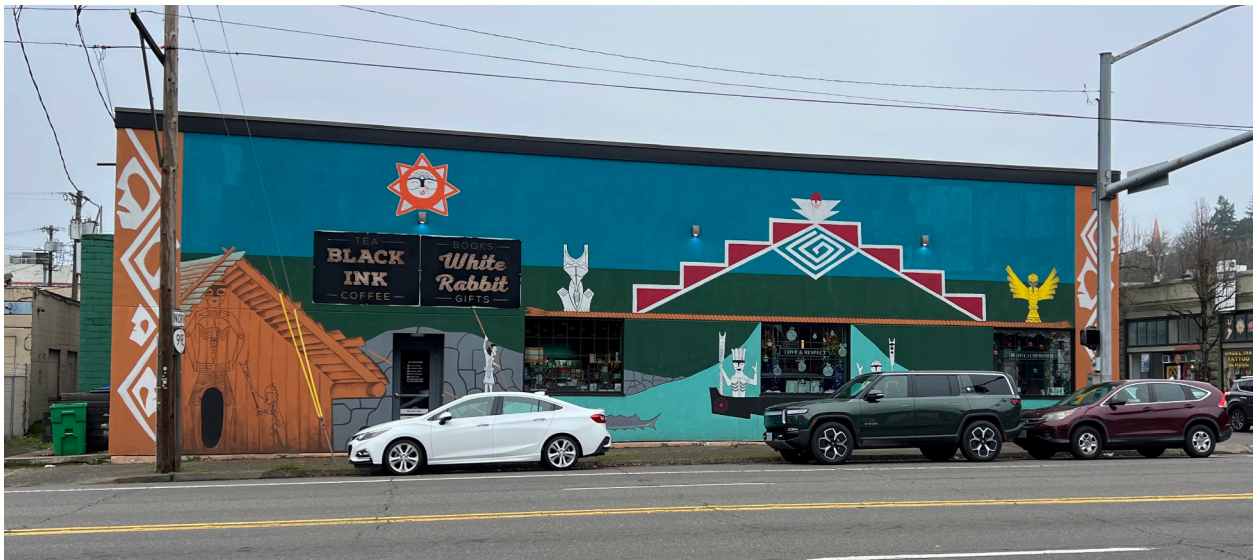
I recommend that the Public Works file be updated, placing the Larry Kangas mural on the “DEAD” list. To see the new listing for “Reflections of the Falls” go to listing #137.

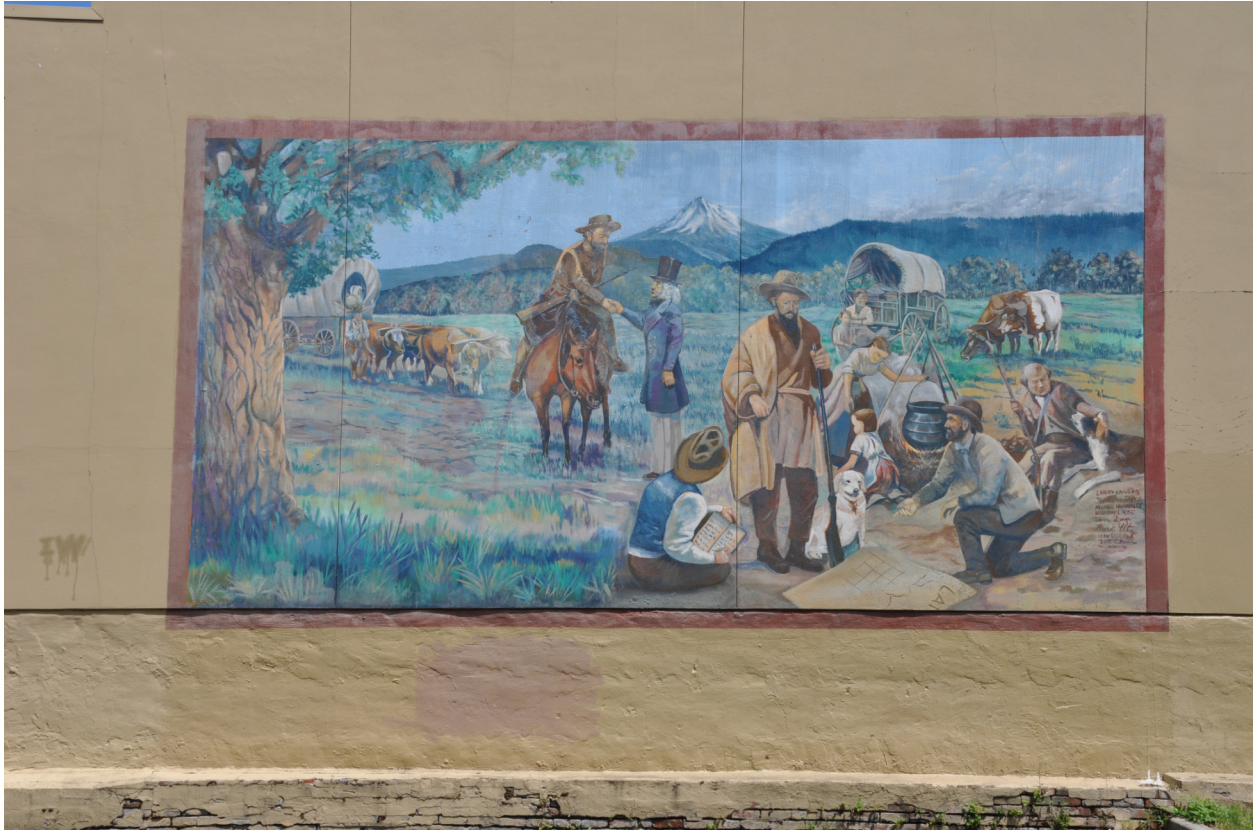
#38 “Abernathy Green” mural
by Larry Kangas, Michele Nunnally, Don ?
Was Located at 719 Main St.
date unknown (likely 1993)

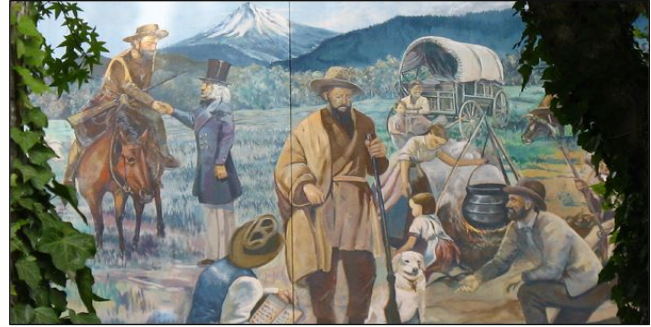
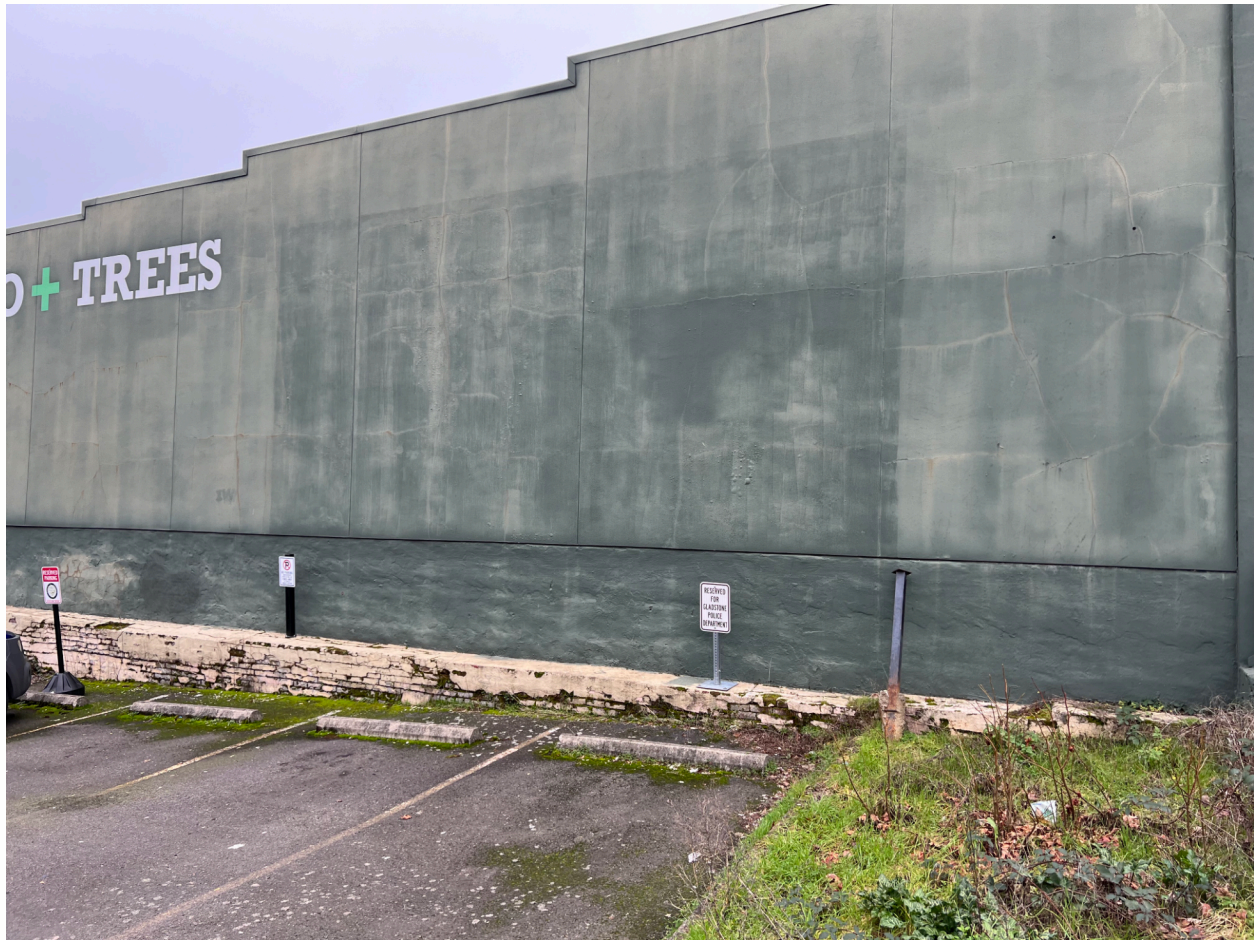
**#39 “Ripple Rack” sculpture:
“Spokes in Common”**

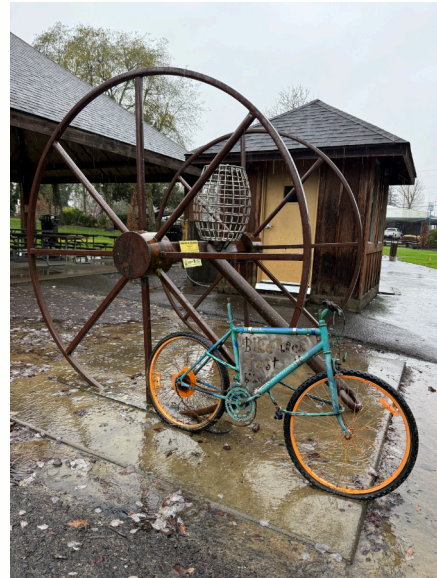
Cost \$3,500 in 2013. Funded by We Love Clean Rivers, Clackamas County Tourism & Cultural Affairs Development. Insured by Oregon City. Current value adjusted for inflation: \$4,667.

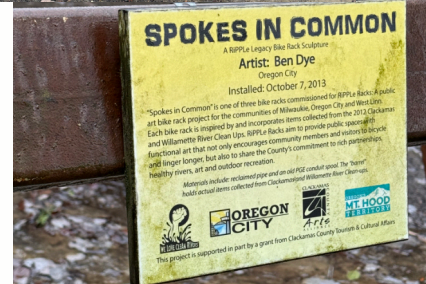
**#40? (Public Works file did not number this piece, but this number was missing) “The Last Stop” mural
by Roger Cooke
Was located at 1001 Main St.
Date unknown (“DEAD” list shows
“Removed 2014”)**

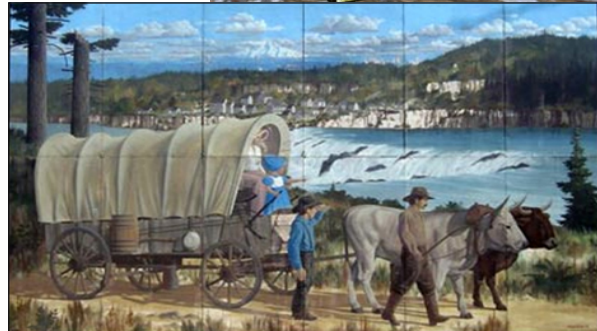
This mural shows a family during the final stages of their trip to Oregon City, standing on the West Linn side of the Willamette River. An interesting note is that the boy walking was modeled on the artist's son, Brady, and the little girl on the wagon seat was modeled after his daughter, Stephanie. It was unclear as to where exactly this mural was located.

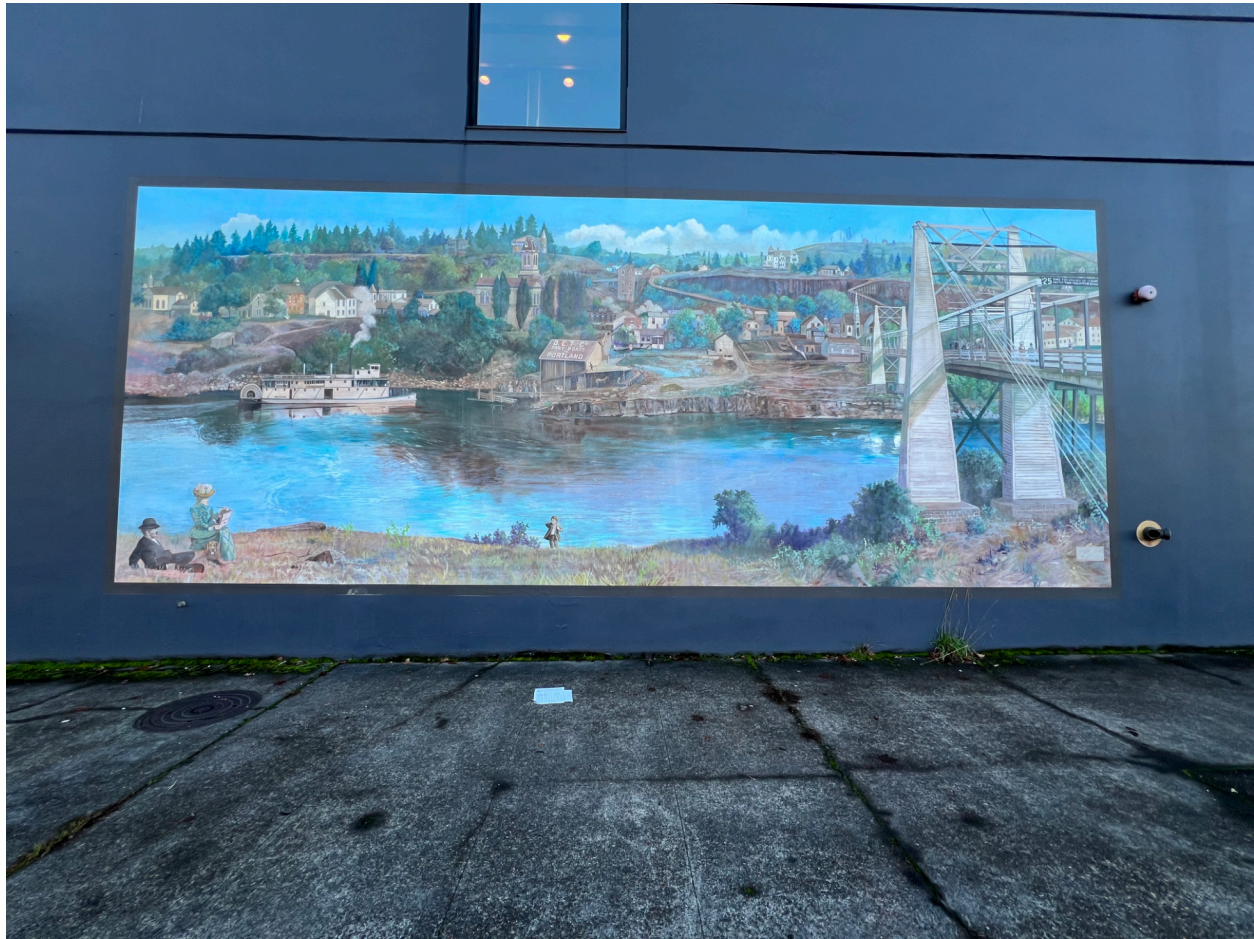
#41 “ OC Bridge Mural”
by Larry Kangas
Located at 502 7th St.
date unknown

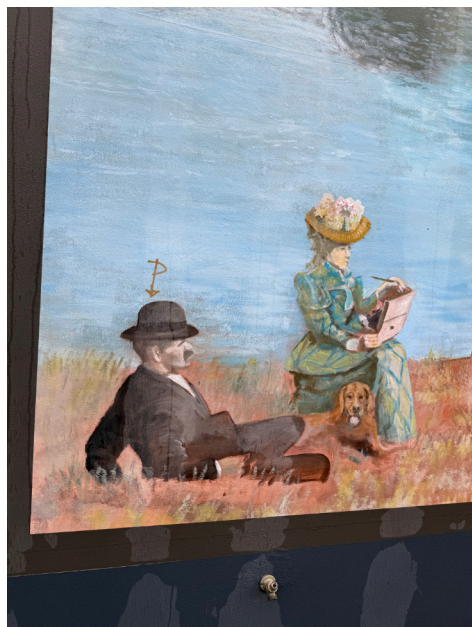
Condition note for 2025

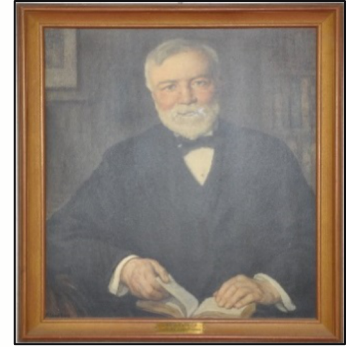
This portrait is a print of a painting of Andrew Carnegie, the main benefactor of the old Carnegie Library wing.

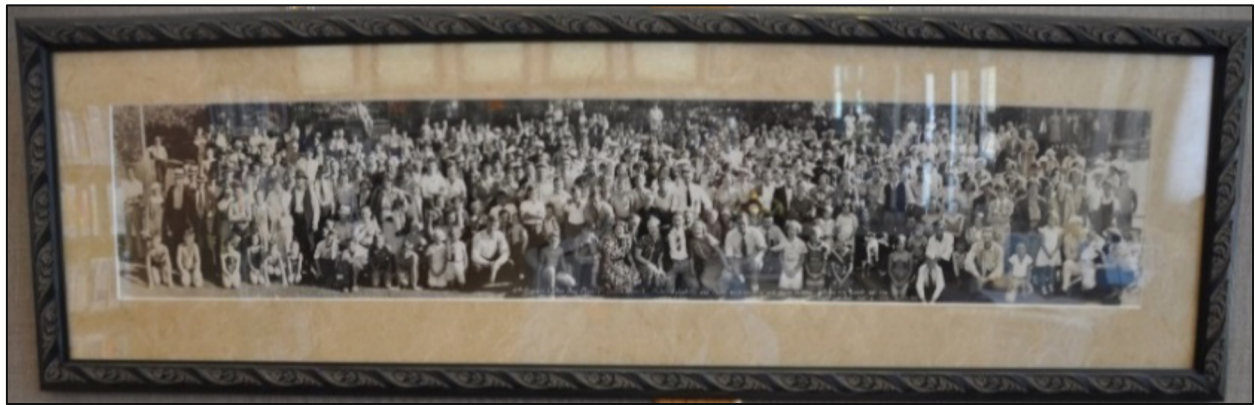
#43 "1979 photo of a company picnic at the mill"
Framed photograph
Located at 606 John Adams St. Library, Carnegie Wing

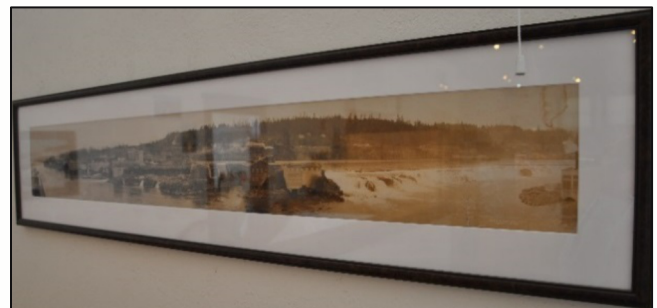
Historic photo take from West Linn of the Falls. Year unknown. I did not observe this piece in storage.

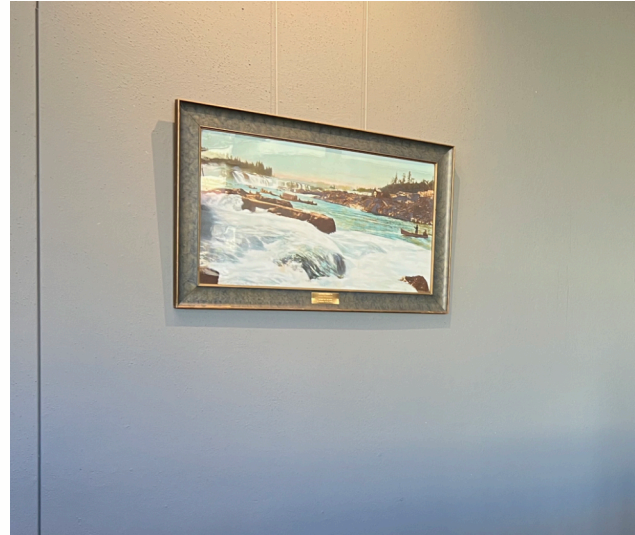
#46 “Public Library Historic Photo”
Located at 606 John Adams St. Library, Carnegie
Wing

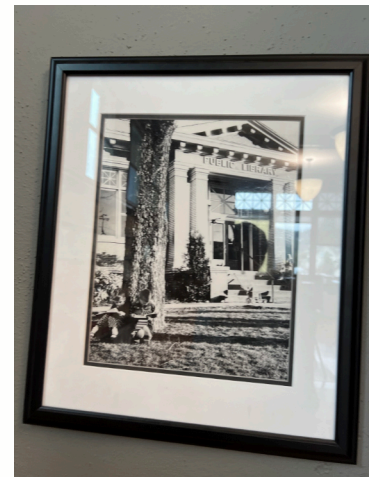
No value given. Not insured. Good condition.

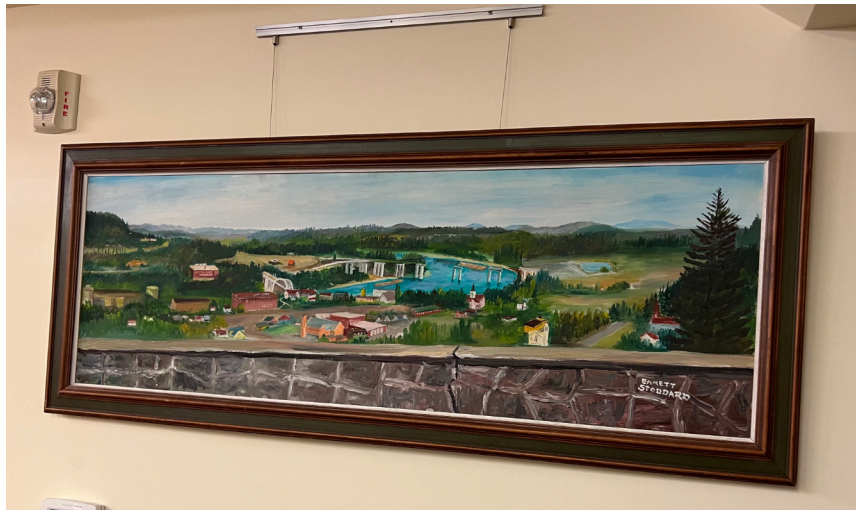
#65 "Prometory Ave Viewpoint" framed painting on canvas
by Emmett Stoddard
Located in City Hall 2nd Floor
Date unknown

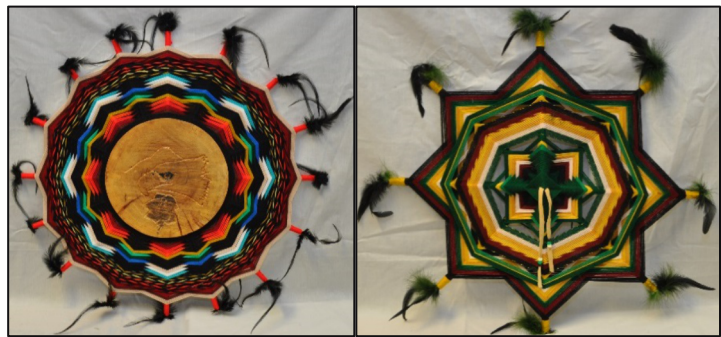
These pieces appear to be of indigenous design, but I could not find any specific information about them. I did not observe these pieces. Current condition is unknown.

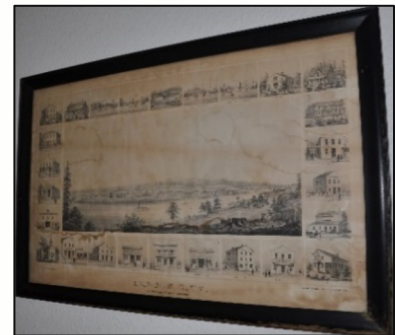
“Oregon City Buildings and Scenery 1858” appears to have some discoloration of the paper that may be from age, previous water damage, or poor handling at some point in its history. This piece may need an assessment to ensure that it is being kept in archival quality conditions. These pieces do not have dates listed in the Public Works document, but many likely have the dates on or with the physical item. No items have a listed or assessed value. None of these items are insured by the City.

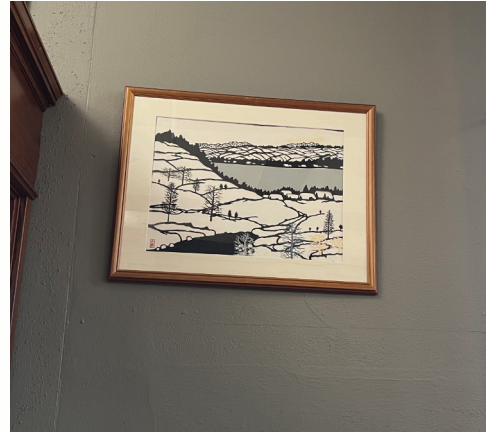
#104 “Landscape Print 2” Sister City Art
by unknown artist
Located at 625 Center St. City Hall
date unknown

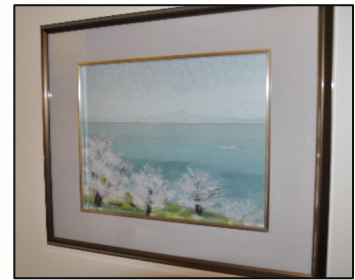
#105 “I-205 Aerial Photo 2”
Located at 625 Center St. City Hall
date unknown

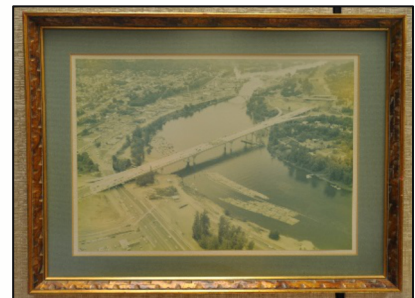
#106 “Ogle Mountain Mural”
by Dan Cohen
Located at 1001 Main St.
Date unknown

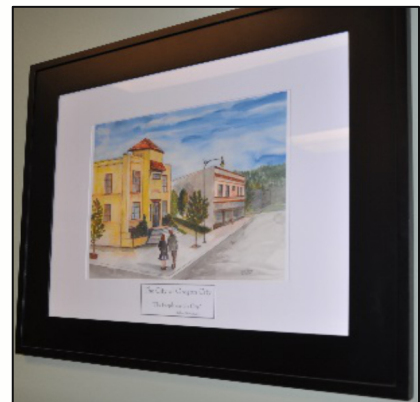
#108 “Street Lamp Art A-L”

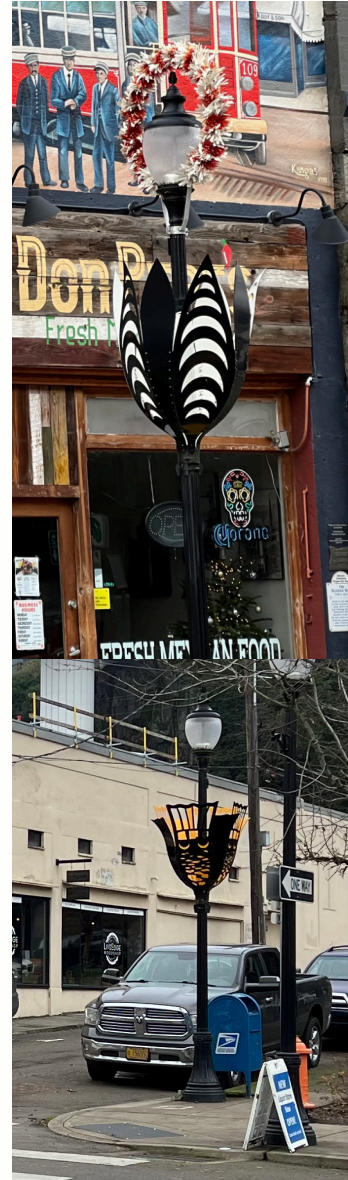
#109 “Storm Drain Photo”
Located at 625 Center St. City Hall
date unknown

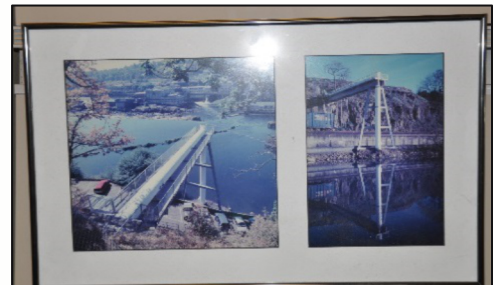
Not observed. Current condition is unknown. I attempted to locate this piece in City Hall, but was advised that this may have been moved to the Public Works Building on 1st St..

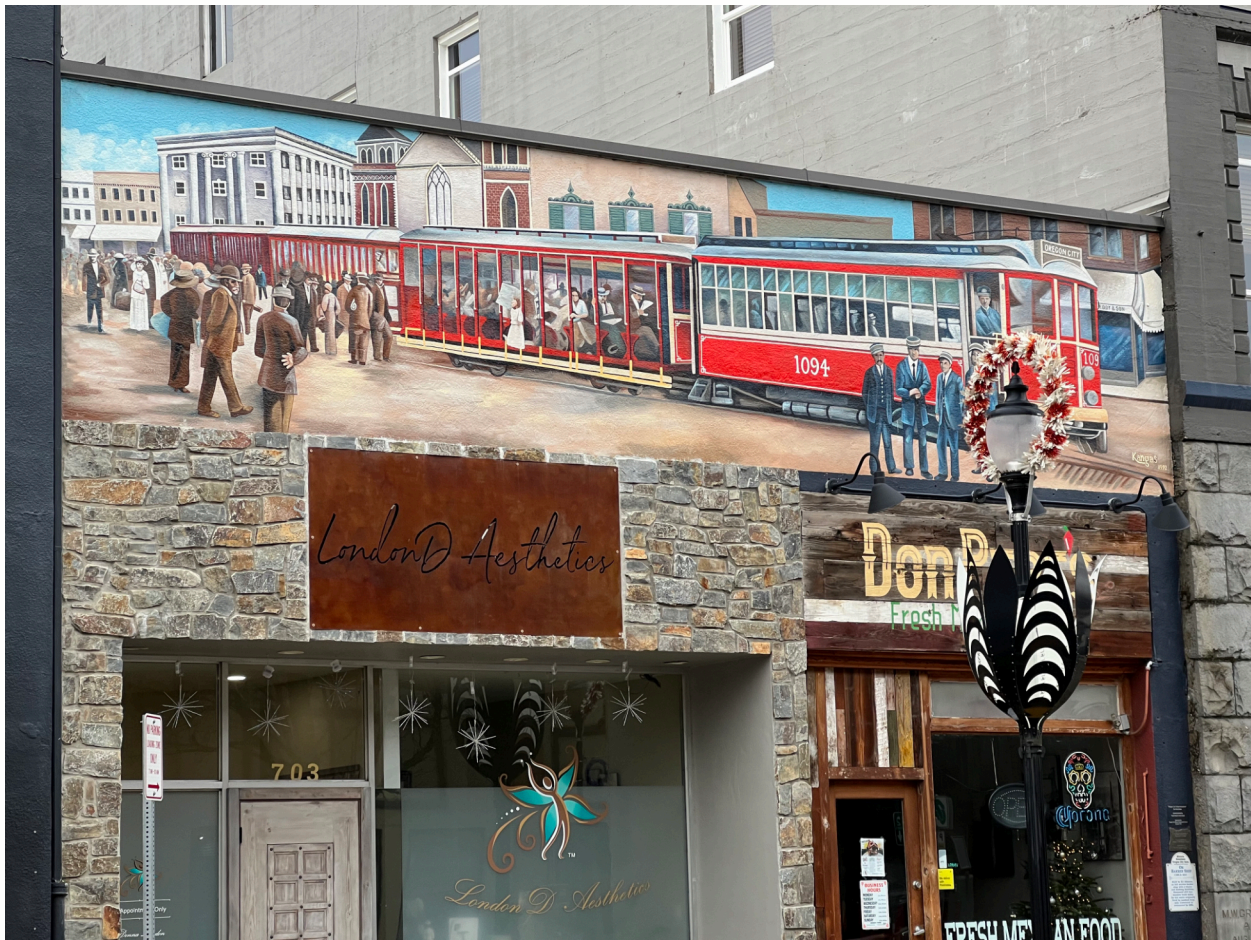
#110 “Main Street Trolley Mural”
 by Larry Kangas
 Located at 705 Main St.
 date not listed in Public Works document (1992?)
 restoration by Cathy Rowe in 2021

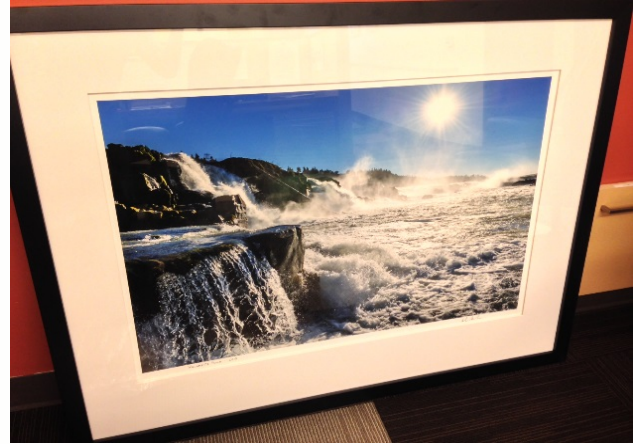
I did not observe this piece. Current condition is unknown.

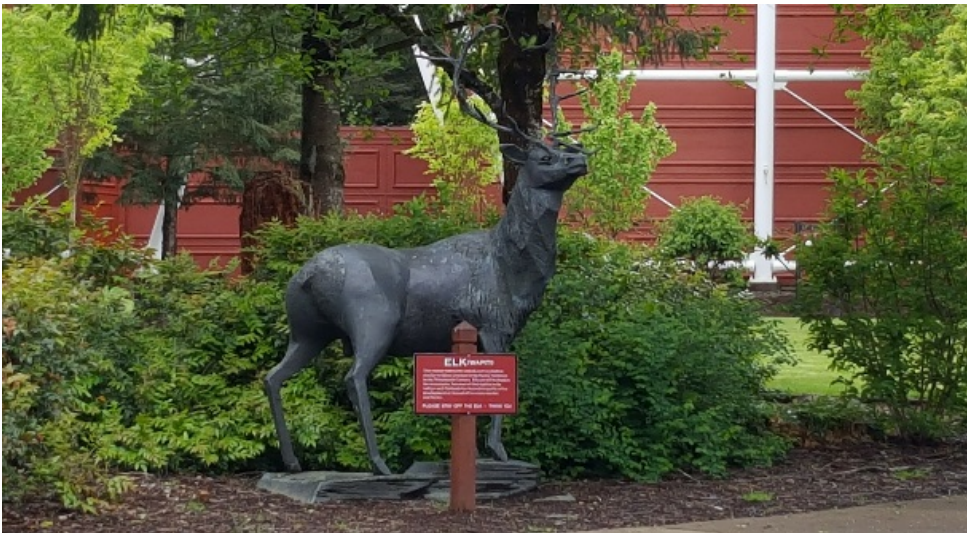
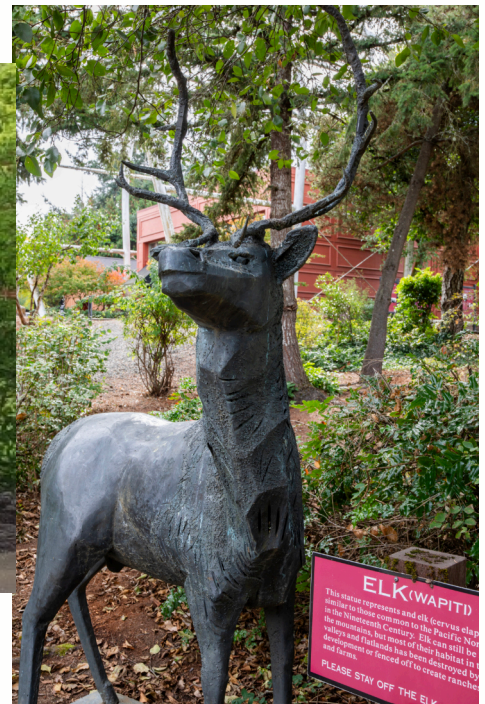
#112 “Elk Statue” bronze statue by unknown artist
Located at 1726 Washington St.,
the End of the Oregon Trail Interpretive Center
2002

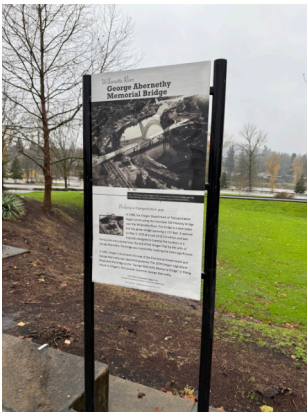
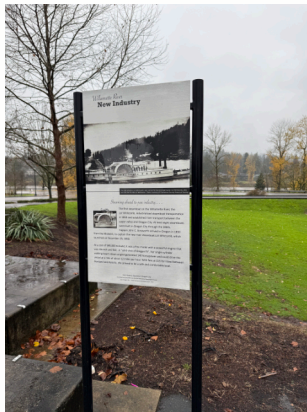
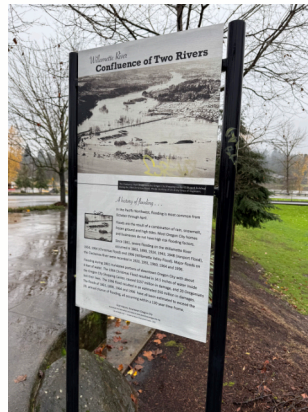
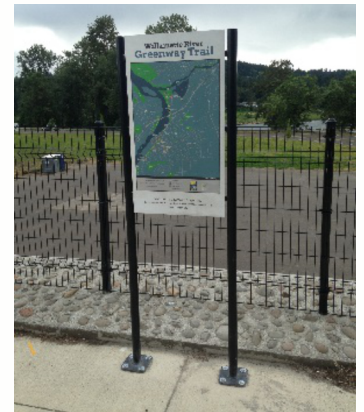
#113 "Willamette River & Greenway Signs" fabricated by Security Signs

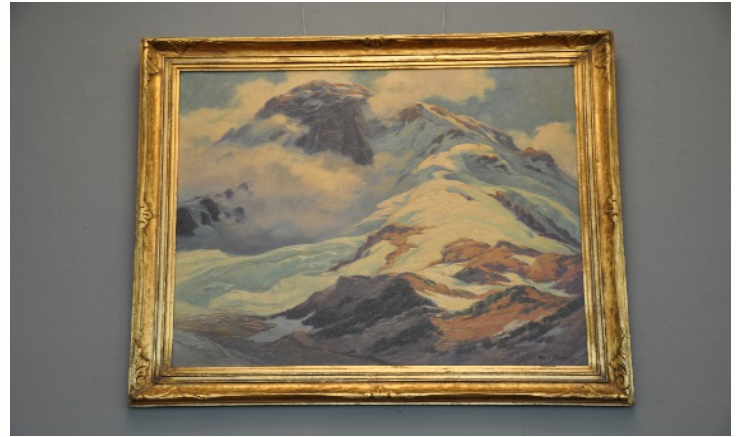
This oil on canvas painting is listed as being in storage in the library basement.

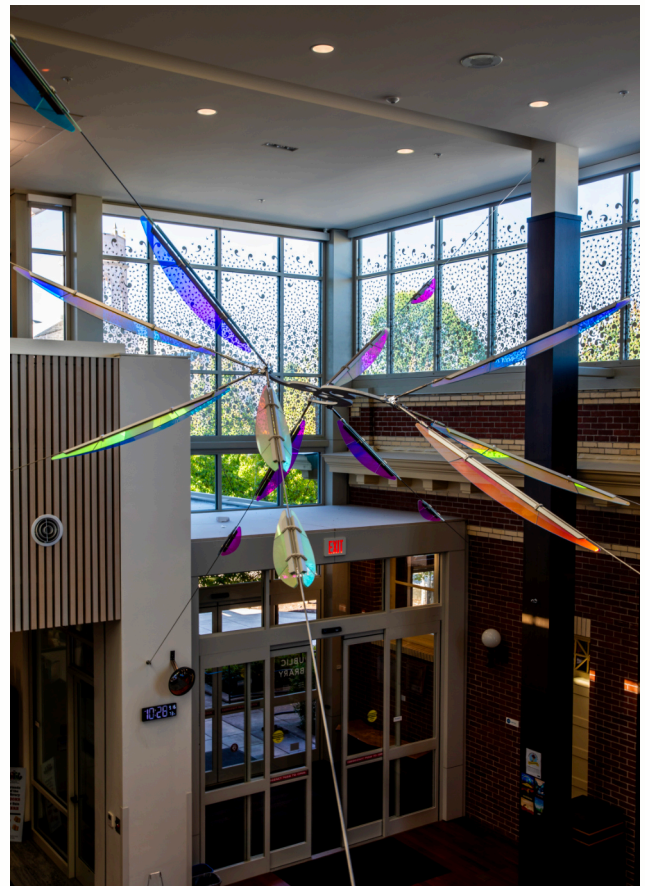
#117 “Top Hat Display”
Top Hat and Late Notice
Located at 606 John Adams St.,
Library, New Wing
date unknown

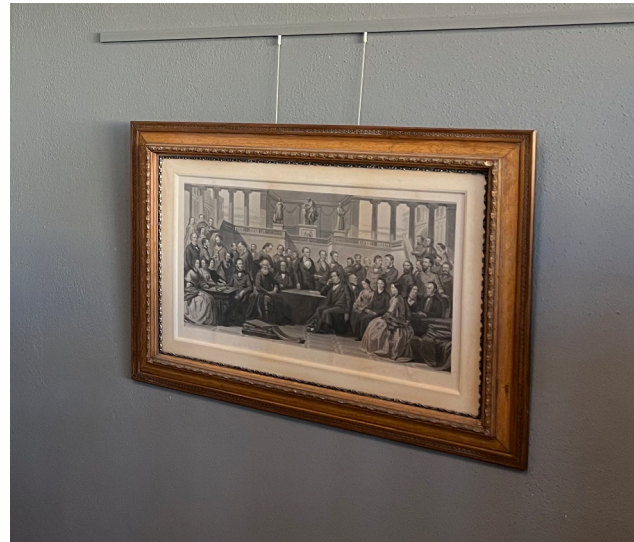
No value listed. Not insured.

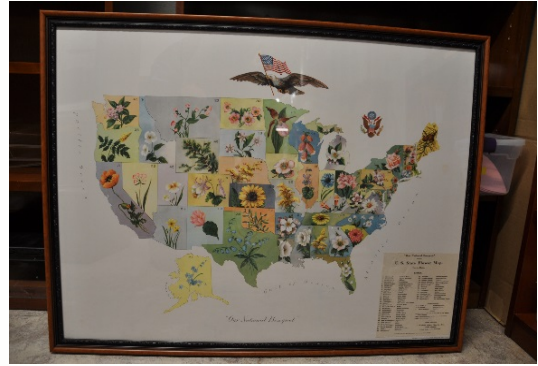
Colorful print or colored pencil illustration of the United States depicting the state flowers with each state.

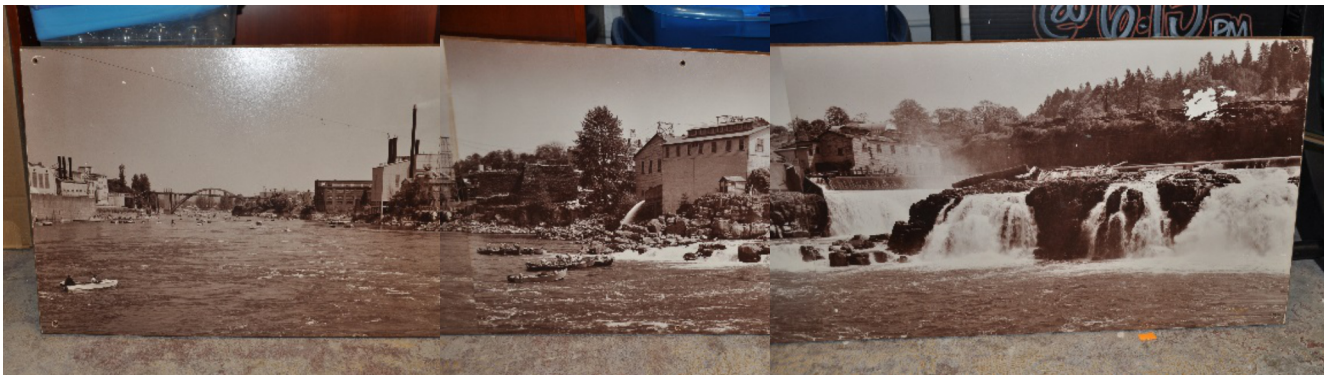
#120 “Willamette Photograph”
Unknown Photographer
Located at 698 Warner Parrott Rd. Community Development
Unknown date

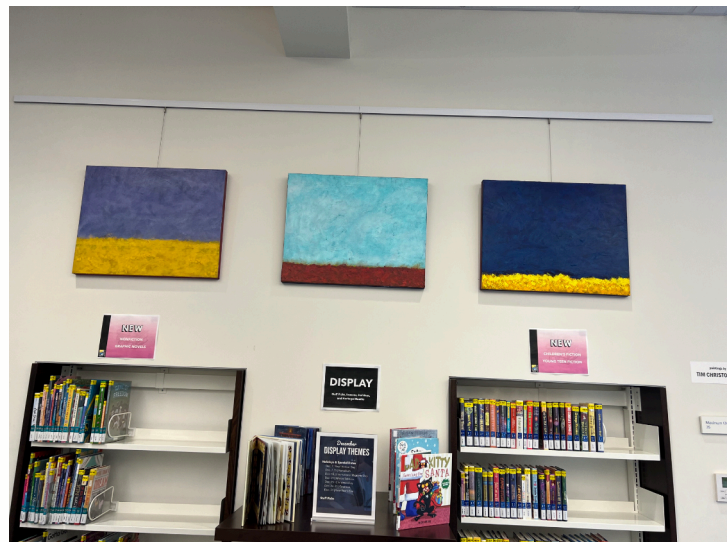
This collection of three unframed paintings on canvas by Tim Christopher. Each painting is about 18x24. Each piece is a different color field style in a landscape format.

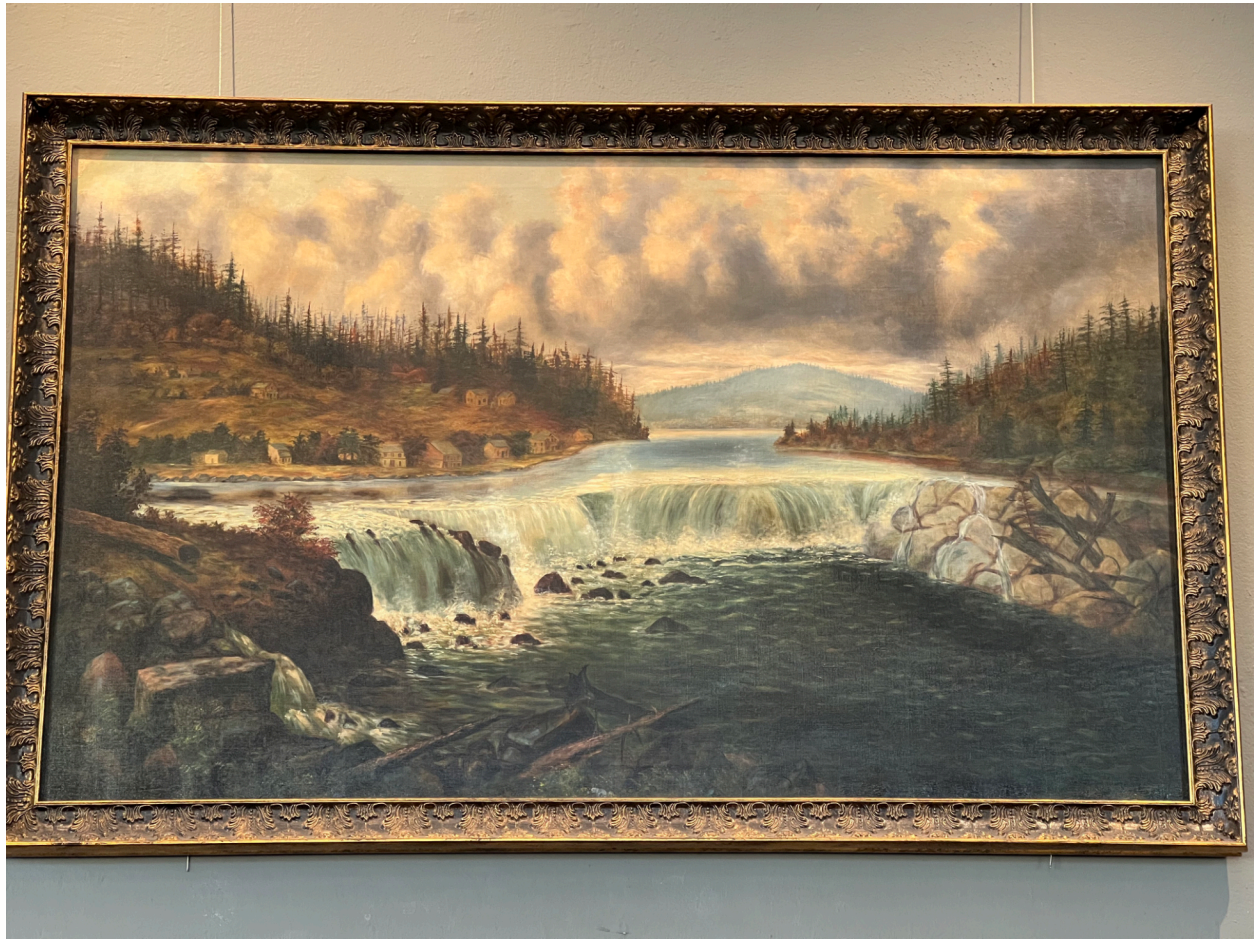
#123 “Willamette Falls” painting by an unknown artist
Located at 606 John Adams St., Library, Carnegie Wing
c. 1900

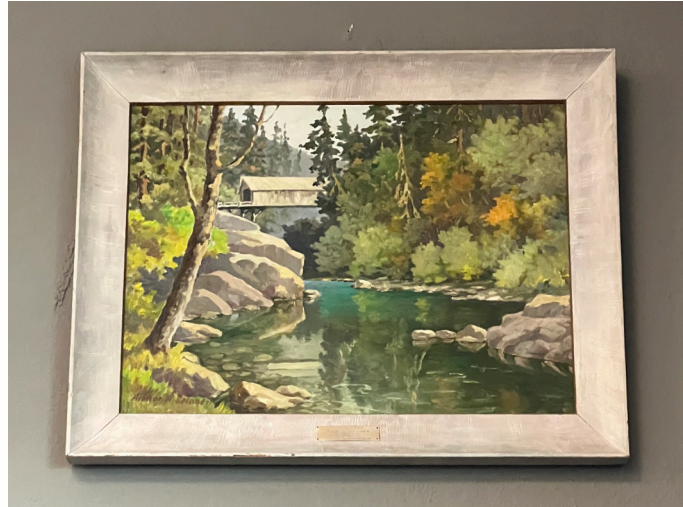
This oil on canvas piece shows a lush river scene with rocky banks and a covered bridge in the background. The painting appears to be an impressionist style and is framed in a silver gilt wood frame with a small plaque. The plaque is difficult to read but may say: “In Memory of Thora B. Gardiner...”. The lower portion of the plaque may reference the “Oregon City Women’s Club” but it is difficult for me to read.

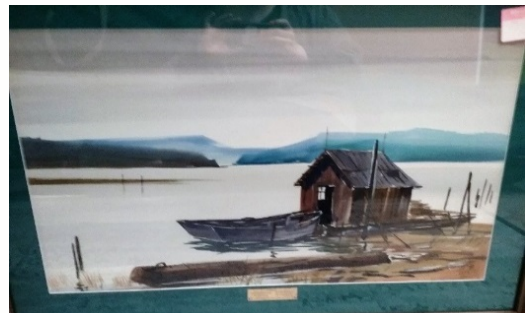
I could not tell if this realistic landscape was photograph, watercolor, or drawing from the image given. Piece is matted and framed with a plaque that reads: “In memory of Gertrude Brumbaugh, Virginia Cookem Dorothy AcAnulty, Charlolotte Weaver”.

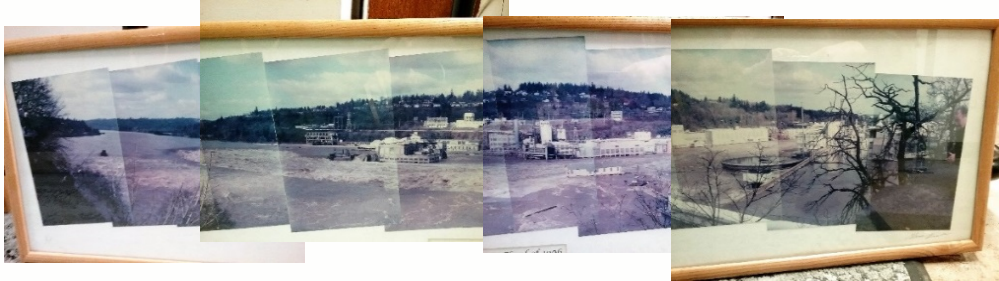
#127 "The Great Flood of 1996" panoramic photograph
by unknown photographer
Located at 606 John Adams St., Library, Basement
1996

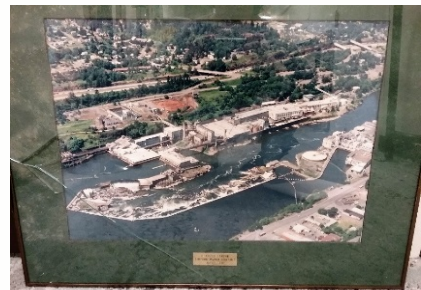
Aerial Photograph Titled "Charles Devore Simpson Paper Company 1951-1991". The Public Works file notes that this piece has broken glass that may be sharp “GLASS FRAME IS BROKEN BE CAREFUL!!”.

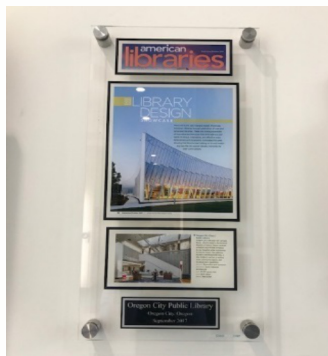
#134 “American Libraries Design Award”
Located at 606 John Adams St., Library, New Wing
2017

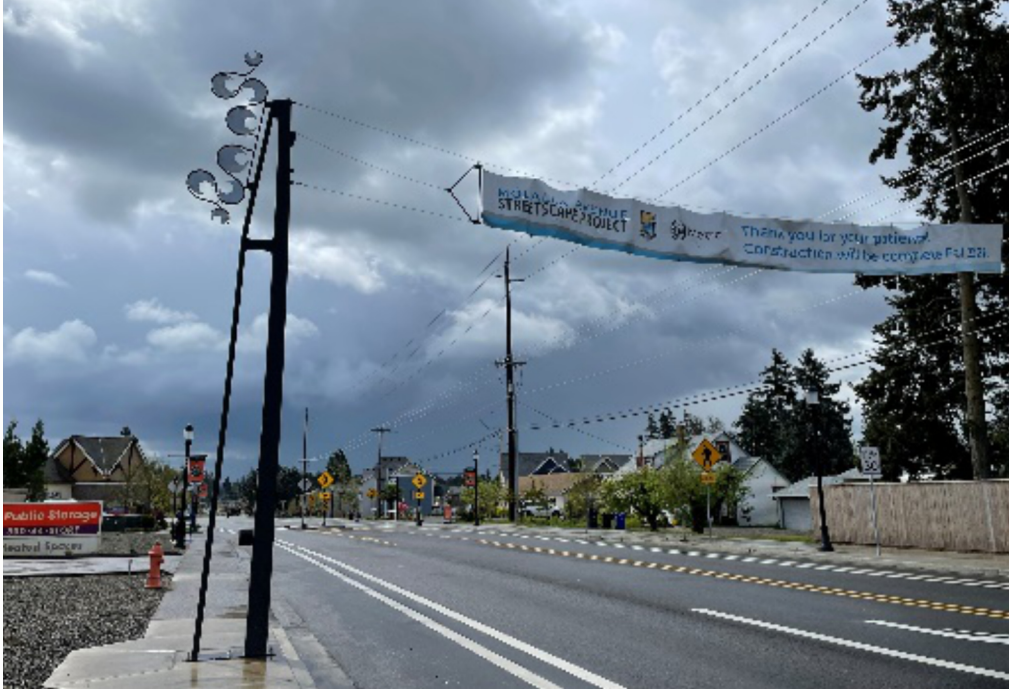
#136 “Cascading Moons” Molalla Cross Street Banner Art
by Ben Dye
Located at 19426 Molalla Ave. South of Chaz Diaz Dr.
2022

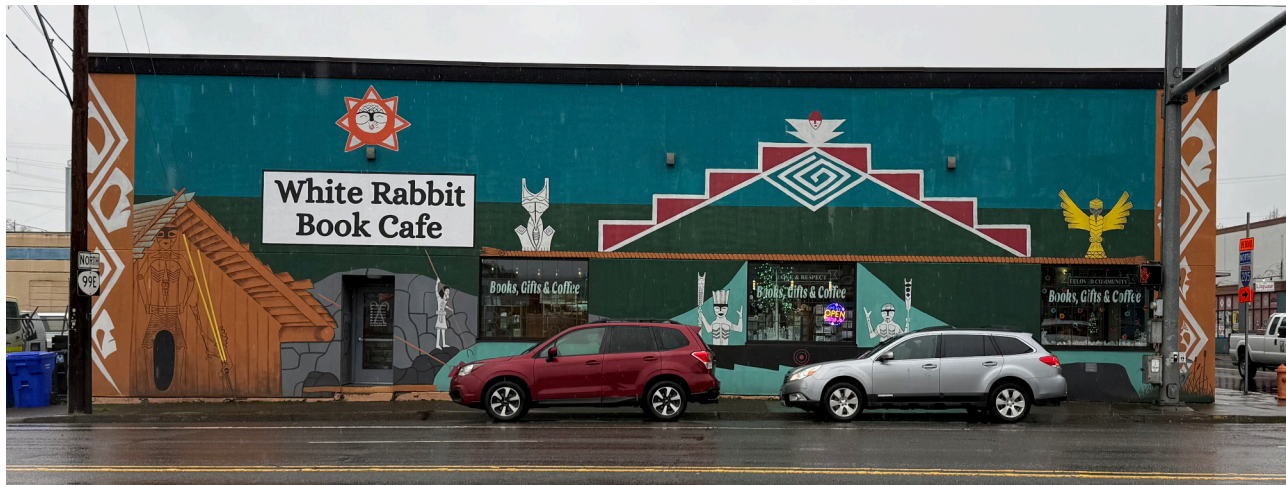
#137 “Reflections of the Falls” Mural

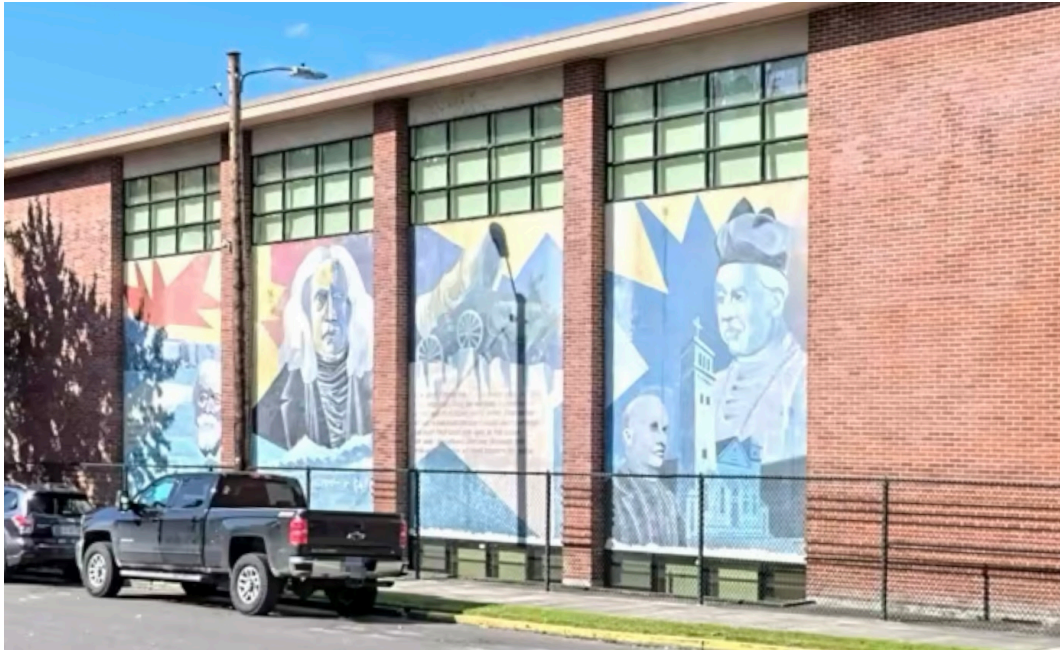
#138 “A Clackamas Indian’s Query” Mural
