CITY OF OREGON CITY ARTS COMMISSION AGENDA

City Hall Mt. Hood Room, 625 Center St., Oregon City, OR 97045
Thursday, January 15, 2026 at 6:30 PM

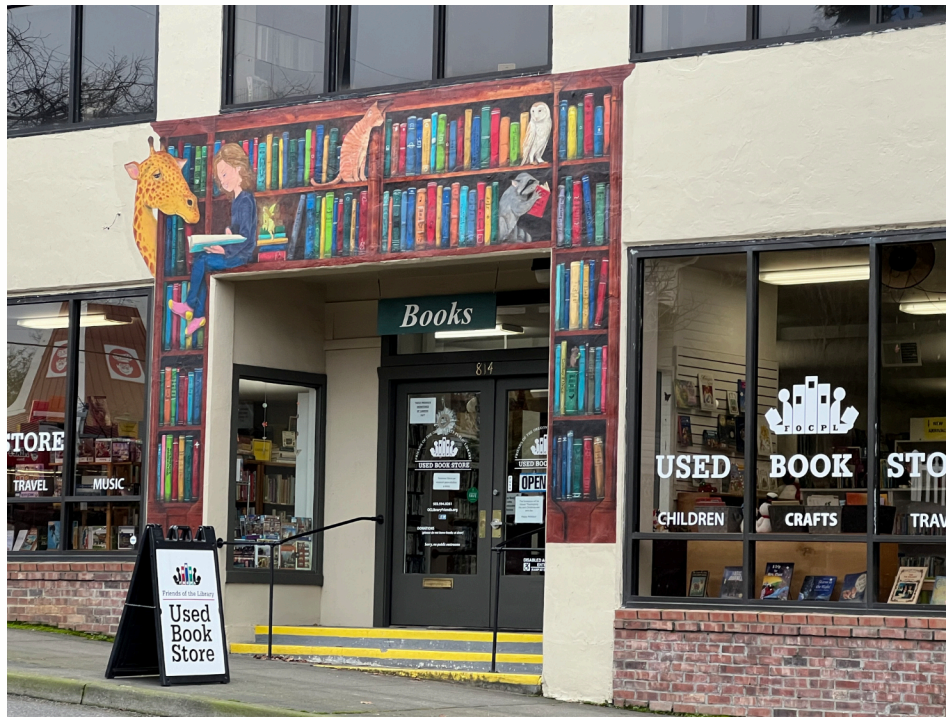
#139 "Friends on a Shelf" Mural

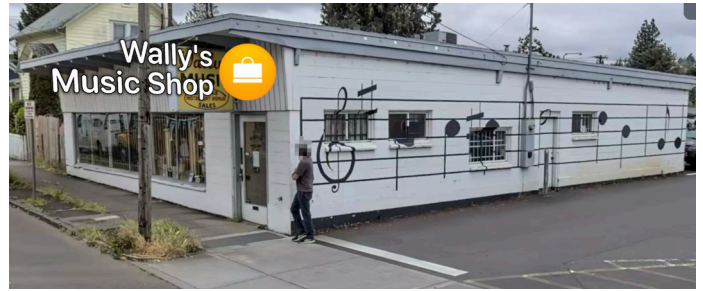
This mural shows a line of music on a staff with a treble clef and several notes. The music does not appear to match any known musical piece, but could be a part of a classical music progression warm-up. This seems likely for a music store. The bold design make this mural highly visible from a distance, but the interruption of windows take away from the visual impact and make the music more difficult to read.

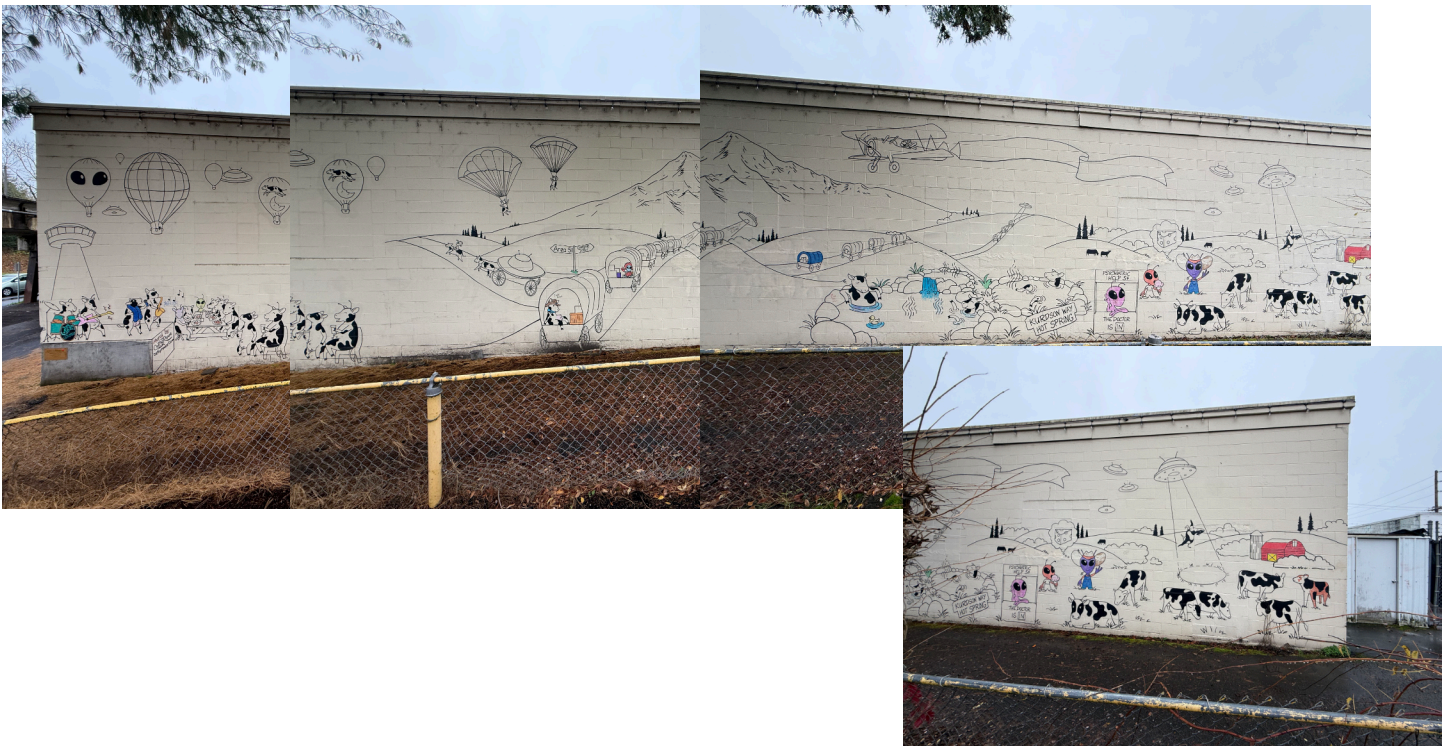
#143 “Elemental Love” Sculpture

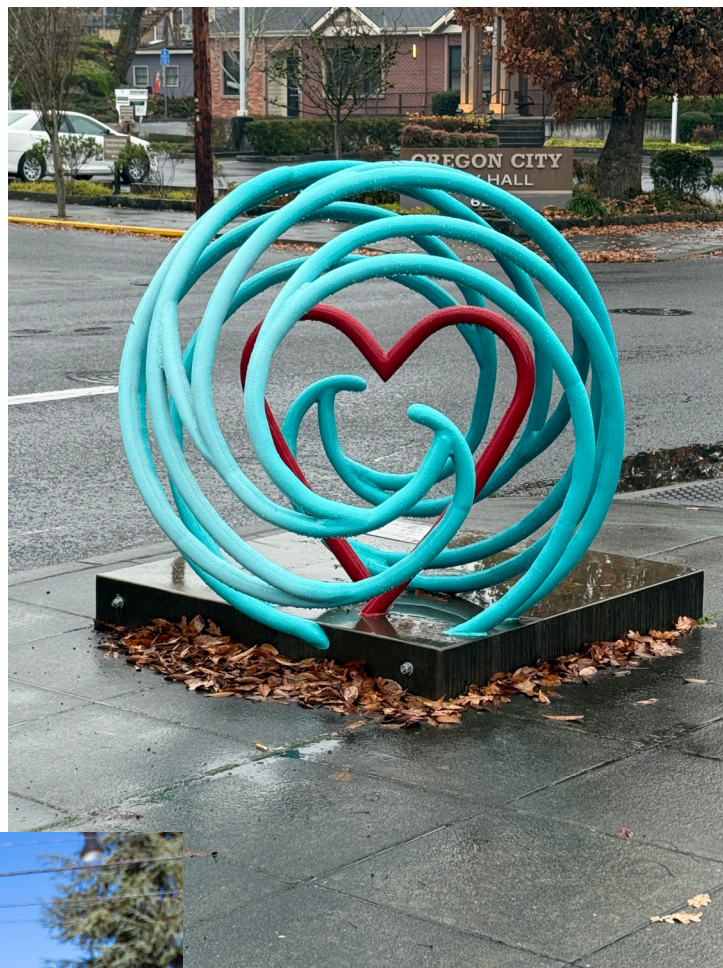
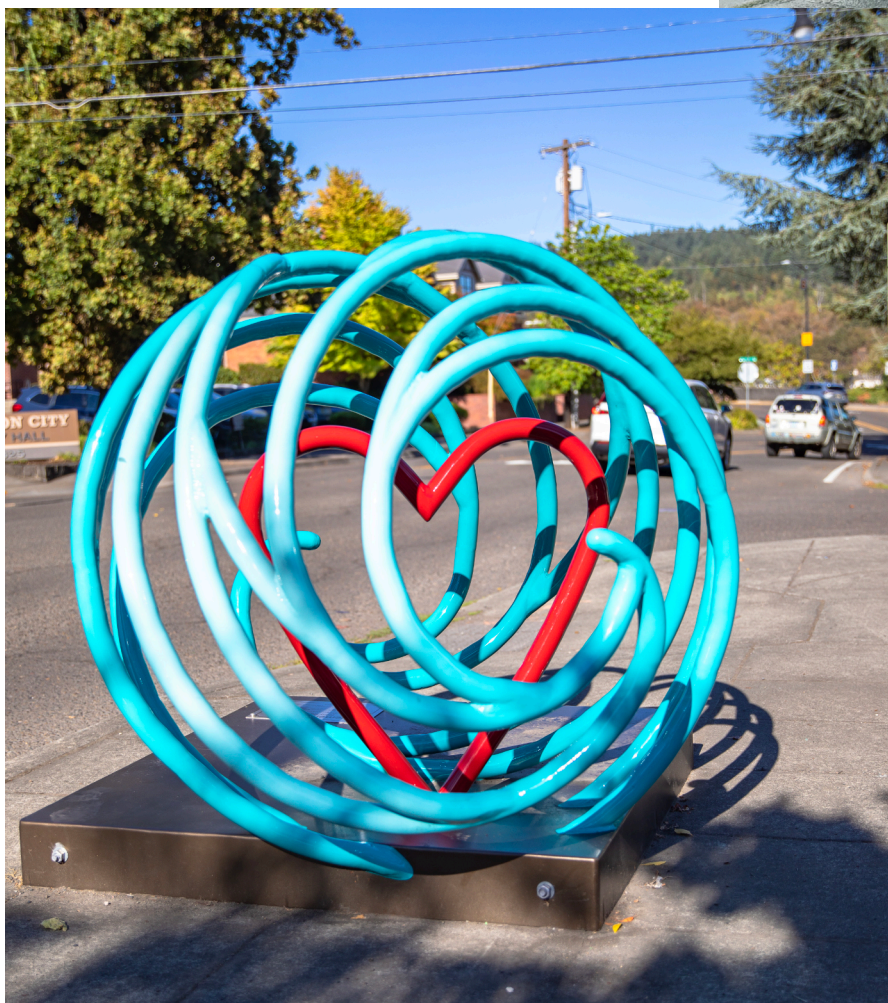
#144 "Ford and Falls" mural series

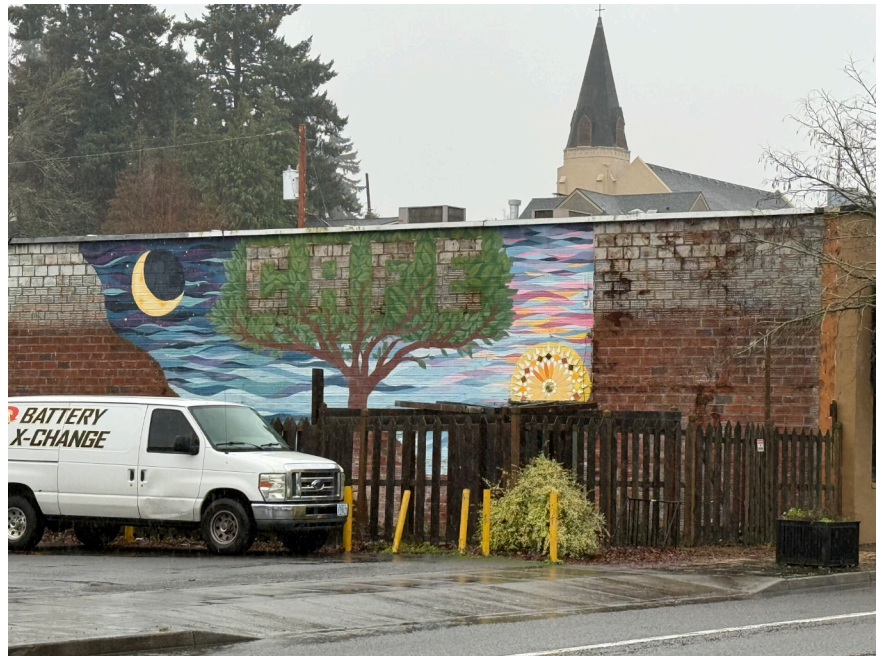
Since the cafe's closing in 2020/2021, the greener had become overgrown with some portions dying and was recently removed. This has significantly changed the visual impact of the piece. The painted and mosaic portion are in good condition.

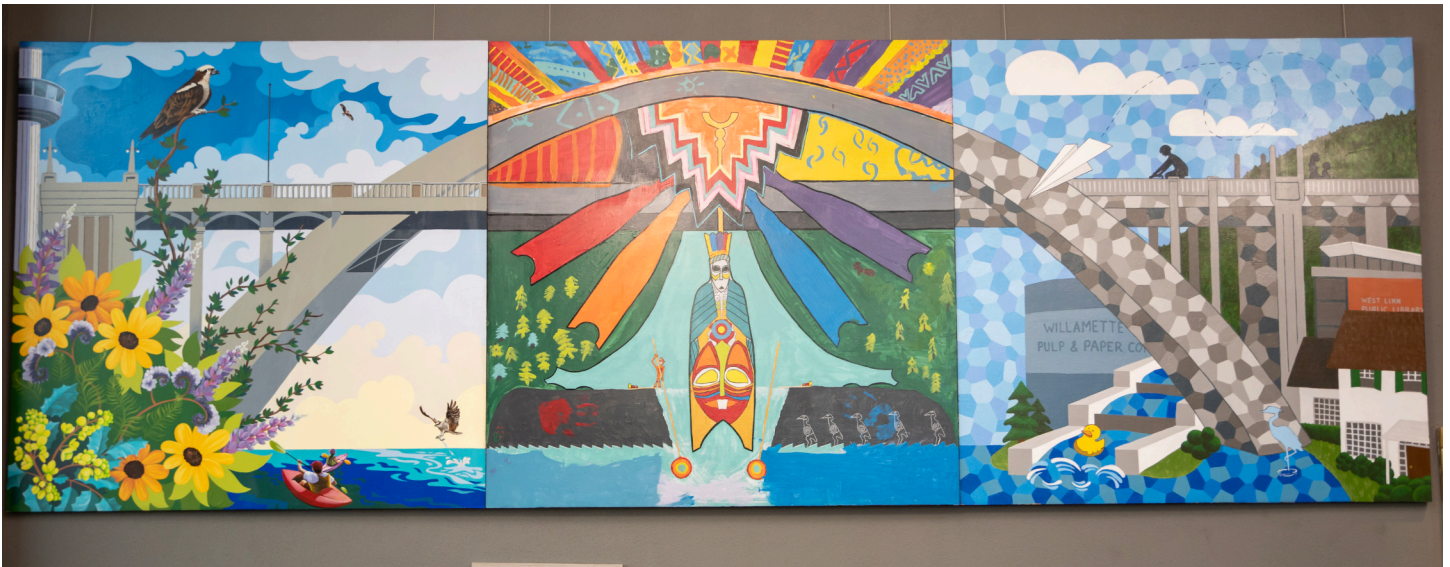
#148 “Building Bridges” collaborative mural project

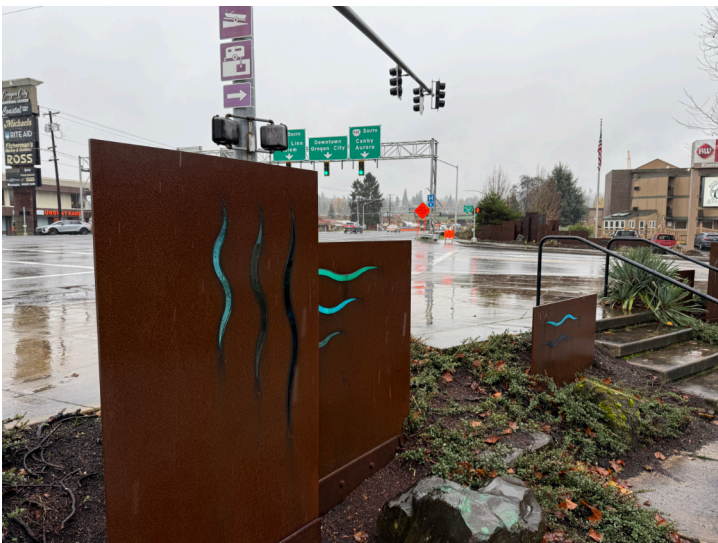
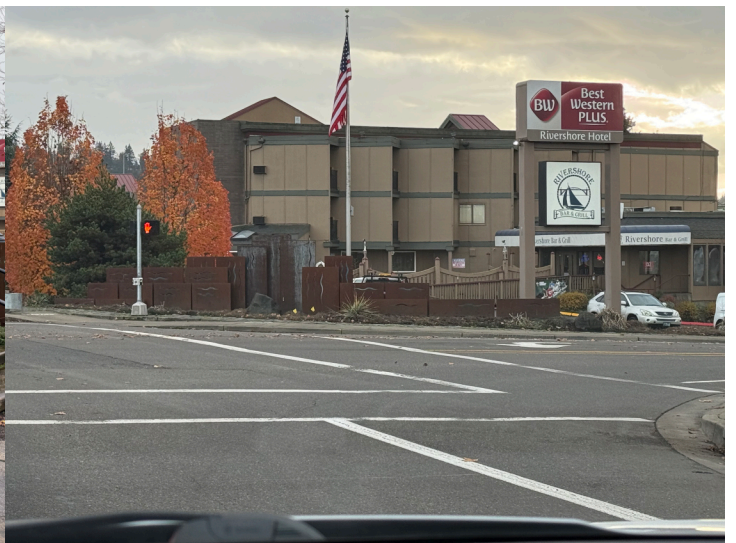
Points of action for the Arts Commission
