## **CITY OF OREGON CITY URBAN RENEWAL COMMISSION AGENDA**

## Residential Repair Review

## Residential Repair Report

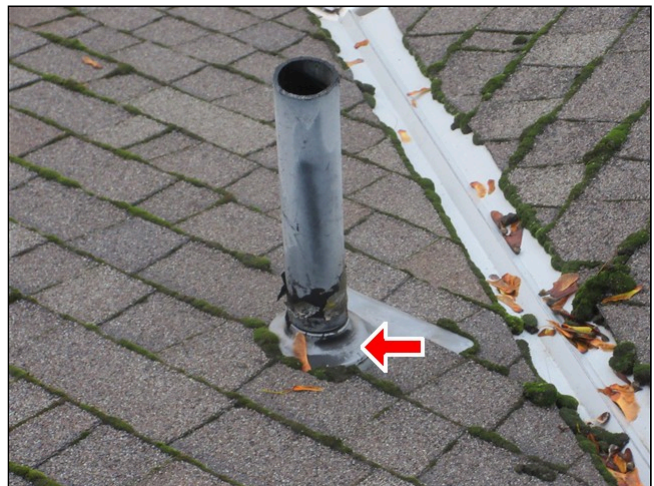
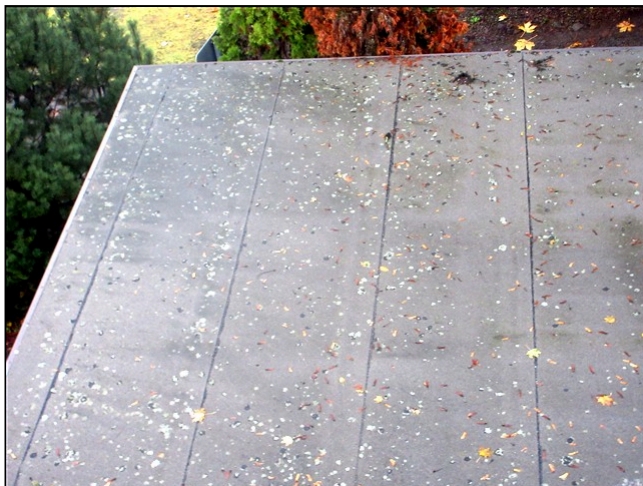
**Old, worn through roof on home & carport needs replacing by a roofing contractor including new vents & flashings.**

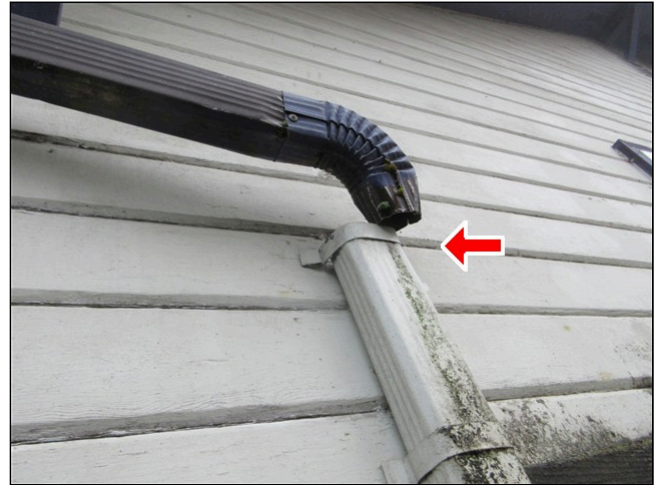
1.3 Item 1(Picture)

**Damaged, loose & leaking gutters & downspouts need replacing when roof is replaced.**

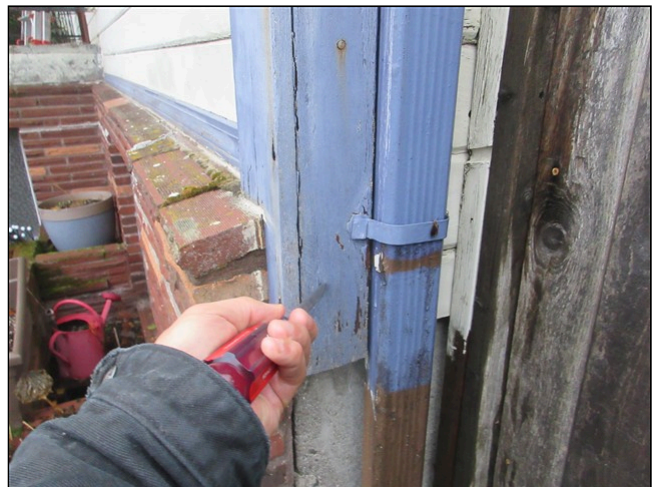
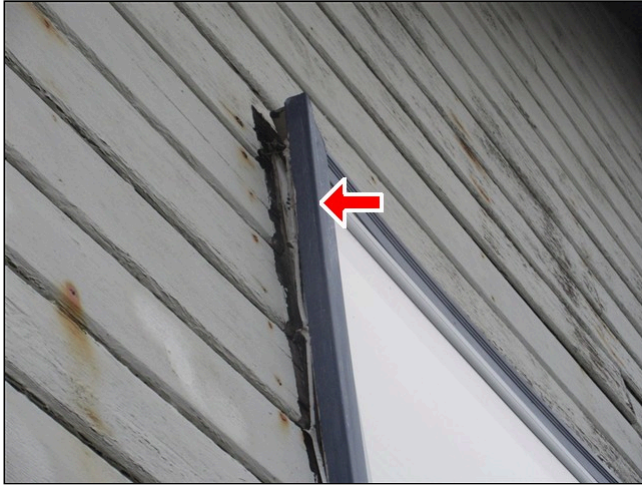
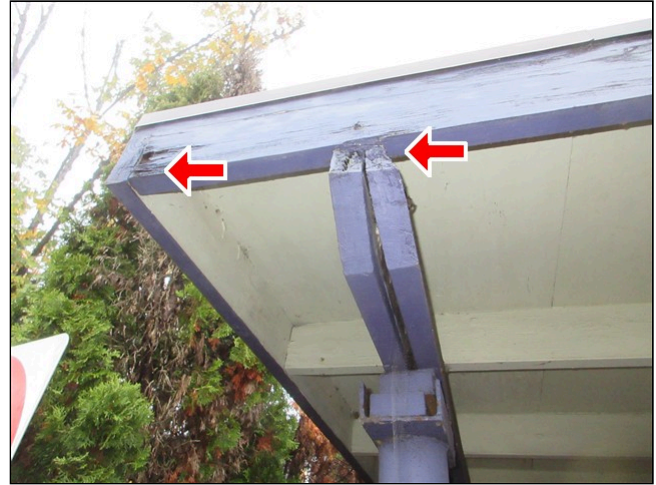
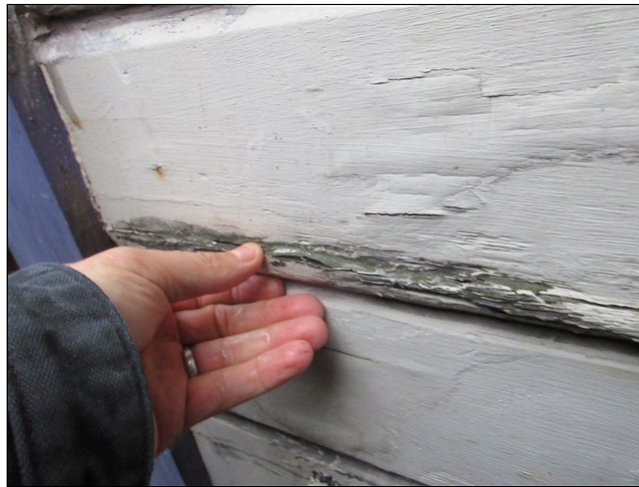
**Siding and trim has bubbling, peeling paint that all needs repainting. Rot needs repair at trim on corners, fascia & around windows where needed. Loose trim boards need securing.**

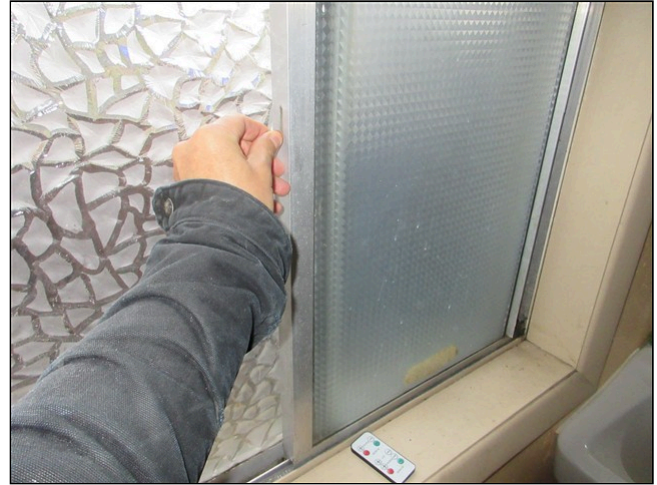
2.2 Item 1(Picture)

**Old metal sliding glass door needs repair to close & lock. Multiple windows need repairs to lock and be more easily operable.**

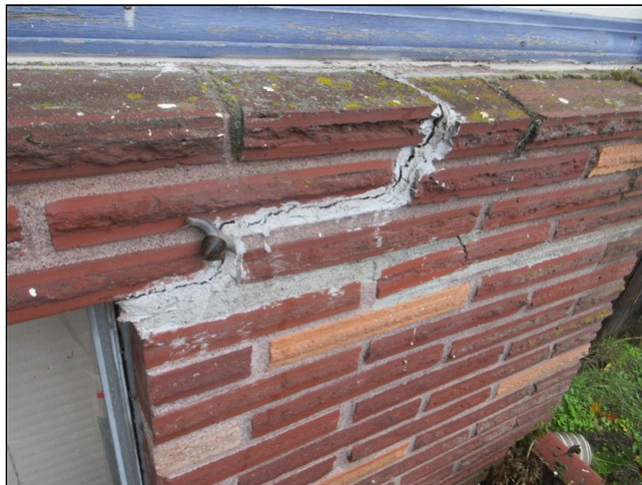
2.5 Item 1(Picture)

(1) **Extensive cracking was note at front porch and brick lower siding that needs repair/ replacing. Loose, corroded porch handrailing needs repair.**

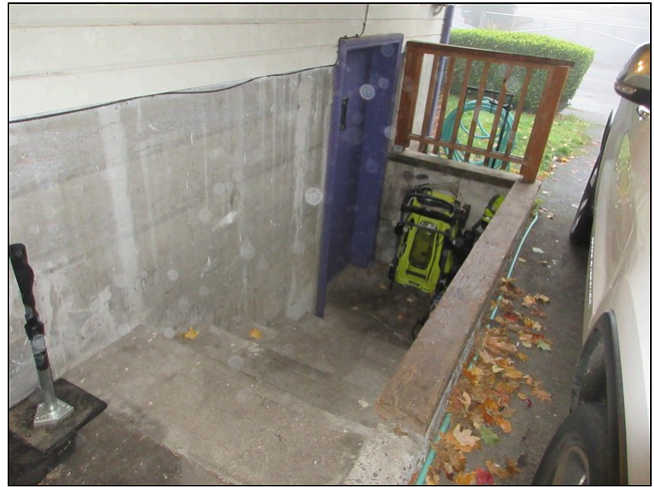
2.5 Item 4(Picture)

(2) **Broken up driveway needs replacing. Cracked rear patio needs repair. Steps need handrailing installed and flashing installed at connection to siding to keep rot from occurring. Side basement entry steps needs handrailing installed.**

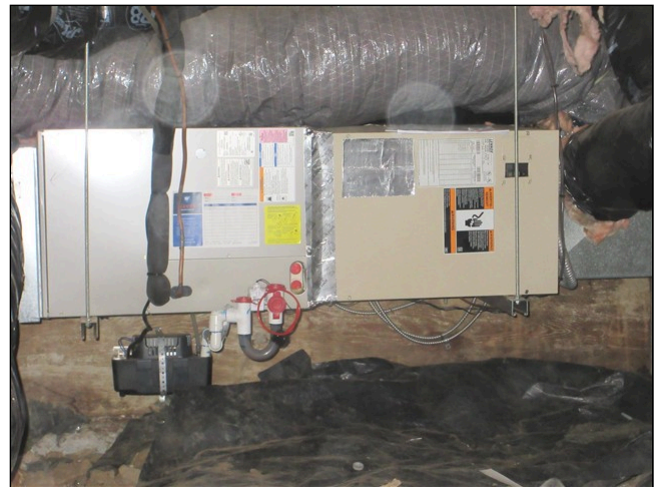
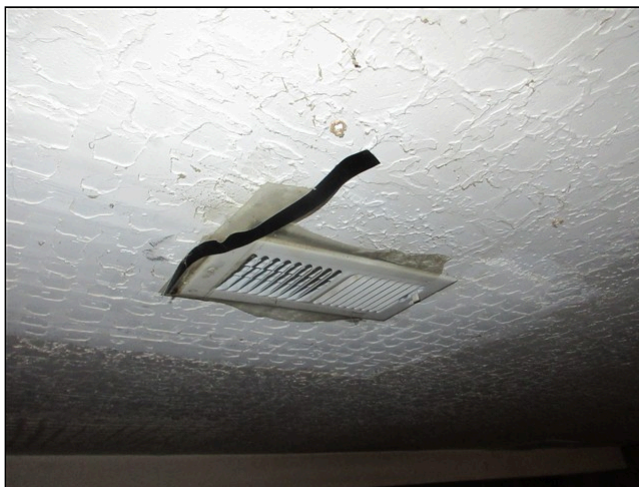
**Furnace & AC units need servicing and cleaning by a heating contractor to maintain including cleaning out ducting. Loose registers need securing.**

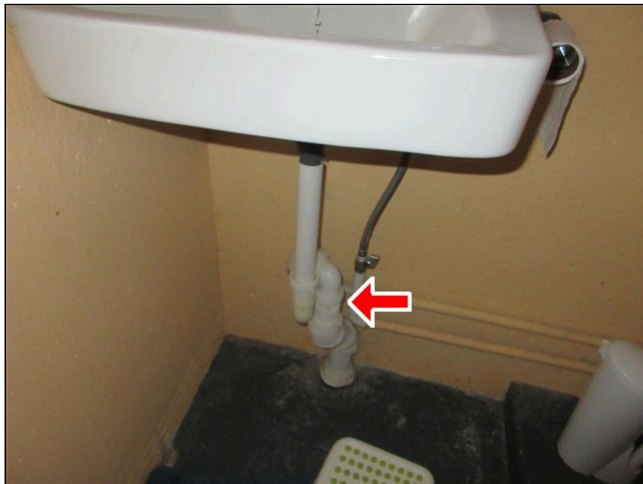
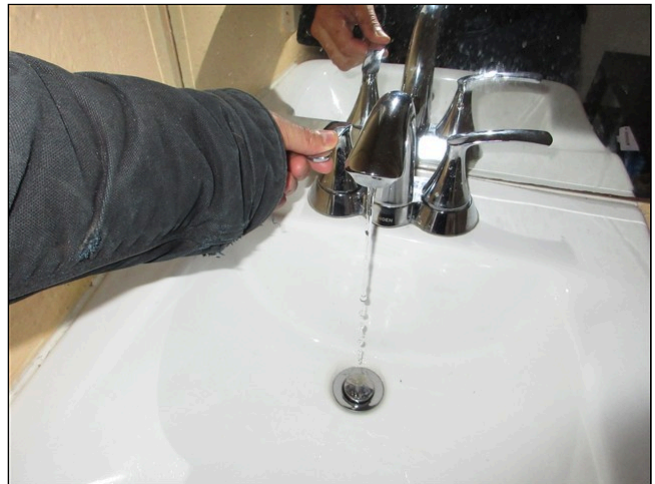
(3) **Basement bathroom needs AAV installed on sink drain to vent correctly. Loose sink faucet needs securing. Missing vent fan needs installation to exhaust moisture to exterior.**

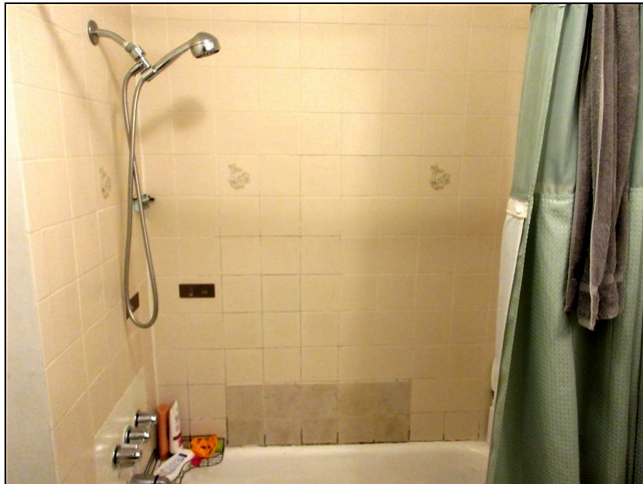
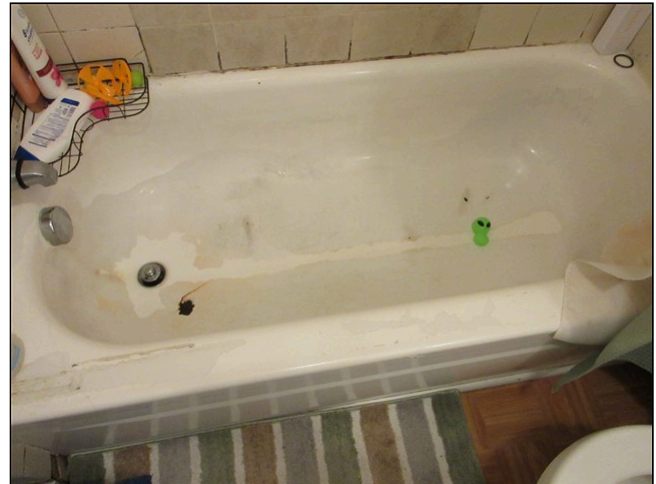
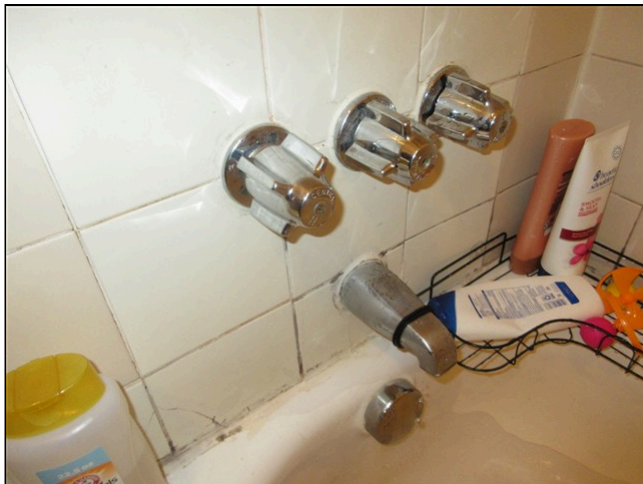
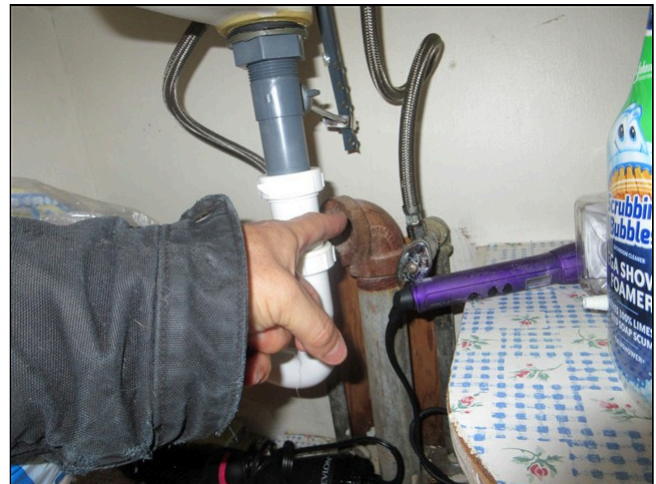
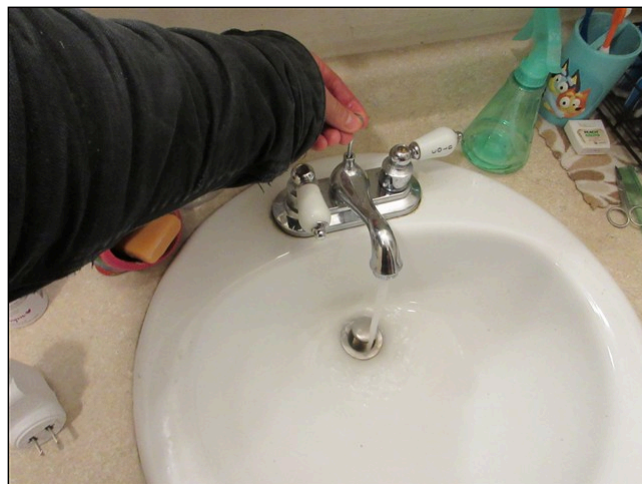
(4) **Main floor bathroom has poorly patched, leaking tile surround at shower that needs tear out and replacement. Heavily chipped tub also needs replacing. Leaking shower valve handles need repair. Sink drain needs AAV installed to vent drain pipe. Sink drain plug needs repair.**

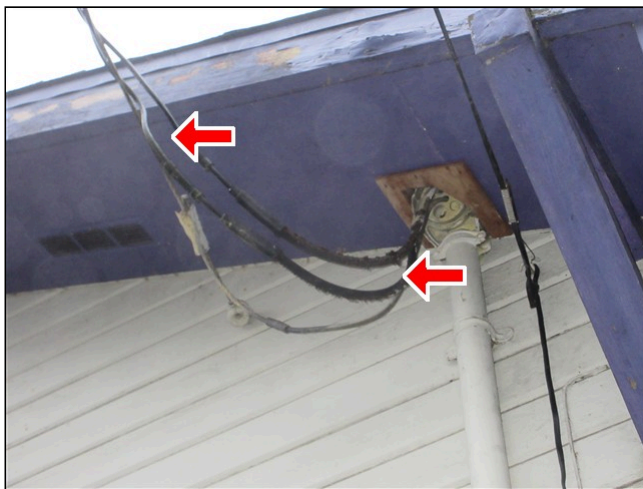
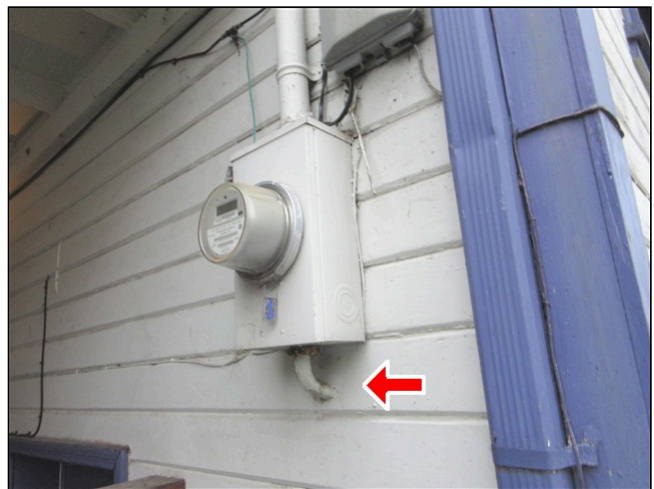
**Old frayed electrical service entrance cables need replacing including enclosing lower service cable that's exposed in conduit for safety.**

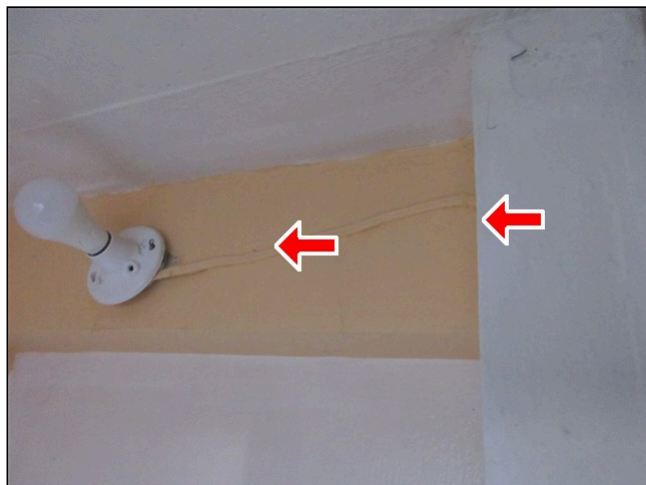
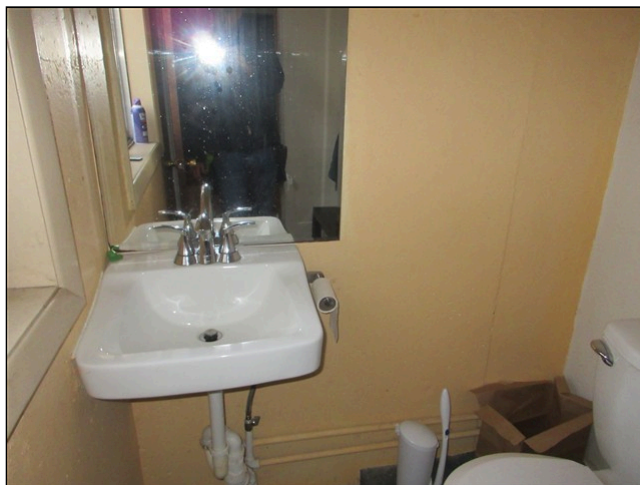
**Basement bathroom needs GFCI outlet installed by sink. Exposed wiring to light needs enclosing in conduit.**

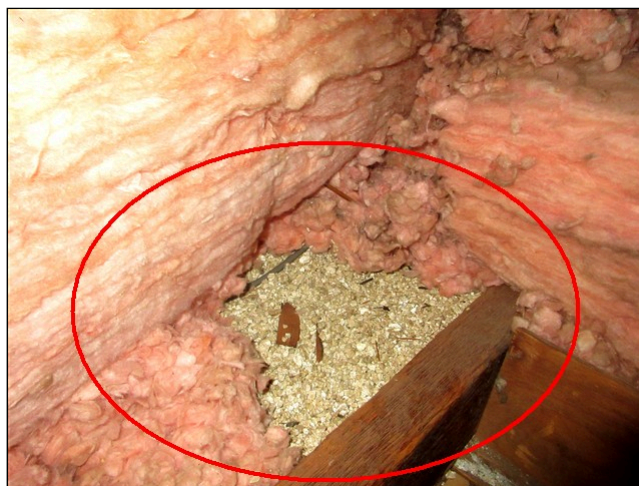
8.0 Item 1(Picture)

**Vermiculite insulation was noted in attic which contains asbestos and will need removal by an asbestos remediation contractor. Note: No new insulation can be installed over old knob & tube wiring if found and will need replacing also.**

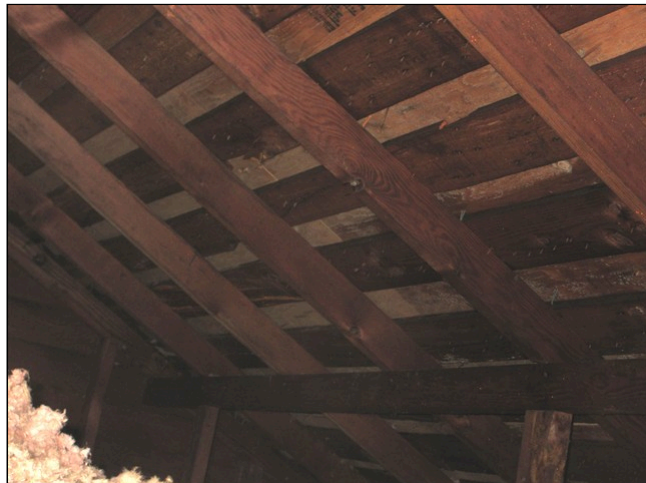
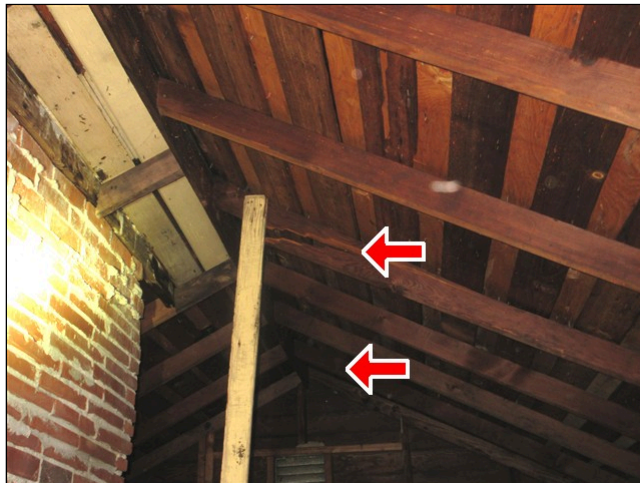
**Mold growth was noted throughout attic and needs removal by a mold remediation contractor. Cracked rafters need repair where needed.**

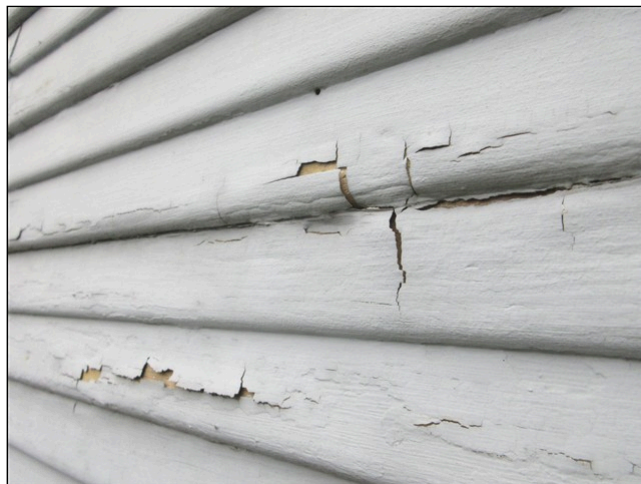
2.0 Item 3(Picture)

**Siding and trim has peeling, bubbling paint and needs house & garage to be repainted. Missing lower belly board trim needs installation.**

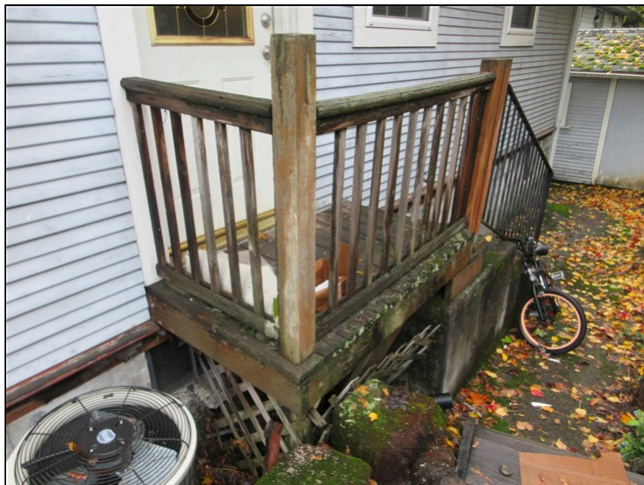
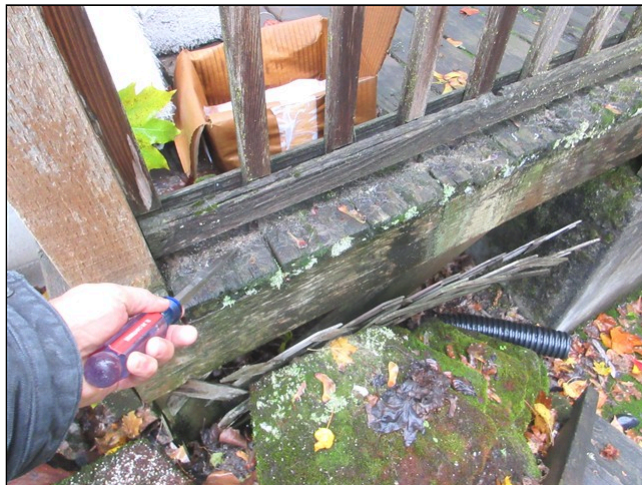
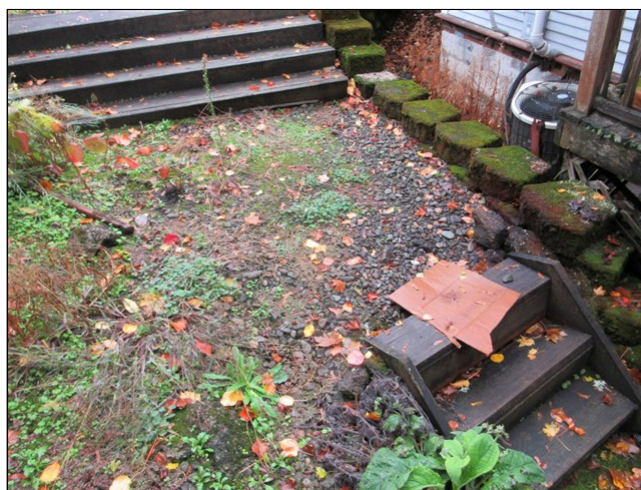
**Old, rotted rear entry deck needs replacing. Displaced, rotted landscape steps need replacing.**

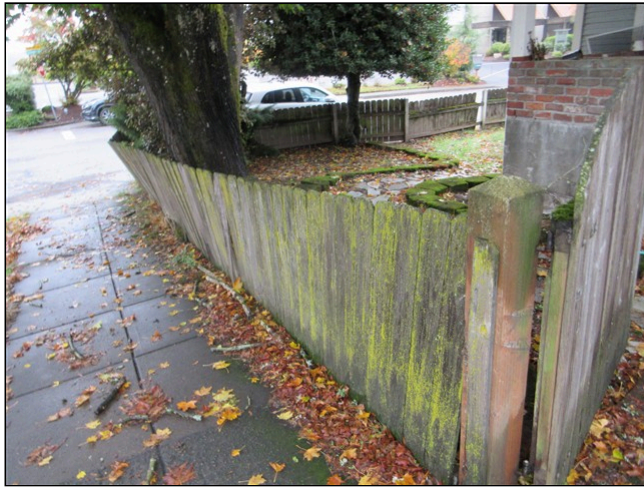
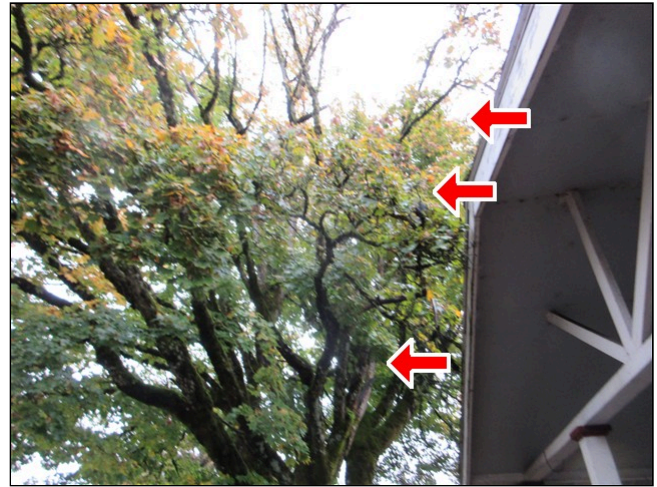
(1) **Rotted fencing needs replacing. Trees need pruning well away from home & garage.**

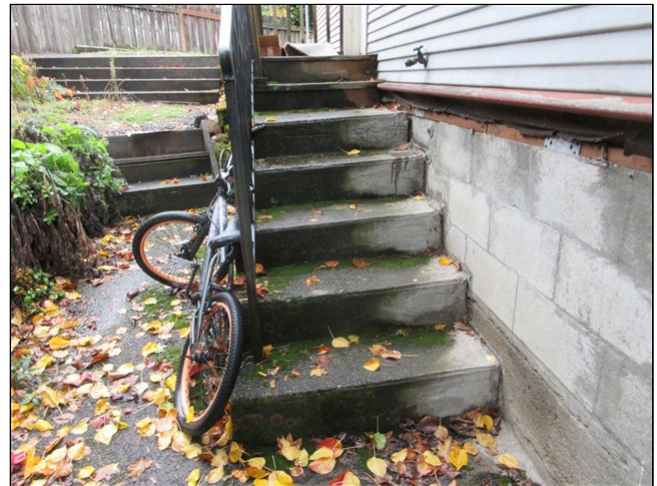
2.5 Item 4(Picture)

(2) **Front porch needs handrailing installed. Rear entry steps have broken away from house and needs replacing. Broken up driveway needs replacing.**

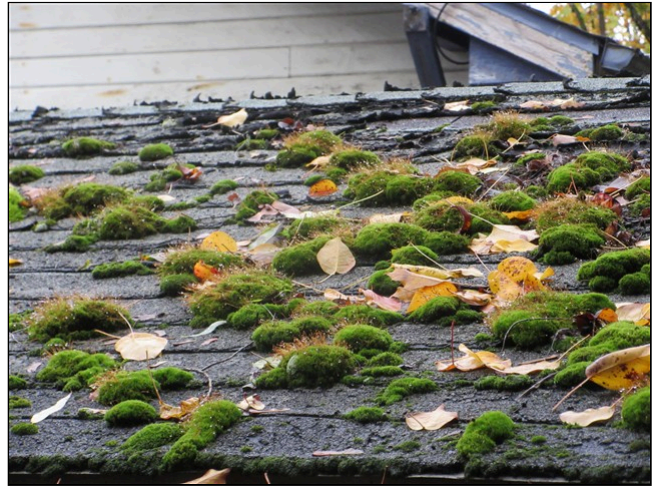
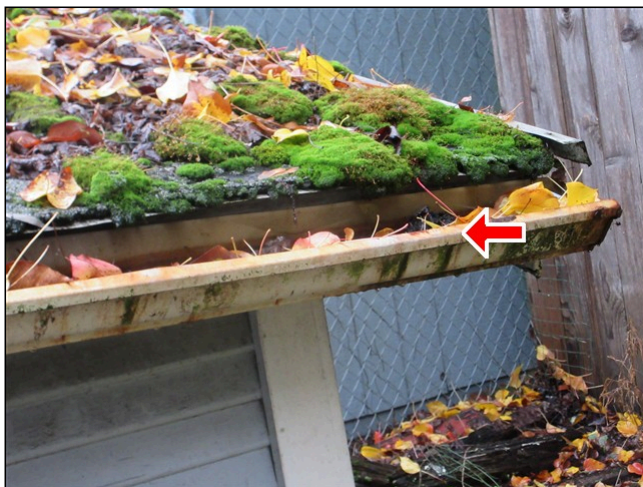
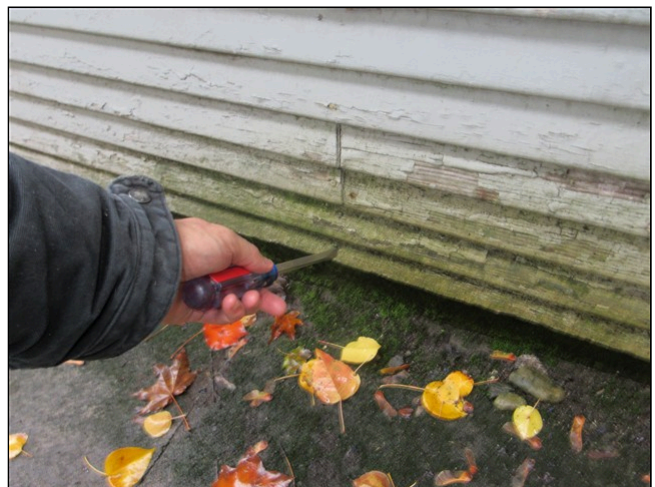
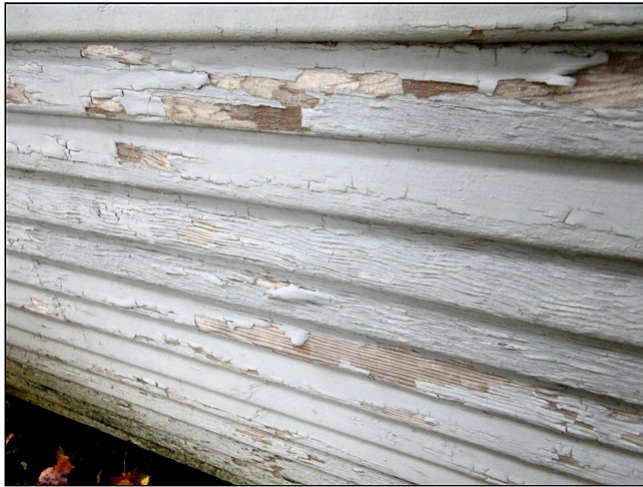
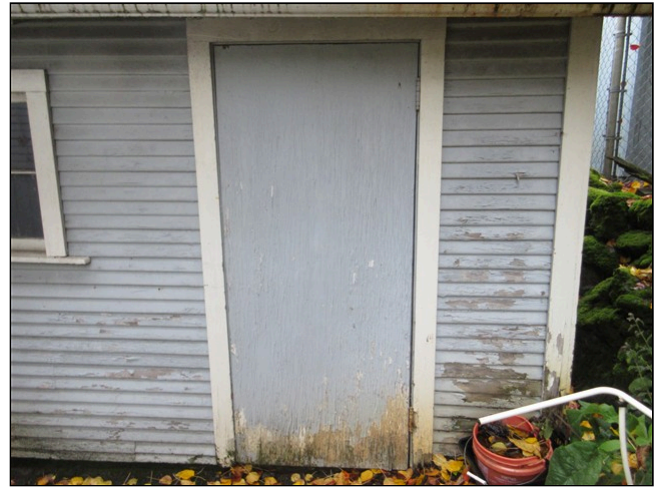
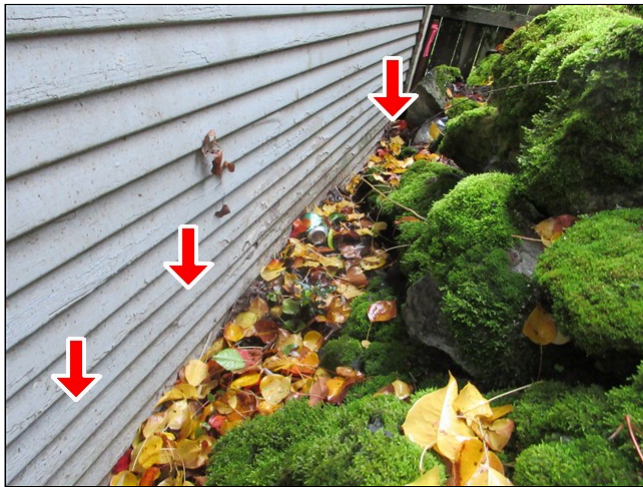
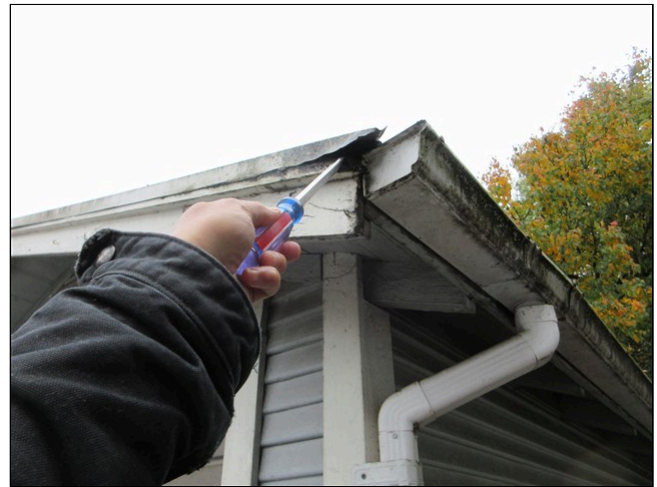
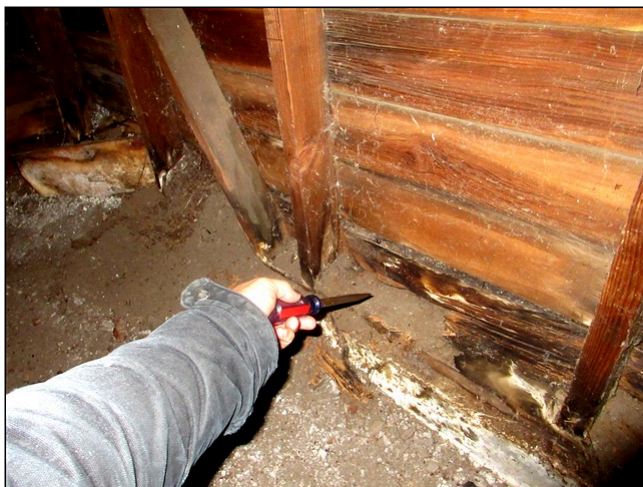
**Old garage structure needs repairs including tear off and replacement of worn through roof. Broken leaking gutters/downspouts need replacing. Entry door needs replacing to be operable. Siding and trim needs repair where rotted at base and building repainted. Siding to ground contact at base of building needs digging out to keep 3-4" spacing in place. Lower walls & sill plate at foundation is rotted and needs repair. Electrical has been decommissioned and no longer functions.**

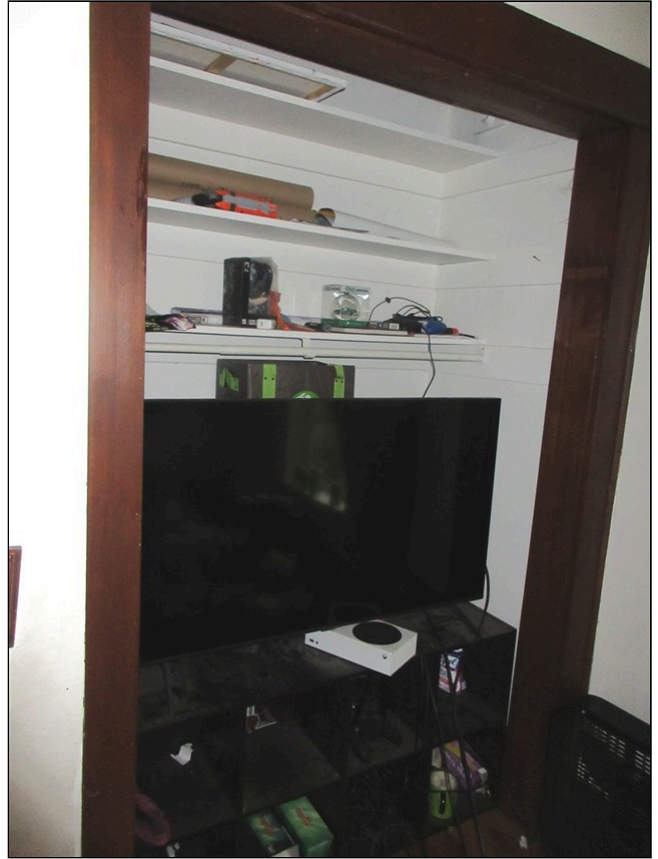
4.5 Item 2(Picture)

**Missing closet doors need installation where needed. Note: Top floor ceiling height is under**

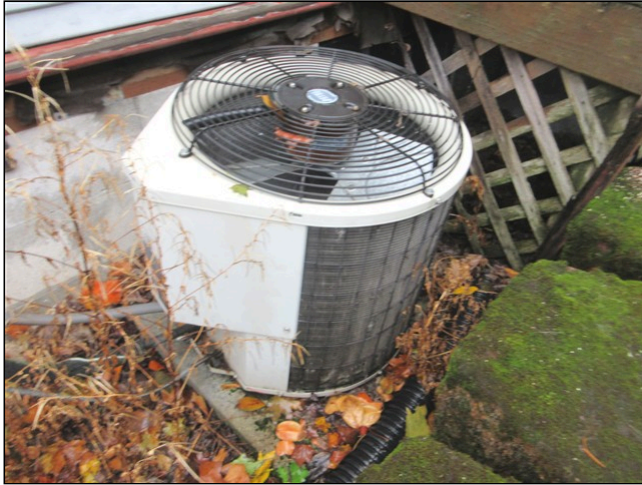
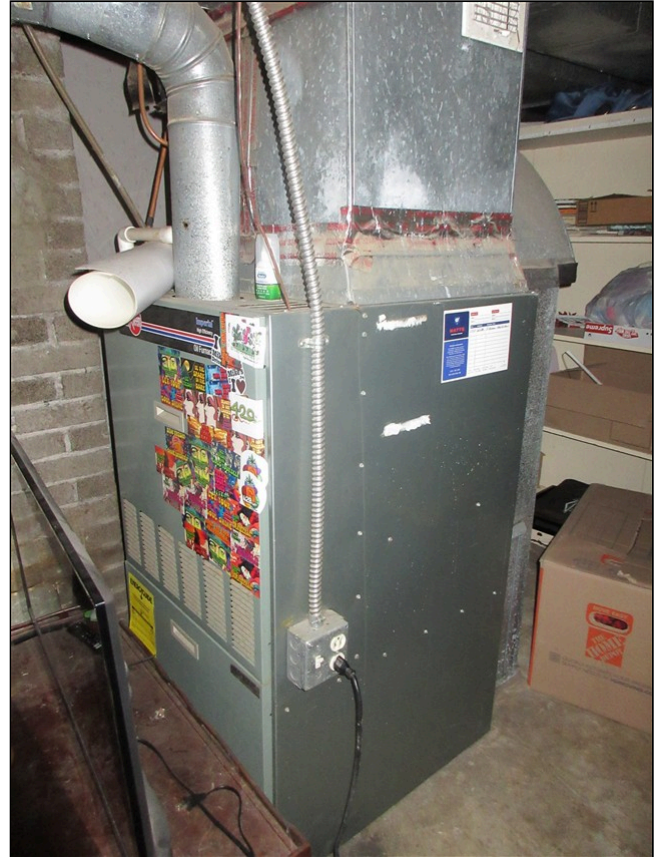
**Old oil furnace & AC units need servicing and cleaning by a heating contractor including cleaning out ducting. Units are over 20 yrs old and are nearing the end of there useful lifespans.**

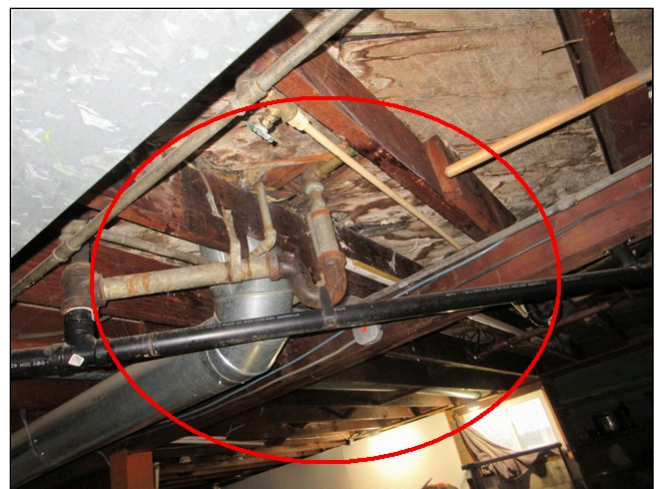
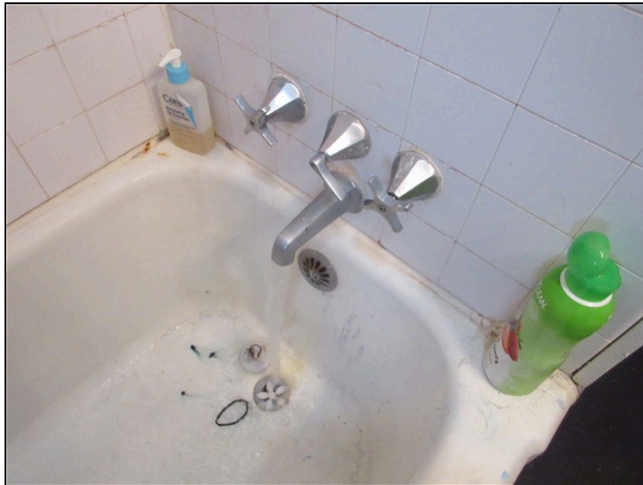
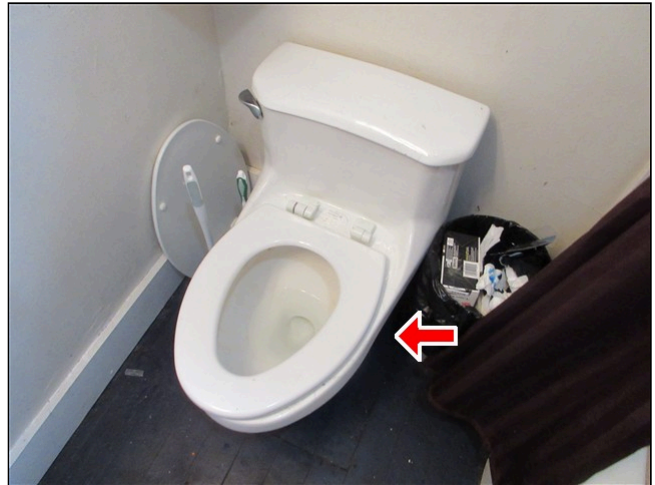
(3) **Disconnected plumbing vent at basement ceiling needs repair. Plumbing drain that extends through hvac ducting needs relocating.**

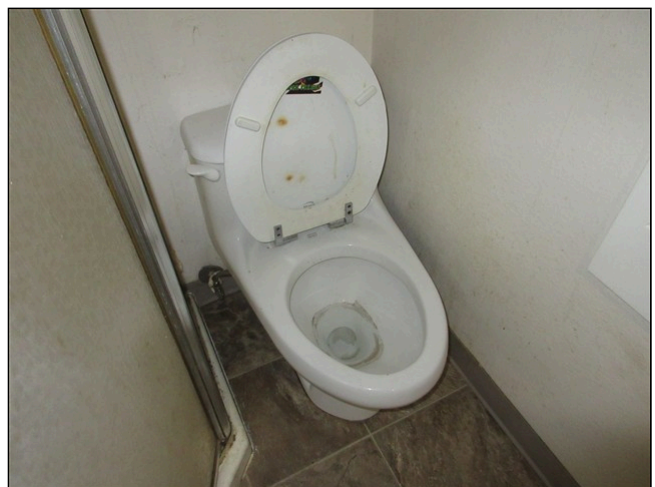
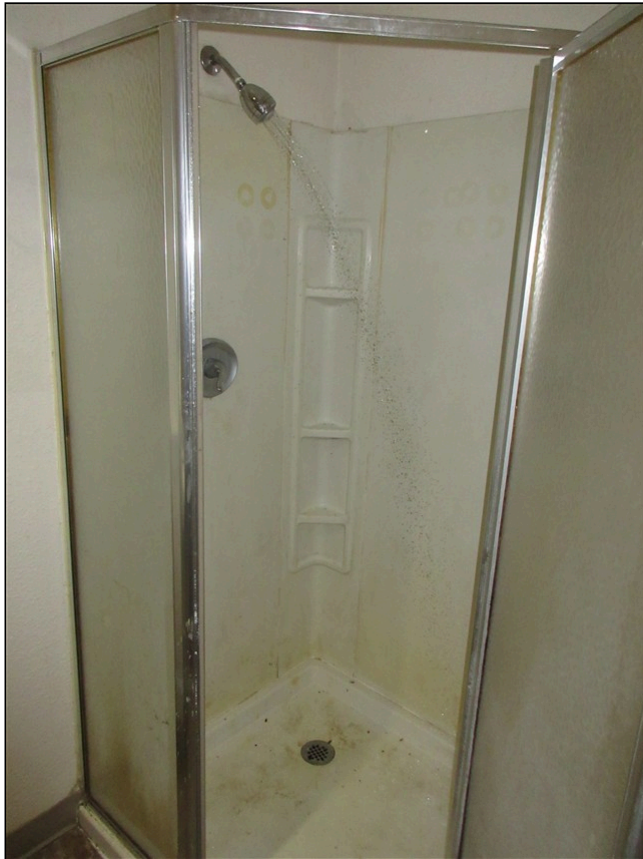
**(4) Main floor hallway bathroom needs leaking shower tile surround replaced and leaking valve handles repaired. Loose toilet needs reinstallation with new wax ring to keep from leaking. Sink needs drain p trap installed with AAV vent under sink instead of through floor.**

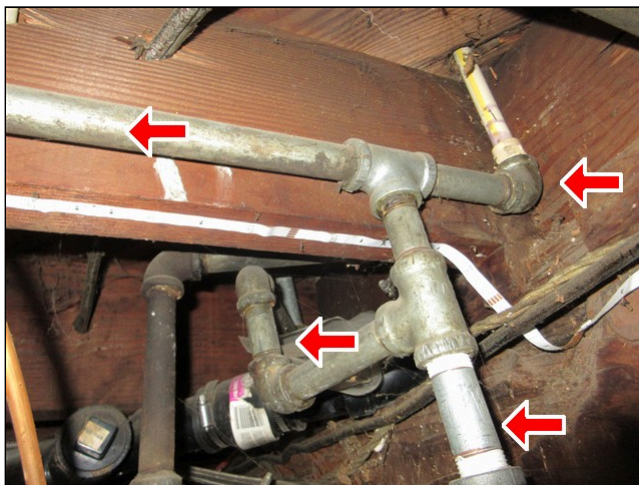
6.1 Item 1(Picture)

**Water supply piping throughout house is old galvanized type that rusts over time and leaks or causes pressure problems without warning. Due to poor pressure and corrosion, I recommend all galvanized piping be replaced with PEX.**

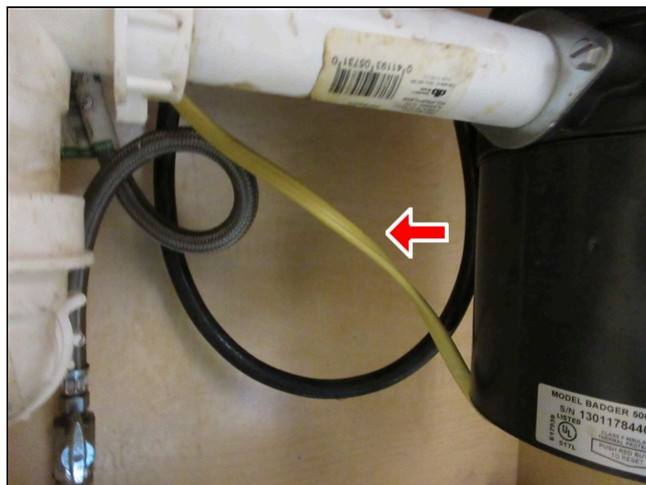
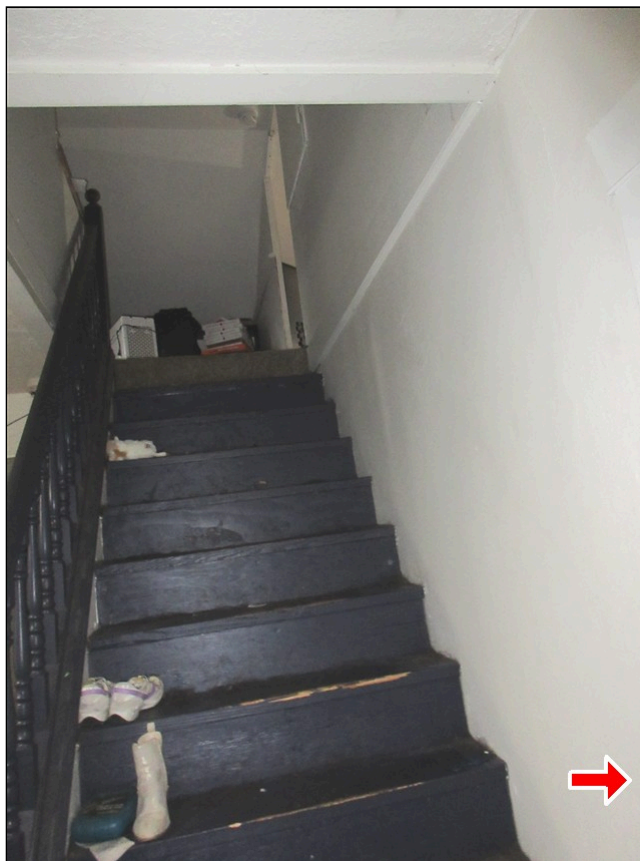
**Exposed wiring under kitchen sink needs enclosing in conduit. Light switches need installation at both main & upper floor stairwell to control light from both floors.**
